1). PROJECT : 12AR BOILER HYDRAULIC PRE-TEST (26 JAN):

2). PROJECT – WHEEL LATHE REBUILD:

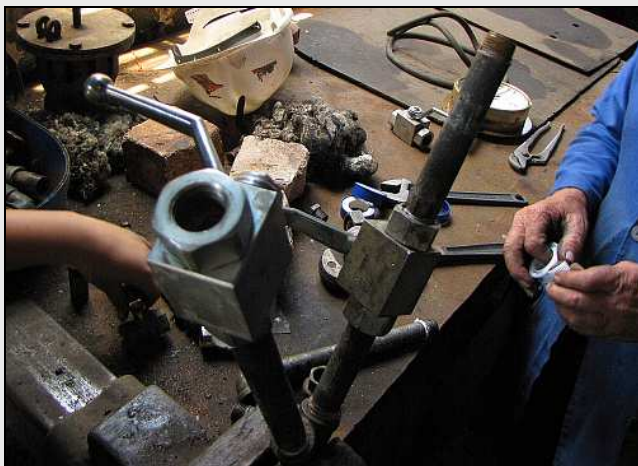
P01 – A view of the two new high-pressure ball valves mounted onto the test injection line. The old valves were cheaper plug-type valves and they were leaking under test pressures and causing false boiler-leak readings. These valves need to hold a seal of at least 1640kPa for 3 hours.

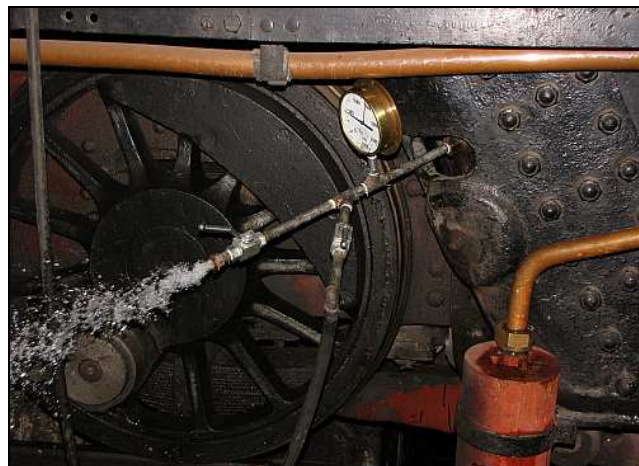
P02 – Here is the finished contraption in use a few hours later while draining the boiler. Note the boiler pressure. The lower valve is the filler line. I was sent out to purchase a tee-piece for that gauge and in classic fashion, the depot chumps had found a spare one by the time I got back. Grrr!

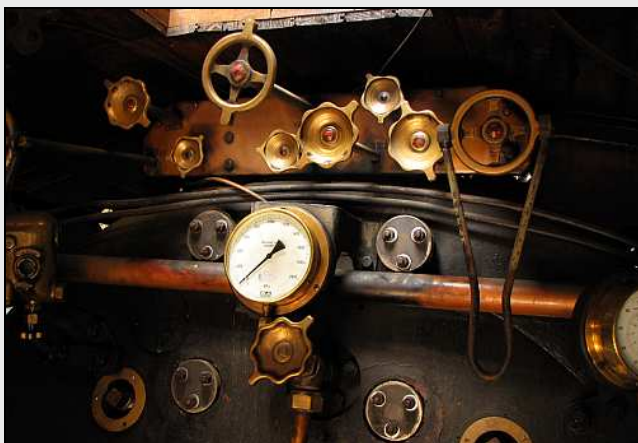
P05 – The serviced gauge in position. It has been recalibrated and certified. However, it won't receive the 'red line' blow-off mark until the boiler is steam tested and the lifting pressures of the two safety valves are set.

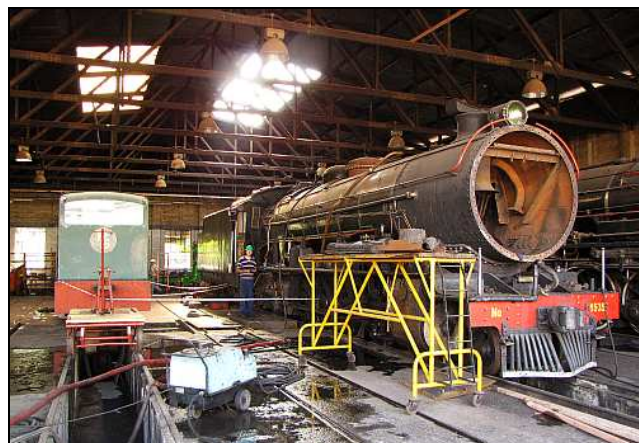
P06 – George tops up the boiler (via a hydrant) using a top washout plug hole. The blue WAP pressure cleaner in the foreground was to be used to pressurize the pre-filled boiler – but some spectacularly bad wiring shot that idea down.

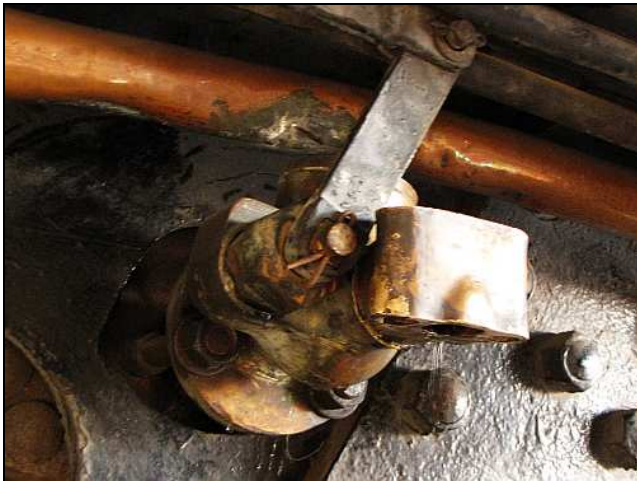
P07 – Oh! This would be SO annoying! The RHS blow down valve is leaking at the conical joint behind that bolted flange. The water was just leaking by gravity and the blow down valve hadn't been sealed for full pressure testing yet.

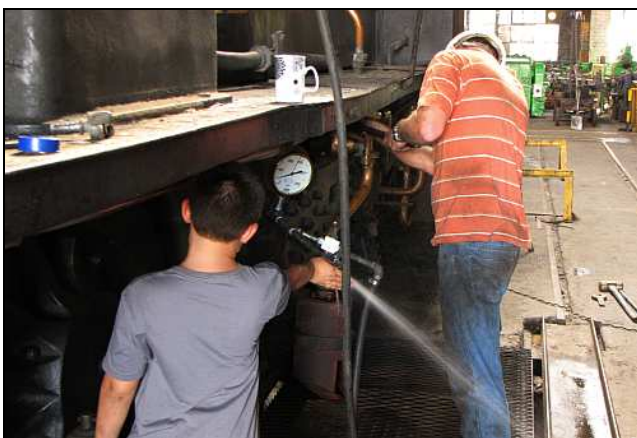
P11 – With the initial pressure bled off, Gabriel is playing with the drain water stream while his 'Bops' is attempting to tap the blow down valve's spacer tube into a better alignment for seating after loosening the span bolts. The improvement was only minor – the two valves would be removed and the spacer serviced the following week.

The leaking blow-down spacers were removed and ground-in again during the week and another attempt was made to pre-test the boiler on Sat, 9 Feb. – to get it pre-tested before the official boiler test on Wednesday, 13 Feb. Initially the blow-downs continued to weep a bit at their flanges but they were tightened up. All this palaver is the reason why Reefsteamers blanks blow-downs at their discharge elbows, rather than at the aperture in the firebox side wrapper sheet.

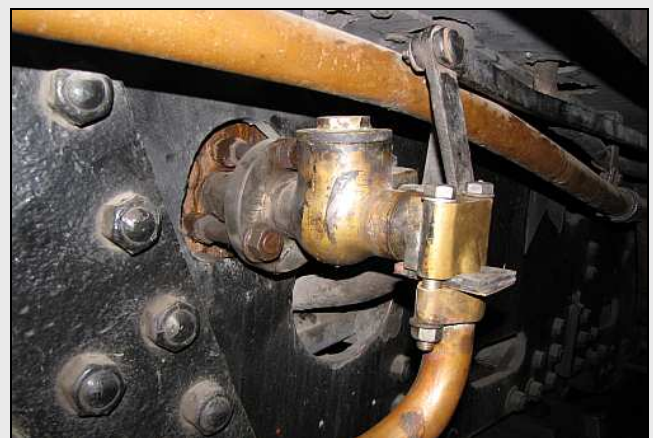
P12 – A blow down valve properly sealed for the later high-pressure hydraulic testing, with a rubber sheet and a steel backing plate securely plugging the outlet. At this angle, you can see the troublesome spacer tube behind the flange. You can also see false water leak trails caused by the water running down from the overflow spout far above.

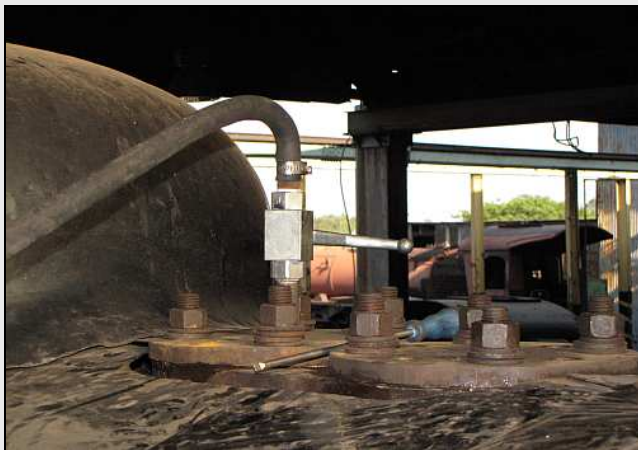
P13 – Even with the piddly blow down spacers leaking on both sides, it was judged worthwhile to pressurize the boiler again. But first, the dodgy venting valve was removed and replaced with this high pressure model. The blanking plates are where the dual safety valves would normally go.

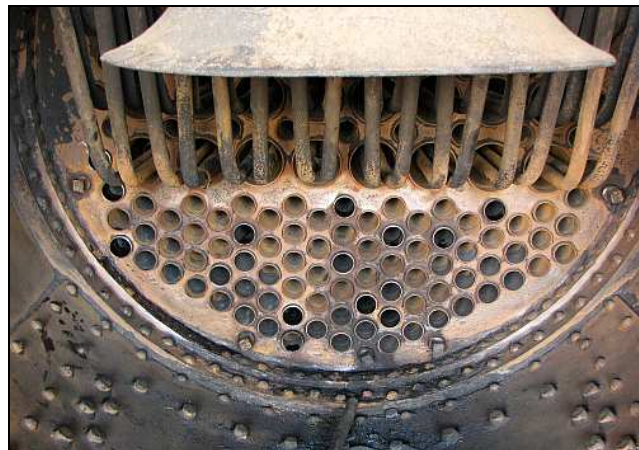
P14 – With the sealed boiler filled up to water mains pressure, there is no sign of a water leak at the recently completed front tube plate. This was between 700-800kPa. The tube plate had been labourously cleaned with a pneumatic wire brush the previous week by Jeremy Wood.

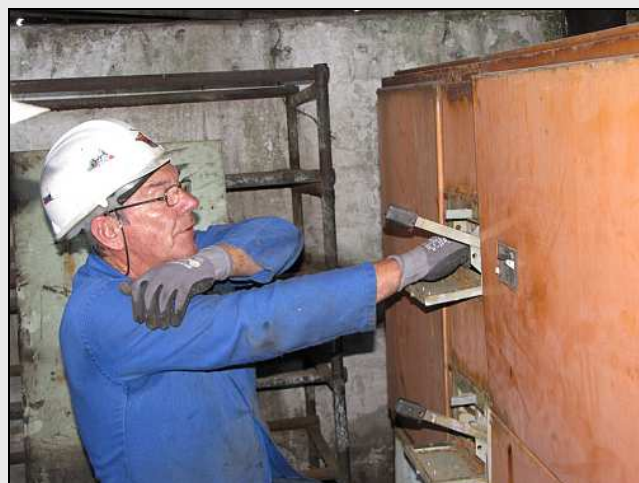
P16 – The wiring for the WAP machine was in bad shape and also had a phase switched with a neutral. It turned out that this board is overfused, and instead of tripping, it allowed the wiring to overheat. Gordon condemned the wiring immediately. Here he is nervously trying to open the fused isolator on the MCC panel in the wheel lathe house. He is deliberately wearing the rubber gloves in this picture.

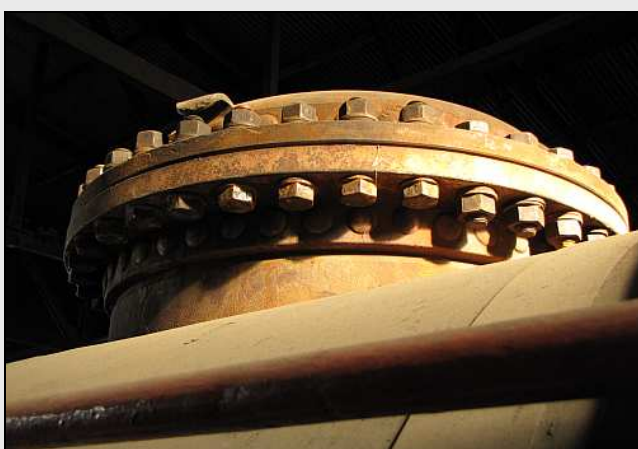
P17 – The dome gave us much trouble when the 12AR was recommissioned three years ago. This time it didn't have to be disturbed so we are confident of no leaks here. (Leaked like a sieve on 9 Feb, but one round on the nuts fixed it!)

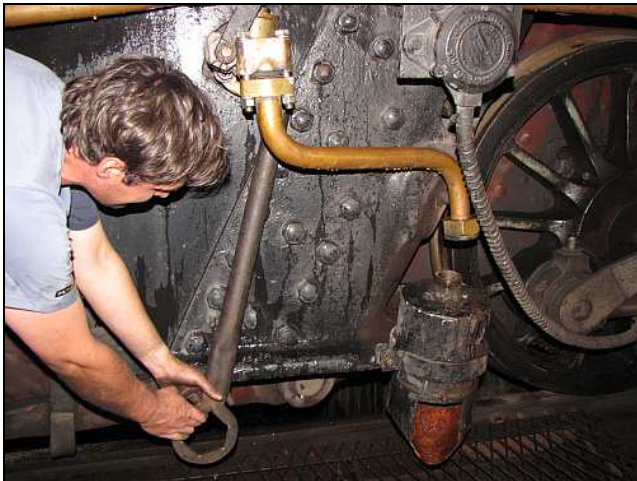
P19 – After the outlet elbow had been put on to totally seal the blow-down, and checked for leaks, Dawie takes a few swings at the span bolts in an attempt to tighten the joints. It didn't work, even with Dawie violating his instincts to deliberately try tightening the joints skew against the leaks.

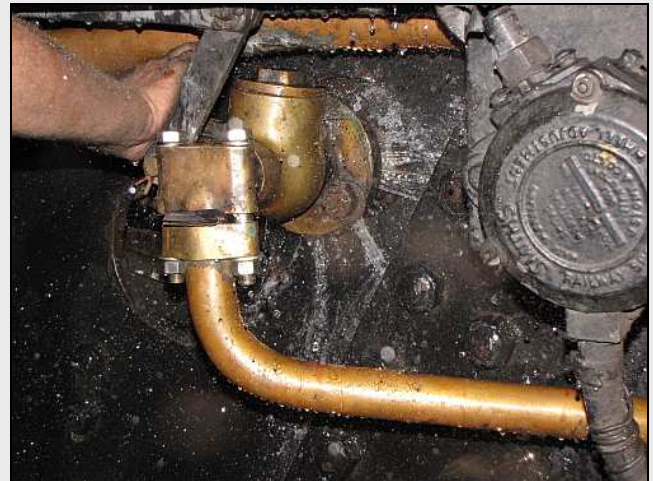
P20 – More wet work. The chaps loosened the bolts to try and free the spacer tube to recentralize it. There was an improvement after a few whacks but no dice. Both blow downs would have to come off and have the spacers and the apertures cleaned and lapped together.

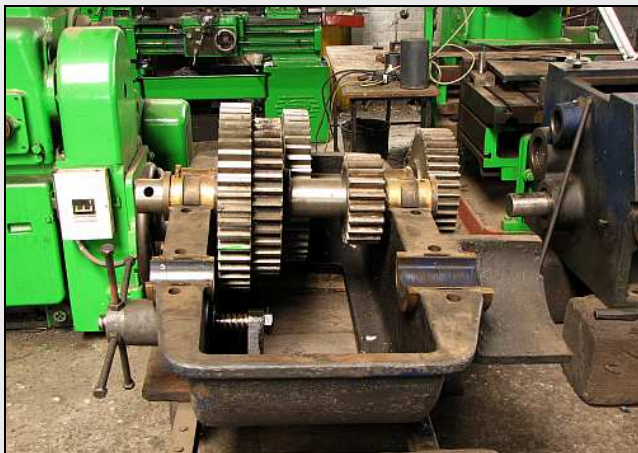
W01 – The completed gear shafts and clusters are being removed and refitted one-by-one as the old shell bearings are being re-lined with Vesconite™. This is to check for the continued correct meshing of the gears as the shaft alignments will change slightly with the new bearings.

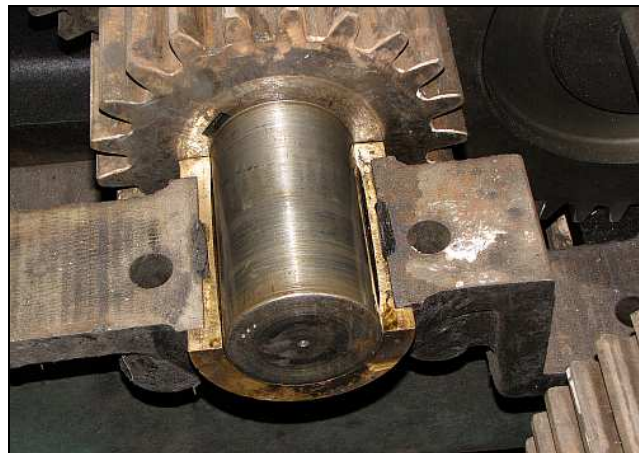
W02 – This original shell bearing previously had the center of its surface milled away as an oil reservoir, fed by an oil hole from above. (It is upside down in the photo) The seal-less gearbox bearings weep oil at the outer end, and need frequent top-ups while the lathe is running.

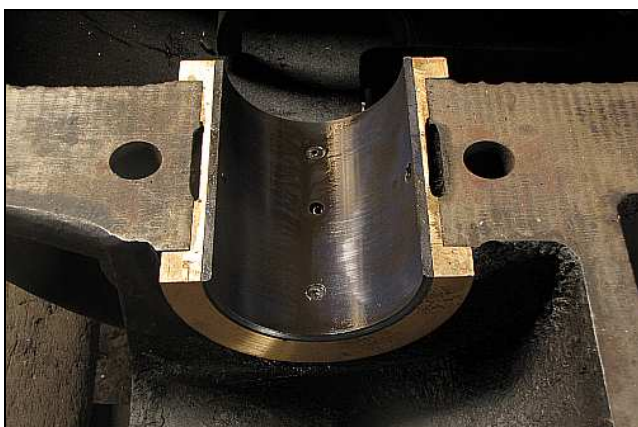
W03 – One of the newly relined bearing shells, with a new Vesconite™ liner. The bronze had been cut back parallel. Vesconite™ is a self-lubricating material. As the shaft now bears on the full length of the bearing the contact pressure is about 3/5 less, meaning less pressure on the oil film.

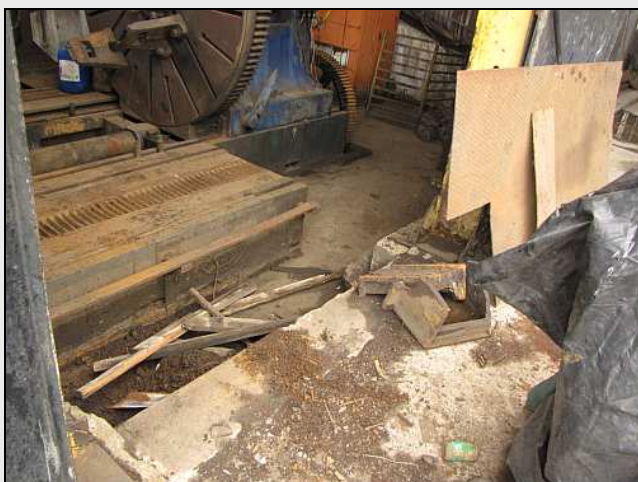
W05 – With the new roof on, it was time to clean out all the junk that was underfoot in the wheel lathe house. This is the entrance way trench - which was totally bunged up with rubbish under the tread-plates and blocking the drainage.

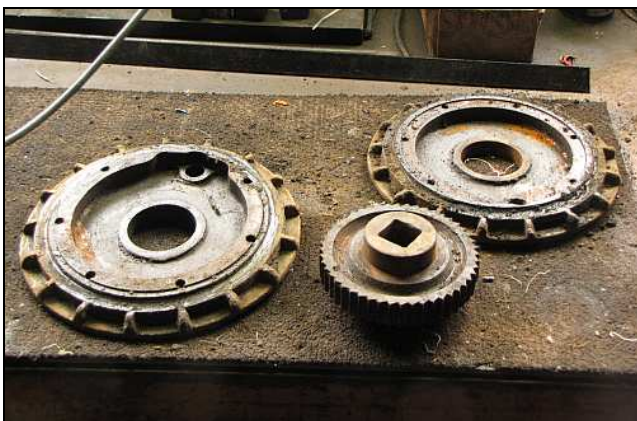
W11 – On the stripping bench, with all the rust that fell off with the handling, one of the ratchet drives for the tool feed has been dismantled and is being examined by Gordon Bennett. At the time, it looked as if one of these was missing and would need to be refabricated.

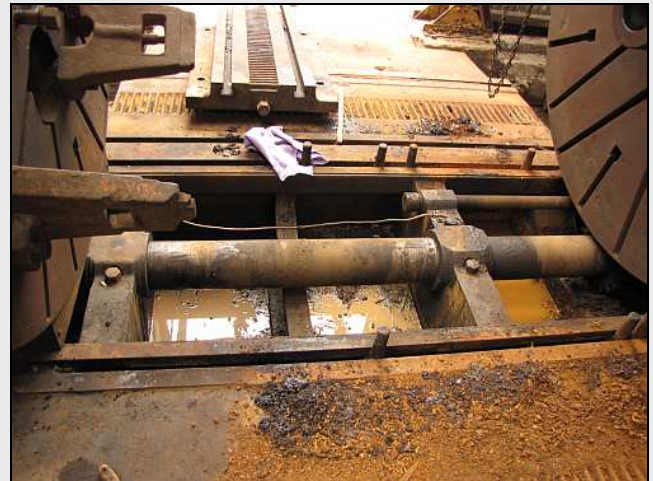
W14 – This was the state of the transfer shaft pit with the project just started. Although the lathe itself was covered in a tarp, water still got into the building through the decayed roof. Note the oil line running to the center bearing.

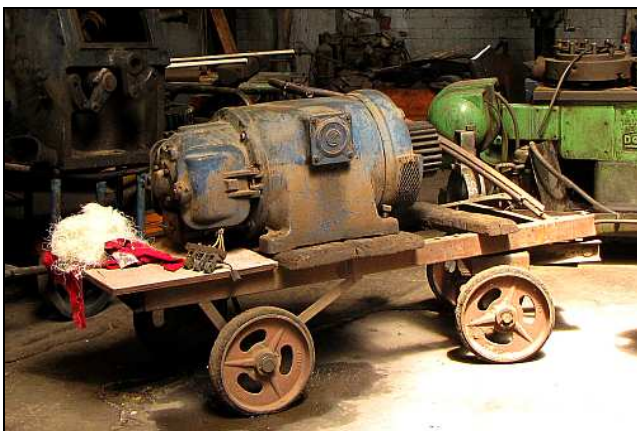
W17 – This is the wheel lathe's drive motor at the start of the project. It has recently been sent to a motor specialist for inspection and overhaul. It is likely to need new slip-ring gear and bearings, but the windings should be OK. We were lent a hydraulic palette loader for the loading job as we can't get the forklift out through the main doors.

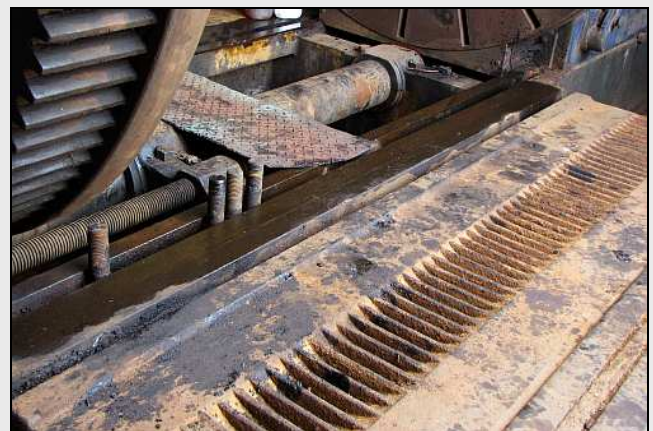
W18 – The sliding tool-stand bolts were found to be stuck. Someone had put a thick layer of bitumen into the traverse groove, probably in hope of stopping the square-shaped heads from rusting up under the old decayed roof. Coenie was tasked with cleaning up the slots – with a fun mixture of solvents, old chisels and scrapers.

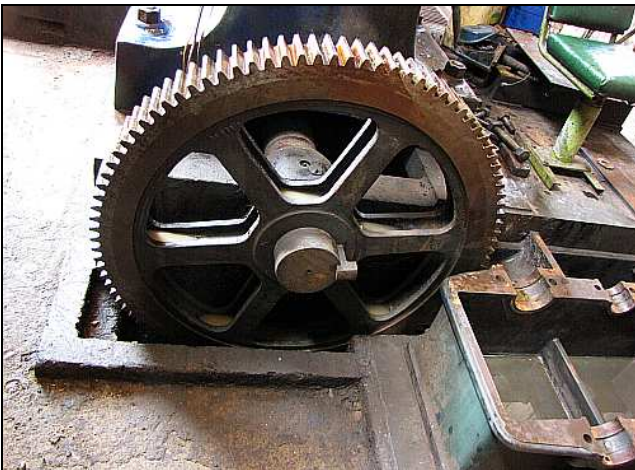
W21 – This is the main gear between the gearbox and the lathe. It has been wiped and then lightly oiled. Notice the key fixing the gear to the shaft. This lathe actually has two gearboxes working in tandem and visible is the lower 1/3 of the 4-speed transfer box. The drive gear was originally caged, (since scrapped) and a new safety cage will be built.

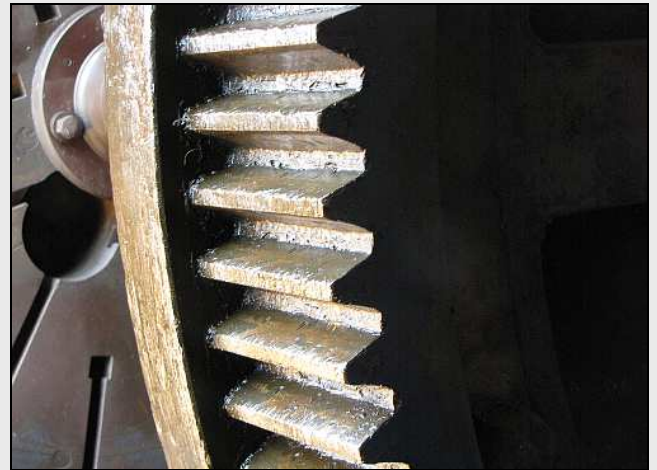
W22 – The ring gears that drive the chucks themselves were also cleaned and then greased. These ring gear teeth are a little worn but still usable. It appears that the main gear damage was confined to the stacked gearboxes, where operators were changing gear ratios before allowing the heavy lathe to coast to a stand-still.

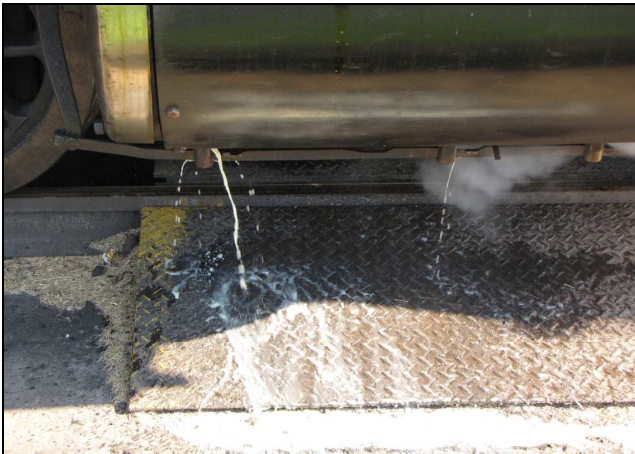
S13 – Safety hazard in the making. The residual steam oil is still running through the cylinders and is going to make that cross ramp very slippery. The steam oil actually forms a soapy emulsion in the cylinders, hence the milky colour.
