**1). REMOVING THE RIGHT SIDE SLIDE BARS – 01 MARCH 2014:**

2). MACHINED SLIDE BARS – 2014-M03-15:

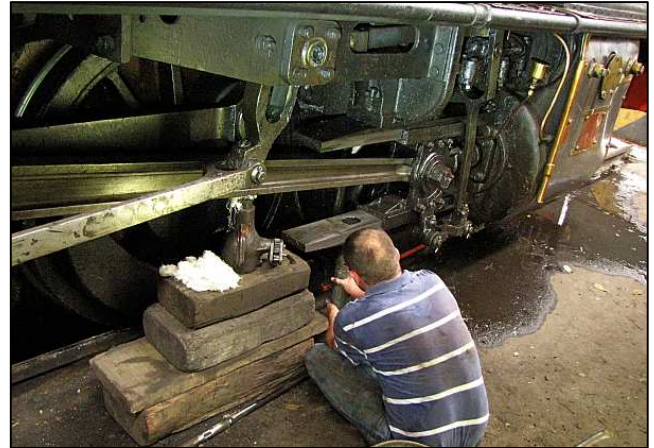
P02 - The center of the lower bar had a clearance of over 4.5mm to the crosshead slipper, when it should be 1mm from end-to-end. The connecting rod was jacked-up to take the weight off the crosshead. Without looking at the rest of the report, can you spot the mistake that had been made?

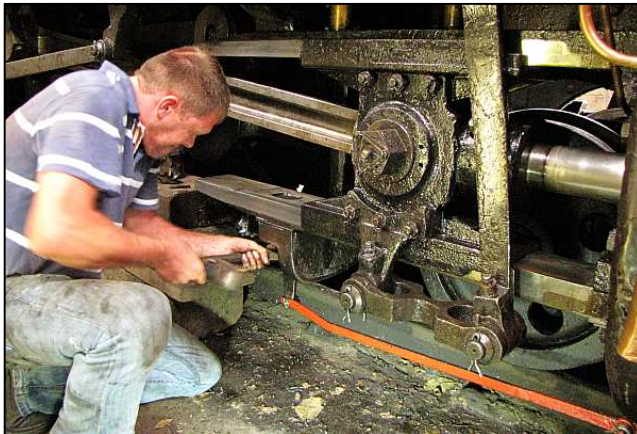
P03 - The lower bar is easy to undo, being held onto the rear motion bracket with a nut running on a captive hex head bolt. (You can see the still oil-filled recess where the bolt head slots in.) The front end is held on by nuts that run on a pair of studs on a ledge under the cylinder gland.

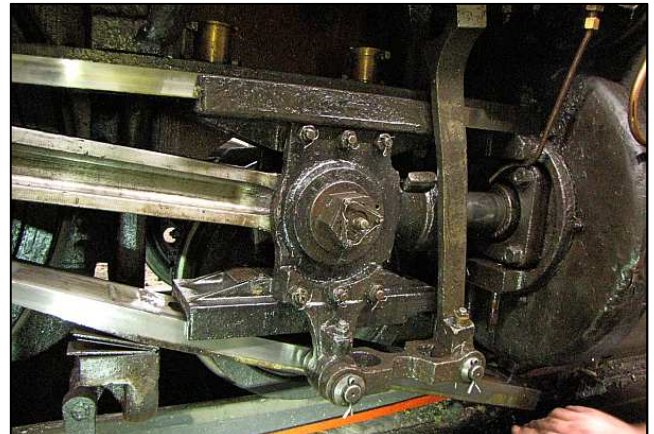
P04 - When uncoupled, the slide bar tips down and forward under its own weight. You can see the stack of shims fanning out on the rear motion bracket. These shims were fitted by Noddy n' Smudge back on 14 April 2013, but even then they knew it that was just a very temporary fix.

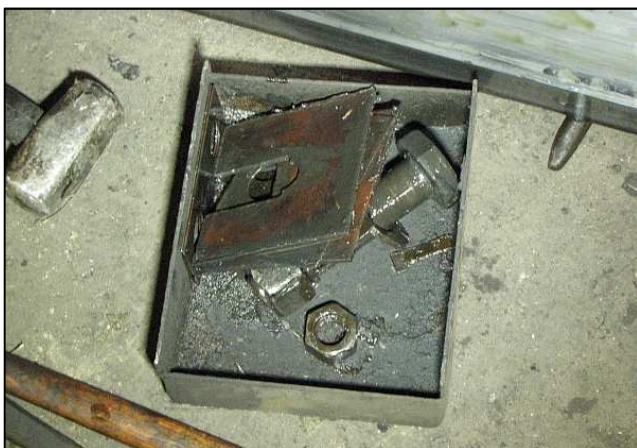
P05 - Here is a spare axle sock-box being used to keep the loose bits and shims together. We need thicker shims, as we will now have to raise the lower bar by about 4.5mm after it has been skimmed. Naturally, we will keep these shims for later use.

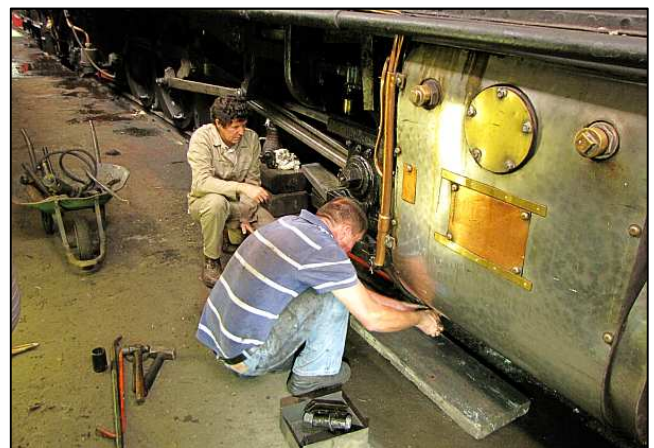
P06 - Although the newly-unbolted slide bar tilted OK away from the crosshead, it was obstructed by the rear cylinder cock. Captain Curley and The Smudge are stubbornly trying to wriggle that bar out past the cock's body but to no avail. (If the crosshead was worn, this might have worked.)

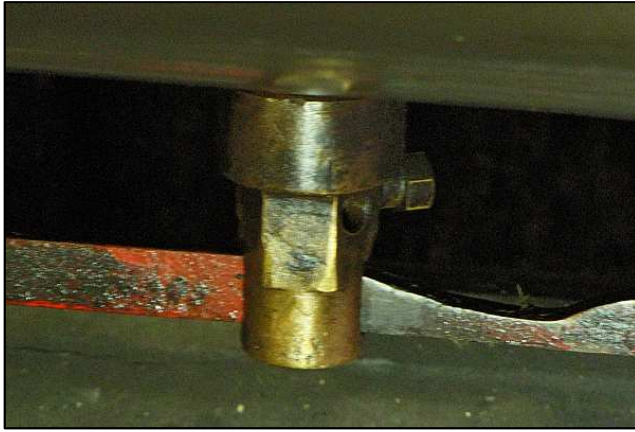
P07 - The cylinder cock that caused the initial hang up. A part of the reluctance for removal was avoiding having even more loose parts lying around, and also (mainly ☺ ) avoiding a long walk to the tool store in the 15M yard!

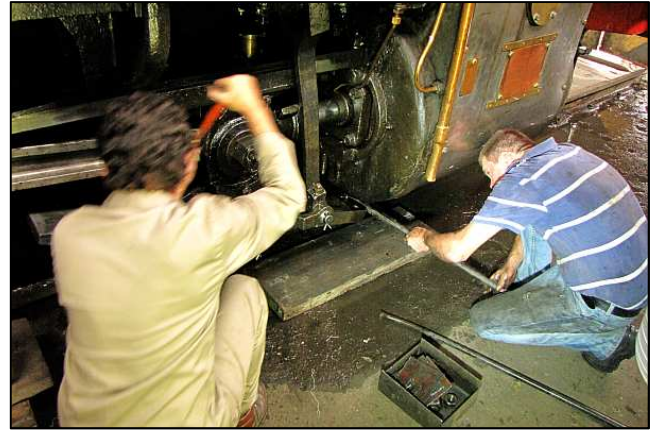
P08 - Even with the rear cylinder cock removed, the bar was still snagged-up. The problem was that the crosshead wasn't forward enough – although going too far forward would get the horizontal union link mixed up into the works.

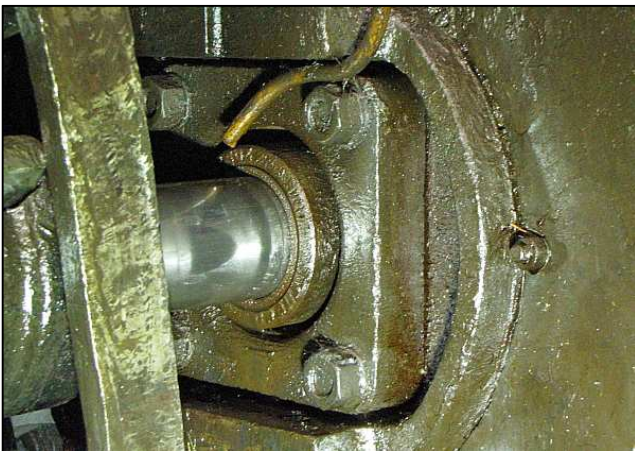
P09 - With the crosshead unsupported, it would not be a good idea to move the locomotive to shift the pistons, due to potential damage to the glanding hardware and the garter rings. Unfortunately, the shunters didn't think about putting the connecting rod in the lower quadrant, so it later got badly in the way to remove the upper bar.

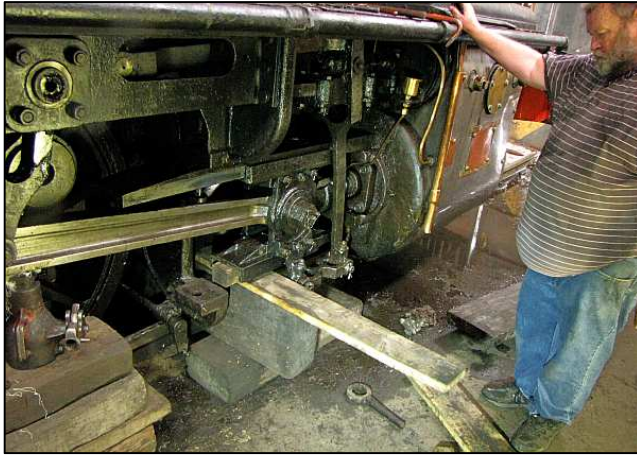
P13 - Here, you can see the error. The connecting rod is in the upper front quadrant and obstructs the slide bar from moving rearwards. Sigh. The fellows had to block up the cross head to prepare to remove the wrist pin. (Small end.)

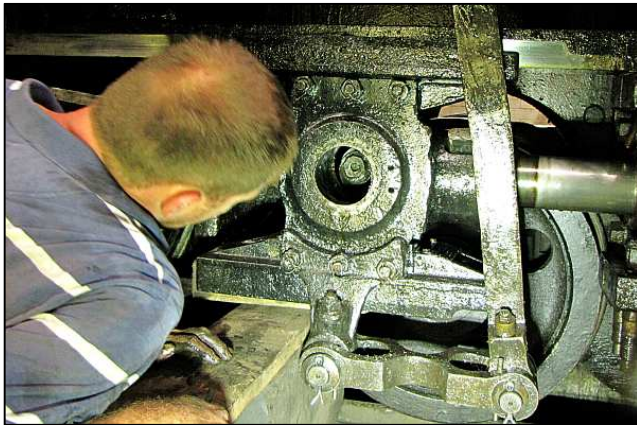
P15 - The gudgeon, or wrist pin, came out easily from the small end's bronze bushing, but then it tilted and started to jam between the crosshead and the bogie wheel. Fortunately, the last few drifting whacks weren't at full capacity (More like steady nudging) so we didn't have a totally wedged pin in there.

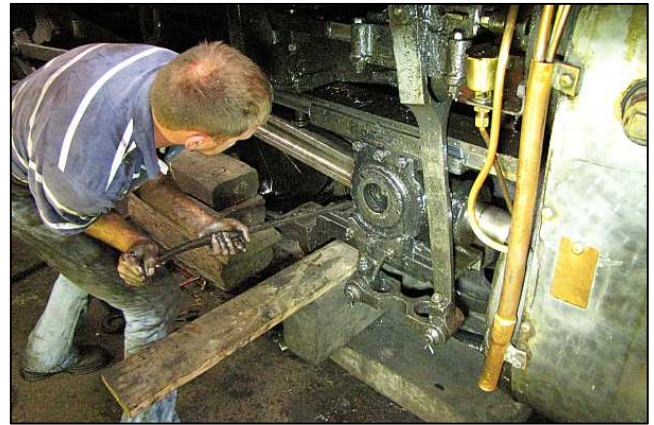
P16 - It was hoped to be able to push the piston (and crosshead) forward to disengage the small end and let it drop. This would tilt the connecting rod down out of the way of the slide bar. But, without the wrist pin in place, the connecting rod was tilting slightly outwards under its own weight and the small end of the forging engaged by friction.

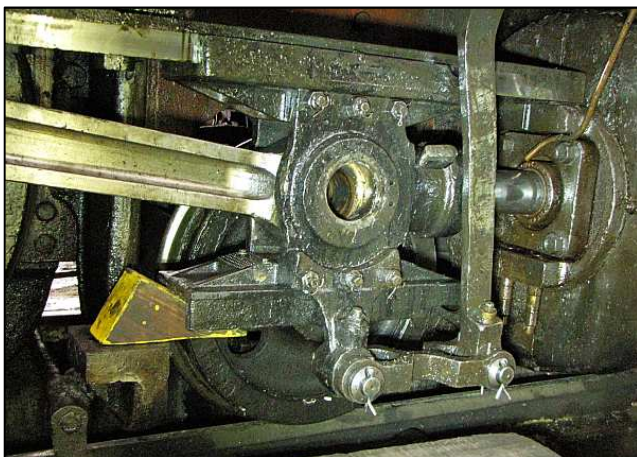
P17 - Then we reluctantly nudged the 12AR back after all, using 'Andrew' the Hunslet shunter to shift the obstructing connecting rod back and to disengage it from the crosshead. But even with the pin out, they STILL wouldn't part and the piston moved backwards instead. Grrr! A certain photographer (Ahem!) suggested that we wedge the back end – and the idea worked with a scotch block.
