1). INTRODUCTION – A DAY ON THE COACH – No.23189:

2). PROJECT – GOLD CLASS COACH VESTIBULE FLOOR:

3). PROJECT – GOLD CLASS COACH BATHROOM WORK:

4). PROJECT – UNDERBODY CLEARANCE ON GOLD CLASS COACH NO.23189:

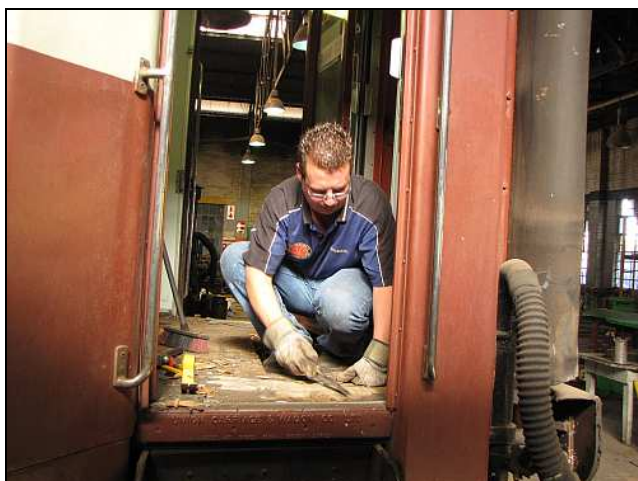
F01 – Simon Bennett is busy working at chipping away the aged vinyl sheets. SAR steel coaches do not have rubber seals on their doors, relying on the protruding lipped frames to channel the rain water at the sides, and the walkway lip as a dam. This area is quite prone to water damage.

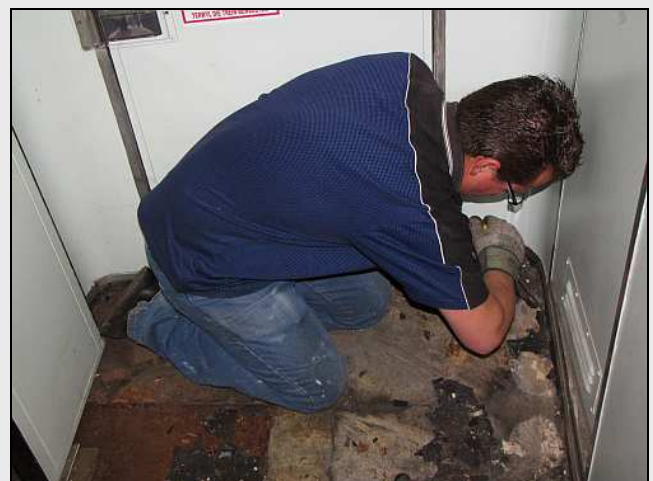
F02 – Over the years of the doors being left partially open, many of our coaches now have rotted flooring. The aged vinyl later cracks in the weather extremes. A domestic vinyl sheet had been laid over this aged floor, without skirting or sealing, so the water was still able to penetrate the timbers.

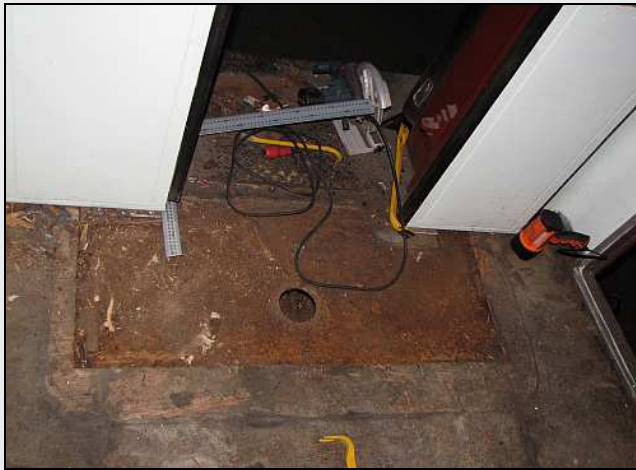
F03 – Most of our still-unrepaired coaches have wood-rot problems in this area where the rain gets in through open gangways and through failed gangways bellows. The vertical bellows often don't meet in a straight line. The biggest issue is the perishing of the drip strips above the head bellows.

The circular hole in the cutaway floor section is the access hole for the coupler's draw-pin. There is normally a cast iron access plate protecting the hole.

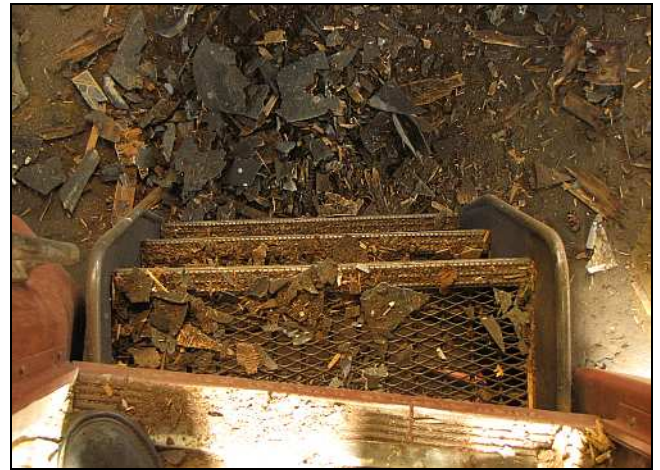
F04 – The vinyl chippings have to go somewhere – tossed over shoulders and out of the doors! Dennis Edgar has a contact who will arrange replacement original specification material for us for free, and we just have pay to install it. (They currently install the material on coaches anyway.)

The material has to be evenly and gently heated up upon installation and rolled into the adhesives as well as rising up into the skirting areas. It is actually quite a specialized job but the floors will last for another few decades if it is done properly.

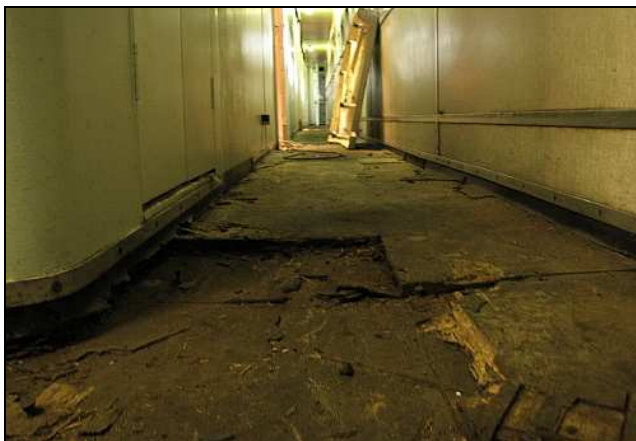
F05 – The steel coaches don't have skirting boards as the coverings wrap up the wall in hospital style. (It is softened in situ with a heat gun.) The joints rising up into the corners can sometimes be welded together and thus not reliant upon adhesives.

The coach floors are continuous under the walls and partitions. The water damage here is from the toilet to the left. The visible cupboard, once a linen cupboard, now houses the vertically-installed hot water geyser, which makes this area another 'hot spot *' for water spills if things go wrong.

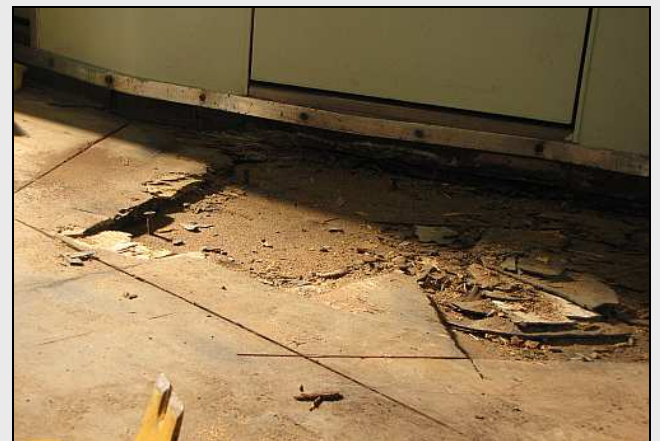
F06 – The marine-grade plywood is laid on top of heavy steel sheeting, under which are the stringers. ('Joists') The stringers themselves are under-plated with a square profile corrugated sheet as a coach body under-pan. (Think : High density IBR sheet.) Nearly all this water damage is from above and through the doors n' gangways.

Pictured here is the original bathroom door for the old communal bathroom. It is now out of service since each compartment has their own ensuite facility.

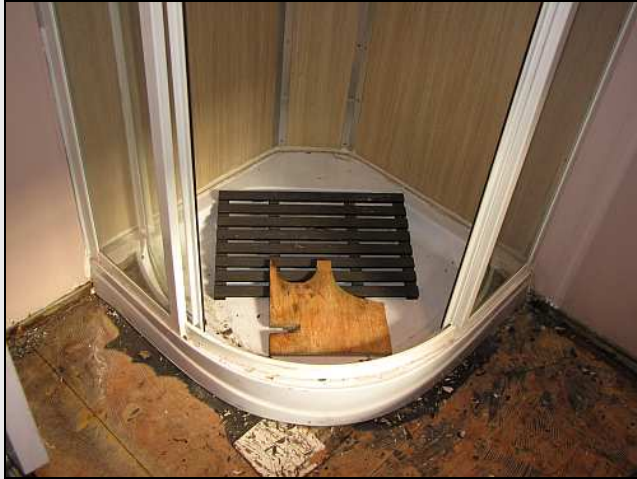
S01 – One of the 'Setimela Showers' shows the weak design. The moulded shower base is circular in outline with the straight side wings poorly braced. They were flexible and tended to leak at the walls and the floor where they had been accidentally kicked. (Breaking the silicone beads.)

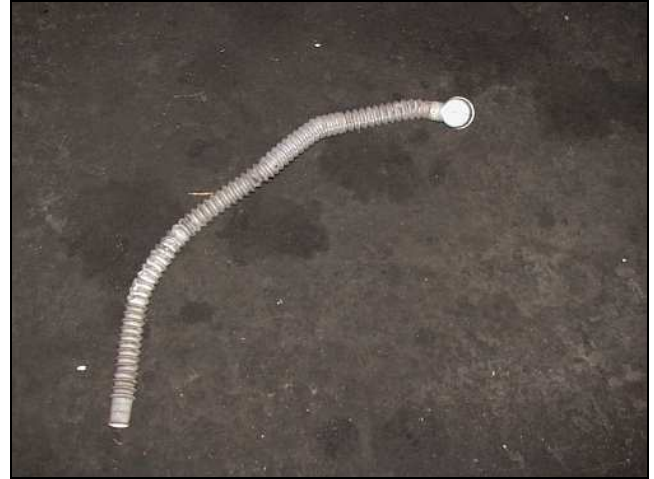
S02 – The old showers also used cheap concertina drain pipes. The ridges impede the drainage and trap the hair and dirt. The pipes also contracted in service, shifting the outlets. The pipes, designed for side exit, were bent 90 degrees just beyond the head, collapsing the waterway.

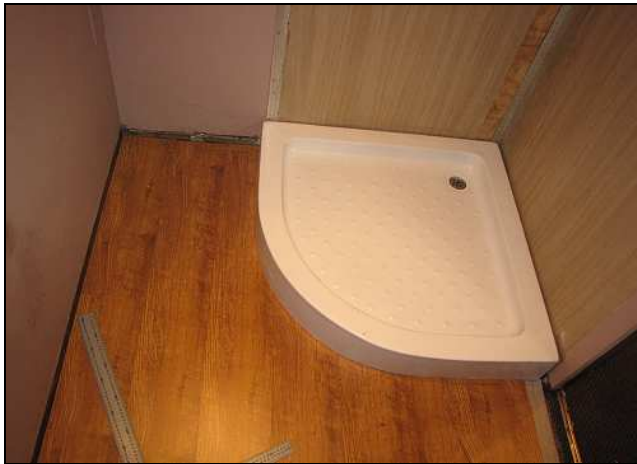
S03 – One of the new shower pans being tested for fit. Mr. Maurer chose a rigid straight-wall design with a deeper base. The shower walls are going to be tiled with the shower base skirts being 'siliconed-in' as well as beaded.

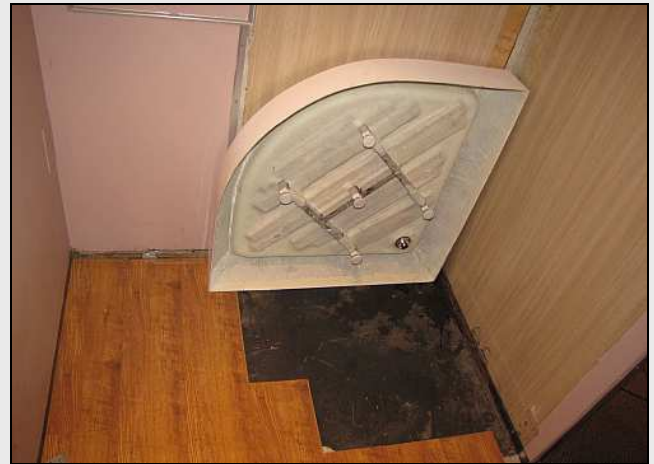
S04 – This view shows how the floor planks proceed under the shower base, which has adjustable feet. We need to exaggerate the drain-fall slightly as sometimes the coaches stand unevenly and the showers form foot wash basins.

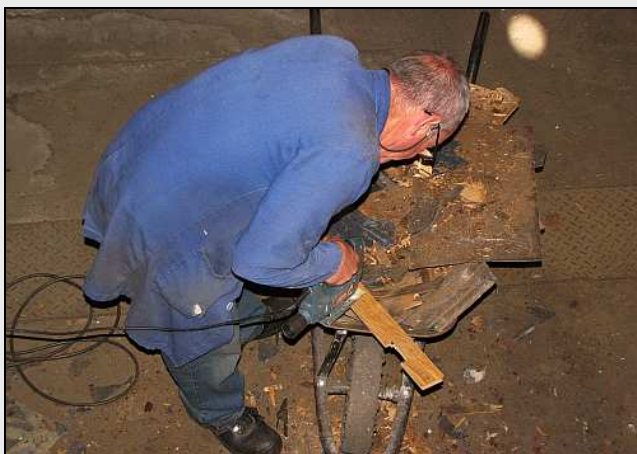
S05 – Gordon uses a barrow to brace both ends of the floor plank that he is trimming for a sink. These prefab T&G planks are labelled as 'laminated,' but they are closer to a 'veneer' with a solid wooden core and laminated coatings.

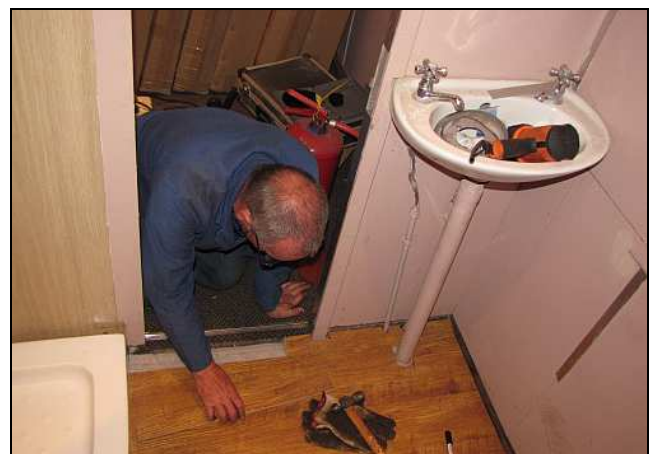
S06 – Gordon fitted the notched plank that custom-fits around the pipes even though we will have a pedestal under the sink. The little gaps around the pipes, especially the drain, will be filled with puddled silicone to floor height.

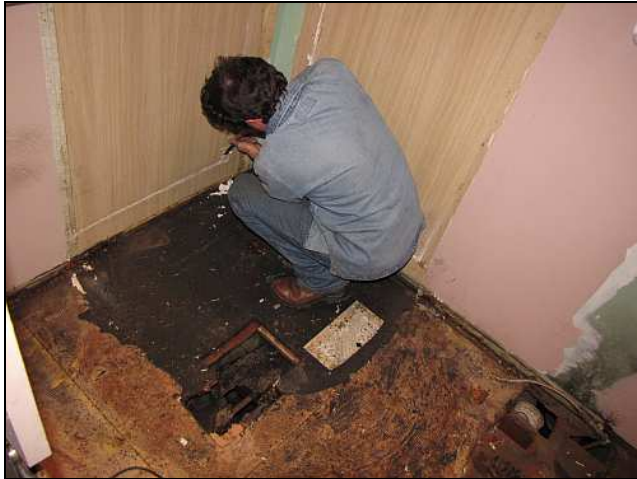
S07 – In Comp C bathroom, Alan scrapes away the stingy single strip of silicone beading from the laminated backing. This floor is in poor state with many extra holes. The triangular-ended hole in the corner is original – it used to be for the Coupe’s compartment’s sink

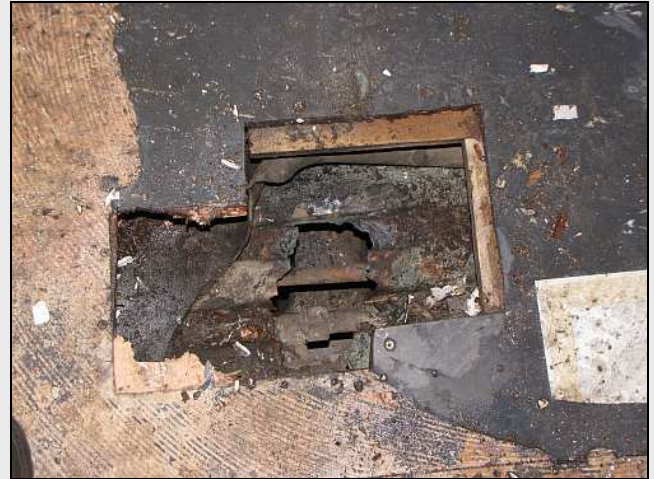
S08 – This roughly cut hole shows the complex floor construction. First the vinyl, then the laminated marine ply floor boards, then the steel backing, then the joist space and then the under-floor covering. The visible pipes are out-of-service parts of the original plumbing system.

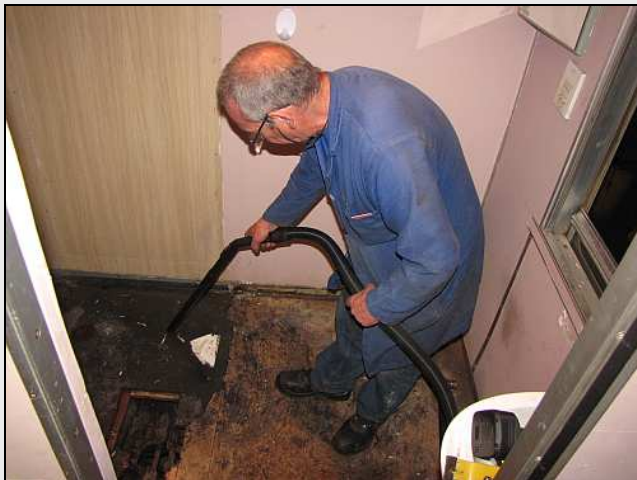
S09 – Gordon vacuums up Alan’s mess. From the time of this photo, the drum type vacuum cleaner is going to block up in just three...two...one... @\$%&@ !

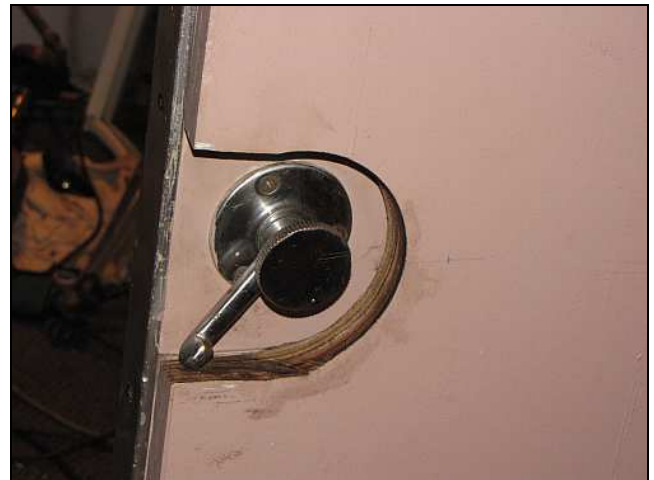
S10 – After a time-wasting battle to remove a door handle in another compartment, this one was simply let into the door panels to allow an extra few inches of opening. The handles and bed bunks were blocking the relocated doors.

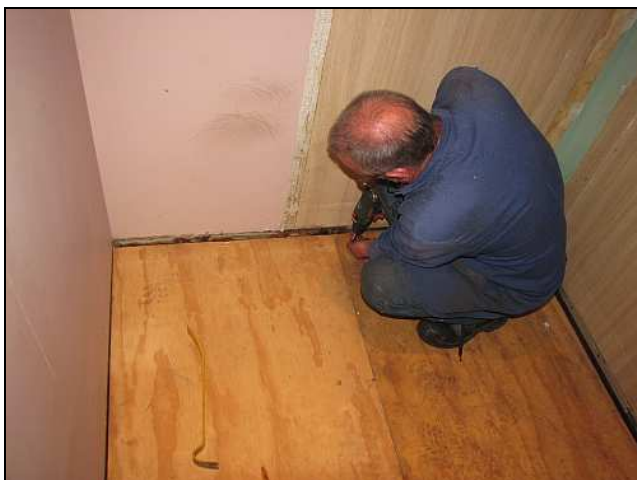
S11 – Gordon zaps in yet another self-drilling screw – these were even able to go through the fireproofing steel sheet in the middle of the bulkhead walls. The floor bowed upwards a bit in the middle and is now under compression.

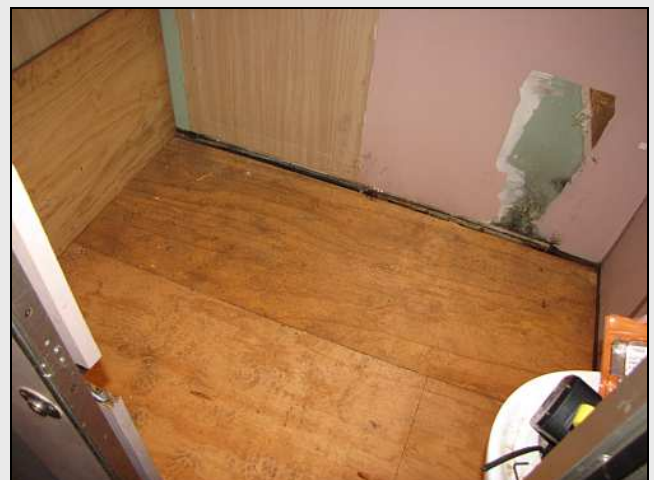
S12 – The poor quality floor had the holes patched in and then was sheeted over with 7-Ply wood sheets. The piping holes are covered up as well, but they will be re-drilled by using pilot holes up from underneath the coach.

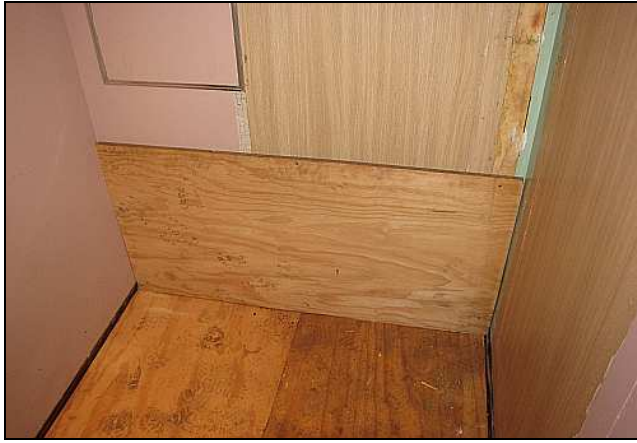
S13 – Panelling also started on the splash wall. This area, as well as the ‘woody’ laminate on the right side, is to be tiled with 150mm tiles. The tiles will be attached with silicone-based adhesive for some flexibility on a moving coach. The laminates will first be scarified with a coarse flapper wheel to enhance the grip of the adhesive.

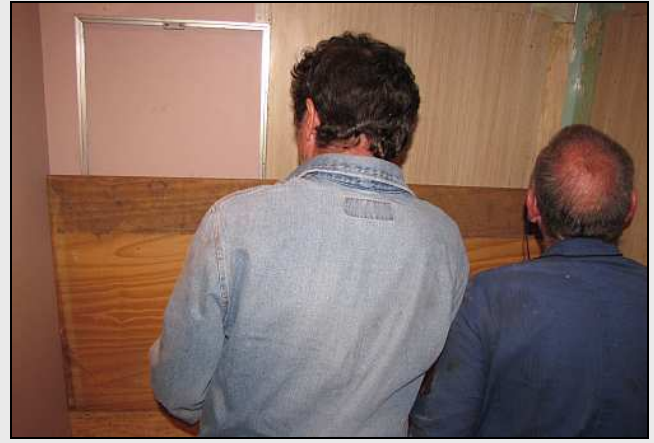
S14 – The center splash board goes in. The laminated area in front of the chaps is where the coupe’s compartment’s door was. The panels will go straight over the sliding window hatch. (This hatch was still functional in the original installation!) The hatches will be either plated in or covered with pwettie-pics on the corridor side.

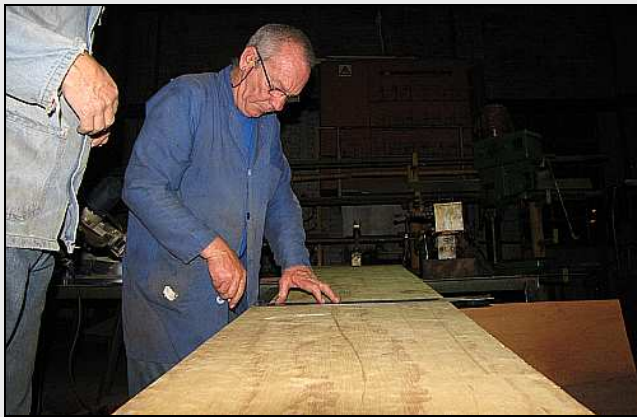
S15 – The day’s beer tasting train had come and gone (The repaired 12AR went like a champ!), the loco crews and train staff gone home and the 15M workshop schmucks still working on into the night! Here Gordon is marking out what is to become the top splash panel for Comp C’s shower.

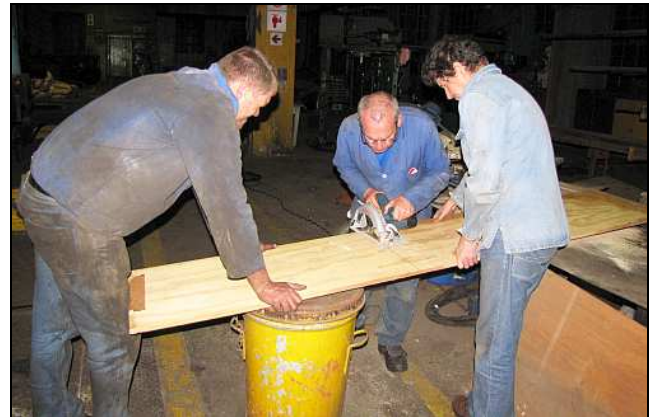
S16 – When doing sheet work, the lack of clear workbench-space became a problem. The fellows are cutting out the final full-sized splash board while being very careful of that blade. The day staff will be tasked with clearing that bench during the week. (The S.Ack. Anti-Sukkelaar policy.)

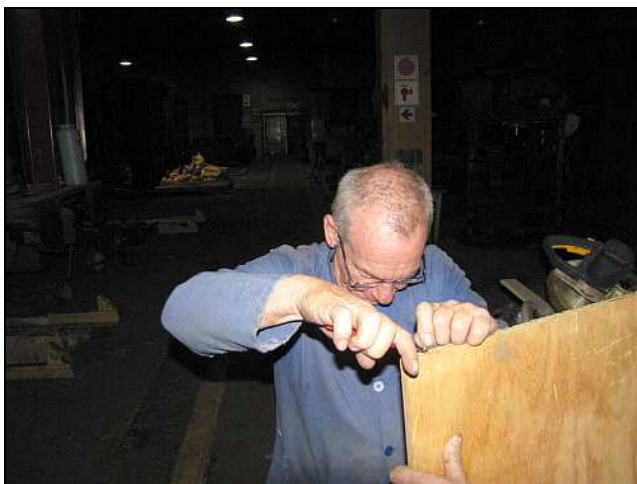
S17 – Tsk! Tsk! Using flush-cut electronic side-cutters, Gordon pulls out nails that were driven into the ENDS of that plywood sheet. It must be good stuff, as there was no evidence of splitting at the nails as you would expect.

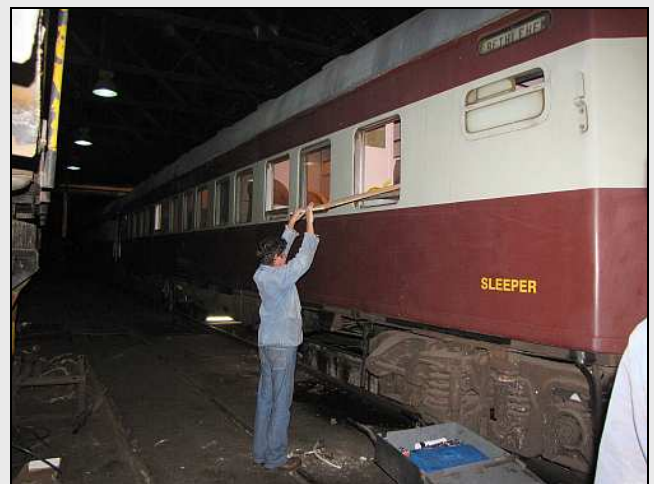
S18 – The plywood boards were sourced from a dismantled model train layout, so it is kinda appropriate that they find a new home on a REAL train! Any items going onto a Cape Gauge passenger coach has to fit through narrow corridors and doorways, or through the windows. Mr. Maurer has already taken note of this restriction for the new furniture!

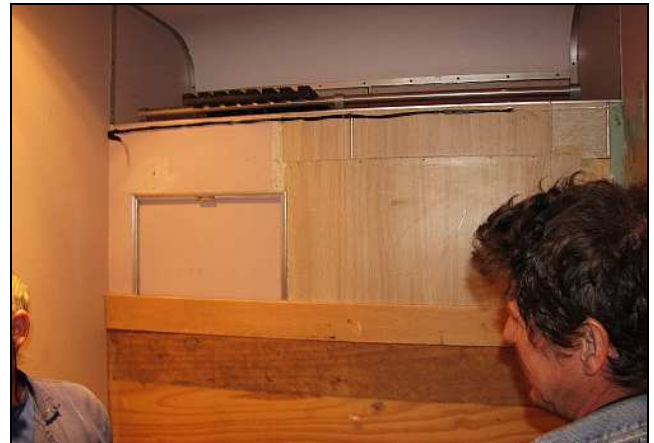
S20 – The fit-board is in place. See the colour schemes? Grey laminate = Original. Institutional green = Dave Rogers Tour 2007. Pink = Setimela. To eliminate the circus-train colour combos we currently have, the coach will be painted in neutral colours based on browns and beiges, with each Gold Class compartment done in a different tone.

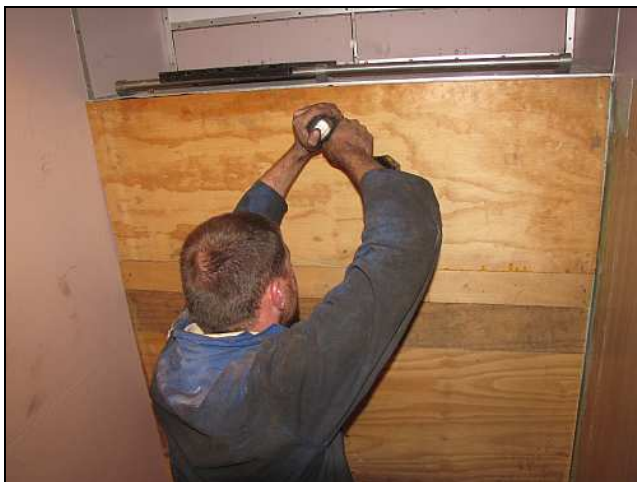
S21 – Dr. Smudge tries out the battery-powered screw driver and was quite impressed! (It's a very high-tech tool for a man who uses hammers and slogging spanners on the locomotives.)

The top of the panel will be capped with a silicone-backed aluminium angle when the tiles are done.

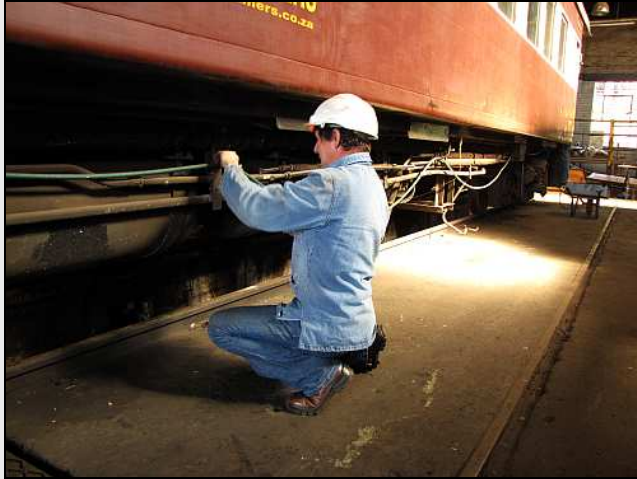
U01 – Alan snips away a cheap green nylon garden hose that ran the full length of the coach. It was used to transfer water along a coupled train and serves no purpose since the pumps are all functional.

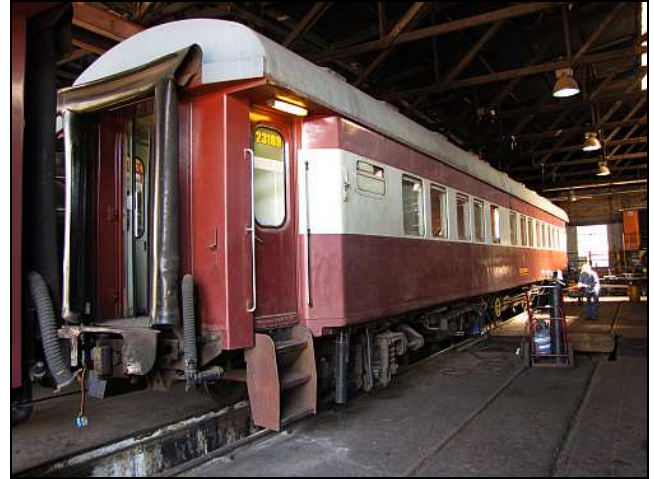
U02 – Gold Class Coach No.23189 in all her Gulf Red and Quaker Grey glory. If this coach's compartments sell well on the steam tours, there is an unused coach in our yard that would be ideal for conversion to a 2nd Gold Class unit.

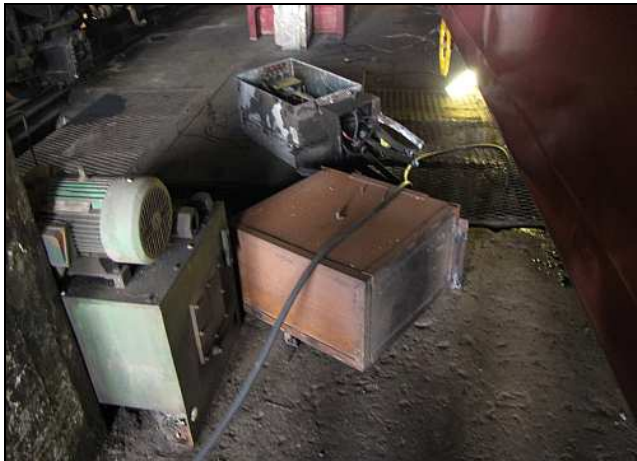
U03 – Some of the obsolete equipment that had been cut away from the coach – no sense in burning good coal to haul this dead stuff around. The green machine to the left is the hydraulic pump-pack for the loco wheel lift jacks.

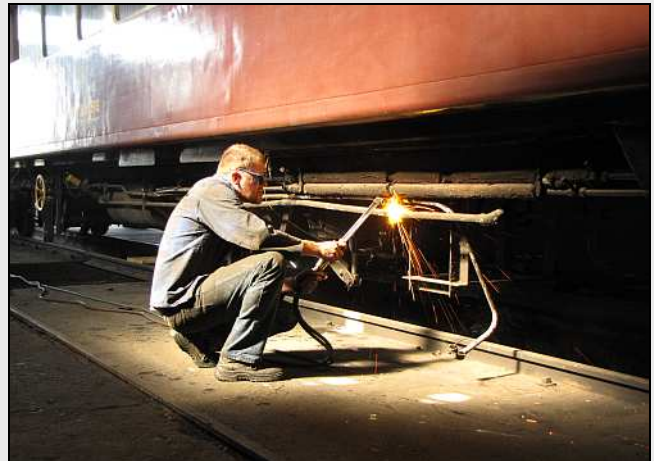
U04 – The Smudge-Meister cutting away some lighter stuff from the coach underbody. (The insulated steam heating line is already gone.) The torch is starting its way through the cold water line for the original under-slung geyser.

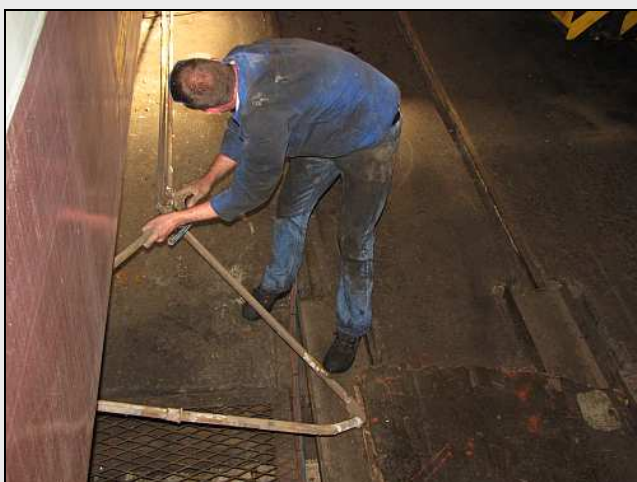
U05 – Now a whole mess of piping had to be pulled out. This is the old geyser plumbing. We do have a coach using the original geyser but this coach already has a 100 litre unit fitted inside – so the existing unit is in for the chop.

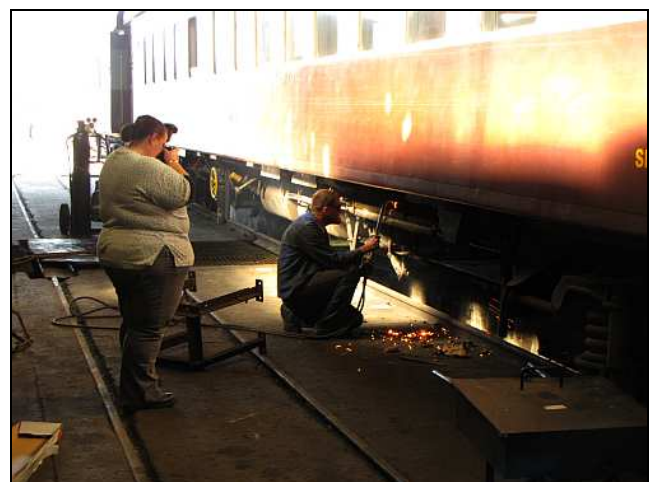
U06 – The Sanderson was present too, so there was no escape from the cameras this day. The underbody clearing is also to facilitate later installation of cess-tanks and additional water tanks for later upgrades.

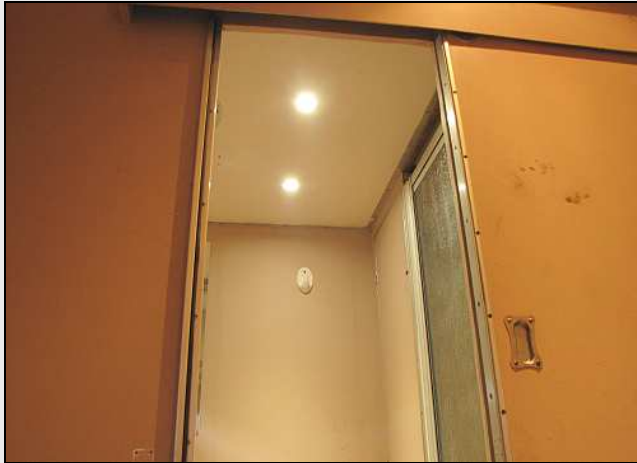
X01 - Gold Class A's shower was fitted with LED type down-lighters during the week. The ceiling is so low that the more conventional halogen down-lighters were heating up people's craniums and certain hairless domes.

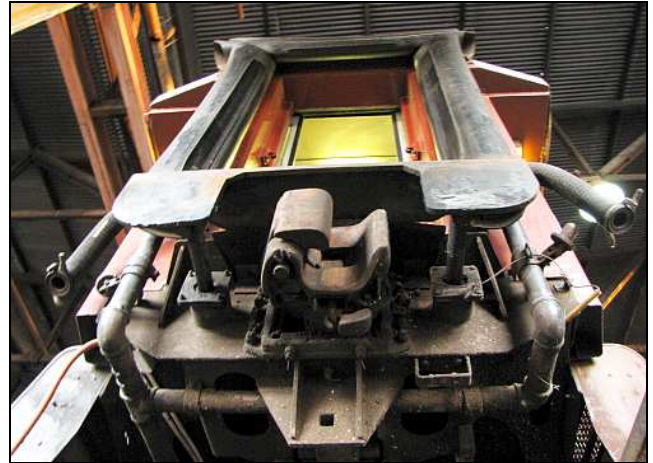
X02 - Looking up at the illuminated gangway above the buffer plates and draft gear. All this hardware (and the bogies) will need to be serviced before the train runs. Time to purchase shares in graphite grease, methinks.

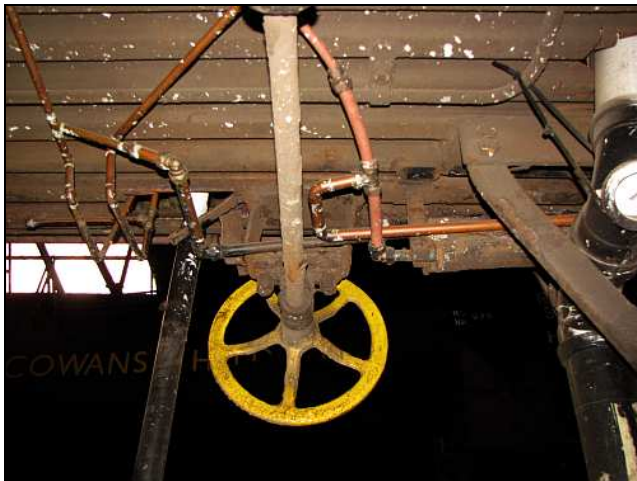
X03 - Some of the crazy plumbing visible above the handbrake. It is a mixture of copper and synthetic. We are gradually converting to the synthetic as it has no scrap metal scrap value (theft) and it is able to withstand sub-zero temps. Because it is semi-flexible, it reduces the number of fittings. Unfortunately, it does perish with hot water, but the duty cycle is so low it will serve for years with no problems.

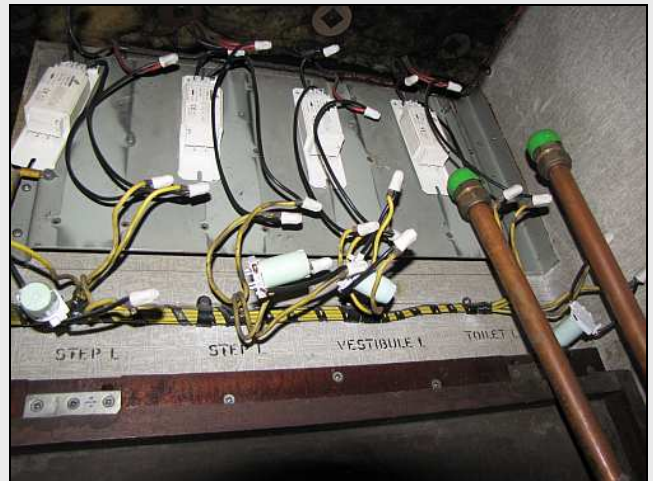
X04 - Looking into one of the wiring chambers above the geyser cupboard. The copper pipes are capped with vacuum breakers, which is good, but they are in direct contact with the live wiring, which is bad news. Shaun Ackerman was happily investigating and poking around with his hand in the semi-darkness, but he withdrew rather quickly as soon as Alan shone a torch in there!

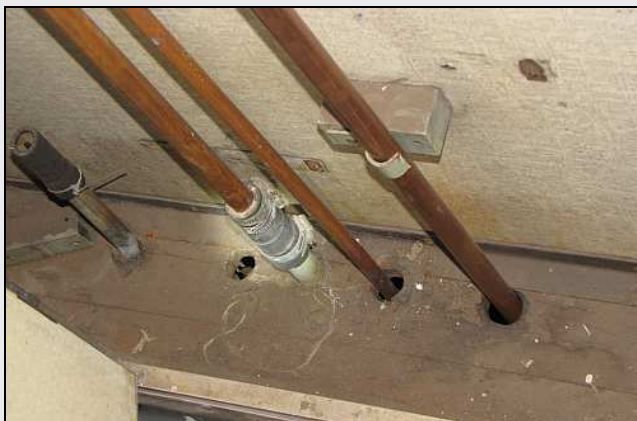
X05 - Another little glitch - a rubber coupling on a riser pipe. It is the cold water line for the geyser, so it isn't so bad, but it will be replaced with a modified bushing.

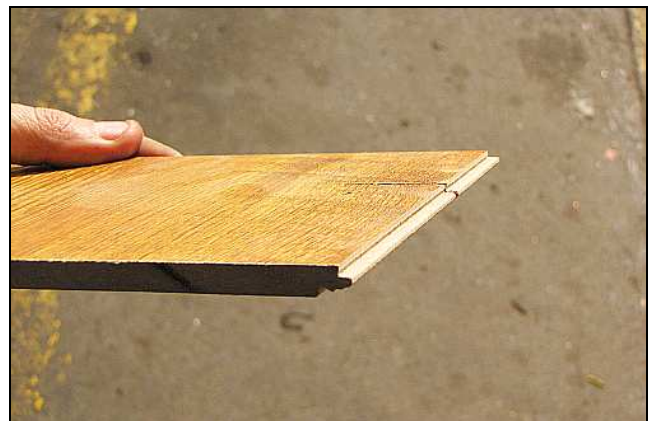
X06 - Here's a close up of the prefabricated tongue-and-groove planking that is being fitted. Notice the design of the tongue to facilitate the slide-and-click action.

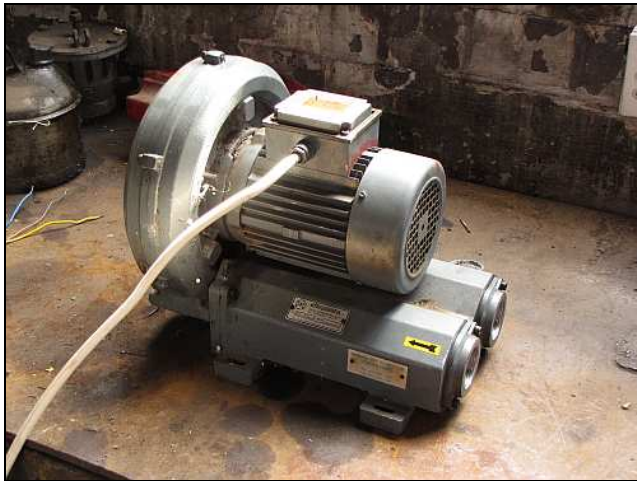
X07 – The recently re-discovered vacuum pump was bench tested and it works a treat. It give about 25kPa worth of vacuum.

We are planning to mount this contraption on an wheel barrow frame as a portable vacuum pump. (We have plenty of barrow frames.) A portable pump will be handy for pre-testing of locomotive and rolling stock brakes within the workshops and during pre-trip inspection.
