Here is the third of the new Reefsteamers Waybills.

**13). WORKSHOP PROJECTS FROM SAT, 11 MAY:**

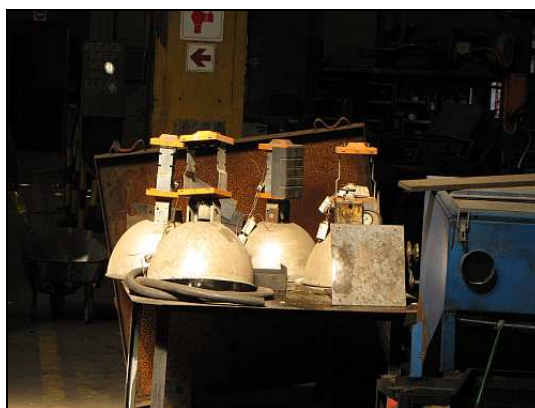
Some of the old lamp fittings awaiting conversion. Essentially, the old ballasts and extra wires need to be removed as the new 'twirly' CFL lamps operate directly from the mains.

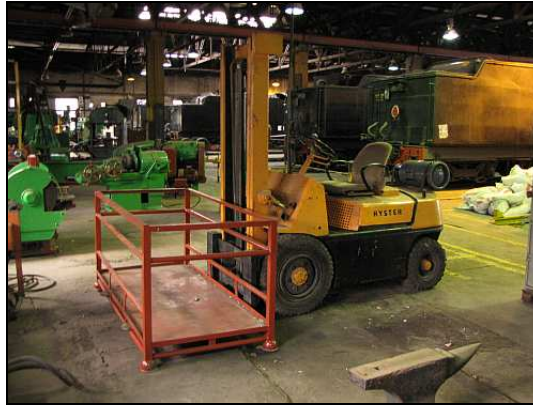
The lamps are accessible via a purpose built man-cage on the fork lift truck so, there are no rickety ladders or scaffolds involved, even though the work is high up.

The forklift with the man-cage firmly bolted to the tines.

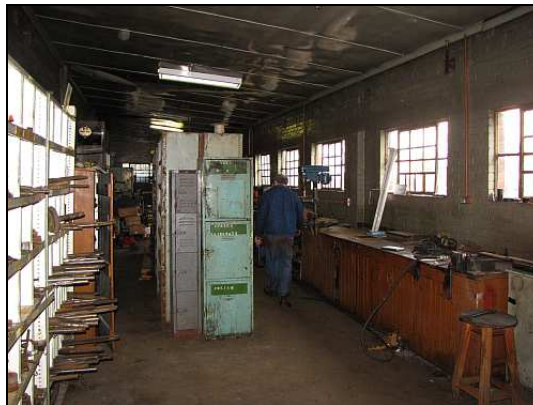
The recommissioned fitters shop and tool store.

We have some extra lamps available for the recommissioned Fitter's Work Shop and would like to have them installed, as well as some extra plugs for the work benches. Extra lighting is especially needed around the tall, long tool racks facing away from the windows.

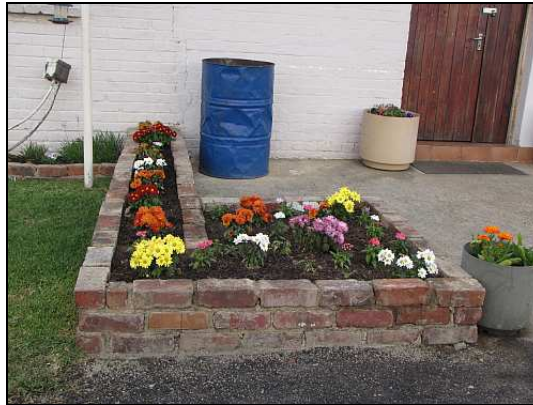
One of the new planter boxes made from re-used bricks.

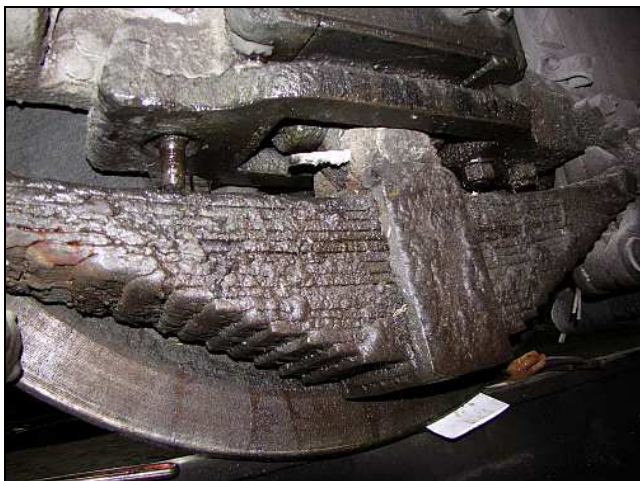
**W01 – She’s a keeper!**

Susan the Class 12AR received some running repairs, which took a little longer than expected. Pictured is the left trailing axle keep just above the old-fashioned under-slung leaf springs. The axle keep on this engine is the slotted bar under the square shape of the axle bearing’s oil box.

The little old lady has a persistent tendency to pound the axle keep nuts loose on the left rear trailing driver, even though that stud and its hole had been remanufactured before. And yet we aren’t picking up excess vibration.

Dr. Smudge did some investigation and thread cutting work on that stud (In rather cramped situ) and put a better nut on. The wedges were taken up on the leading axles on this side as well.

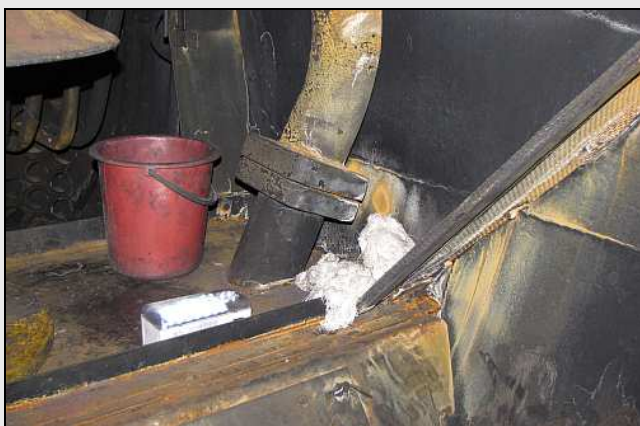
**W03 – Can you get a ruler in there?**

The leaking flanges for the steam delivery pipes were mainly caused by incorrect gasket material, which didn’t help on a new joint that was still settling into service for the famous Viljoen & Thiel Co. 12hr or 12 000 mile guarantee!

Due to the then-time pressure, these gaskets was fitted with the full knowledge that they would need reworking soon, but they failed much quicker than expected.

The right type of modern gasket for this hot, dry application would be a non-asbestos Klinger Rite™ packing but it would cost us several thousand rand! Shaun Ackerman decided to make customized gaskets made from copper sheet, in a similar fashion to the steam dome ring gaskets.

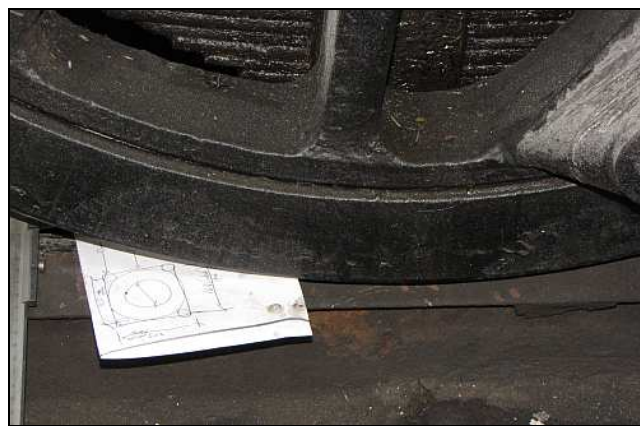
**W04 – Heavy Weight Paper Weight:**

Here you can see the initial plans drawn up for the new gasket material, helpfully wedged under one of Susie’s cute little driver wheels to stop it from blowing away.

We scrounged around for copper material, but Shaun would have to make up the new gaskets from copper stock from home and planned to fit them during the week. It’s not a major job to fit the final product and it should last a long time. The new gaskets will be heated and quenched in the standard way to anneal (soften) them before service.

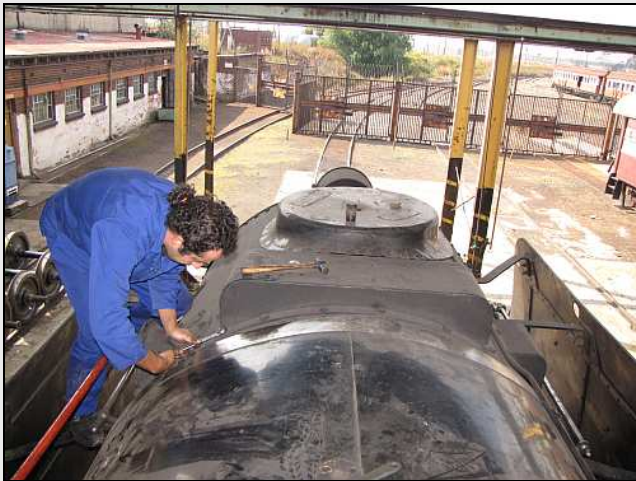
### W05 – Bums and Bobtails Up.

Class 15F No.3046 'Janine' has passed visual boiler inspection and now the big bean boiler is being sealed up for the coming hydraulic tests. Every boiler fitting that can possibly leak and create a false boiler leak indication must be sealed or blanked off – including the blow down valves, water columns, the clacks, safeties and here, the regulator.

Notice the flat-ish 'dome' cover safely stored away on the chimney and keeping the front works dry. (The 'dome' is actually just a manhole on the 15F.)

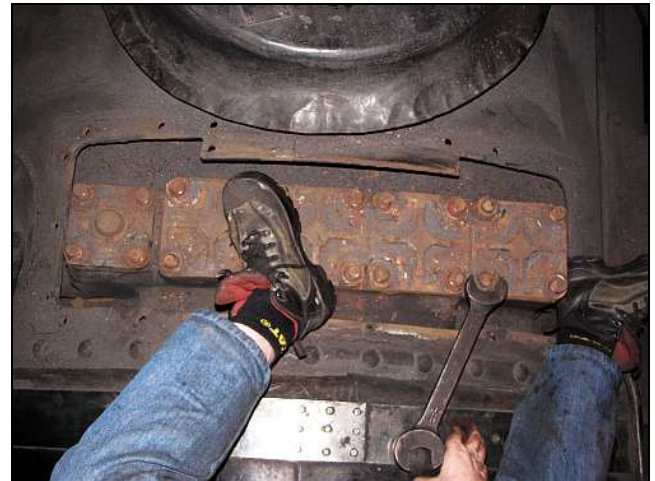
### W06 – Sloggin his way through.

In the evening of the same day, Aidan McCarthy gets to work on the individual spool covers that were exposed that morning by Andreas. Using somewhat heavier tools, he was 'slogging' the individual nuts loose. He wasn't removing the covers yet though, just loosening the nuts to make things easier for the next person to commence work on the project.

The individual regulator spools are usually sealed with silicone sealer and the regulator disconnected for the boiler test. (If someone is fiddling in the cab and pulls the regulator open, the test seals would need to be re made.)

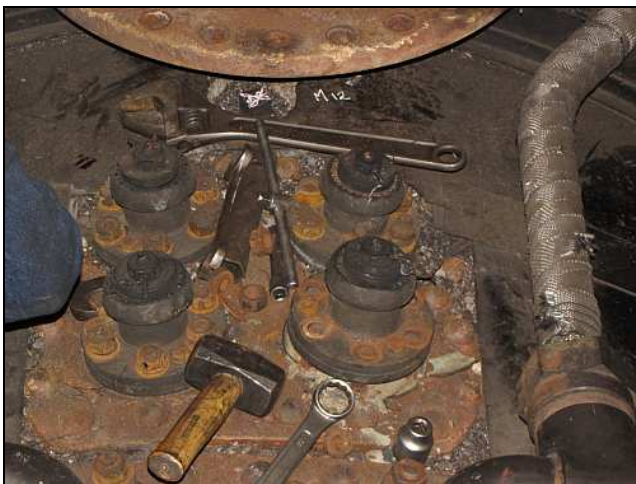
### W07 – Shiftn' Safeties.

Madame 15F has four Ross-Pop type safeties, which tend to obstruct one another in terms of getting the bolts out. It isn't feasible to seal the safeties and temporarily set them to the higher test pressure, so off they must come and gasket-equipped blanking covers are bolted down instead.

The safeties need to be recalibrated and signed-off upon recommissioning, no matter what their condition or spring settings were upon removal.

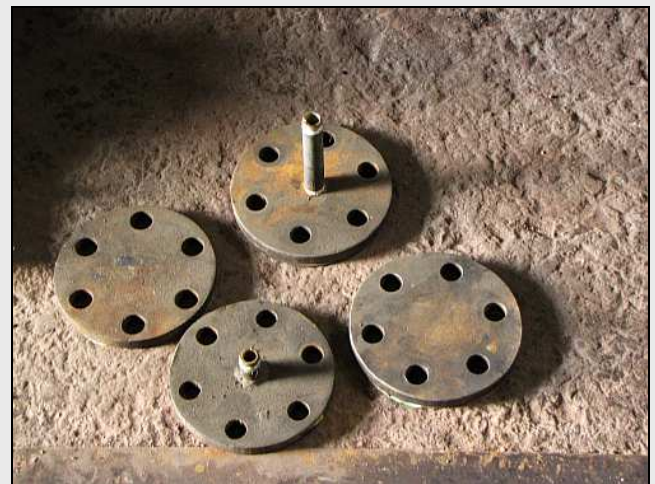
### W08 – Are you Covered?

Here are four covers that were retrieved to blank off the safety valve mounting pads. In fact, three of them still had their gaskets attached from the last time they were used.

The ball valve is connected to a hose leading down to ground level. It will act as an air vent while filling the boiler. It would also allow the initial pressure to be gently released when emptying the boiler after a test. The initial release involves flexure of the steel work and can cause damage if the entrapped pressurized water is released too quickly.

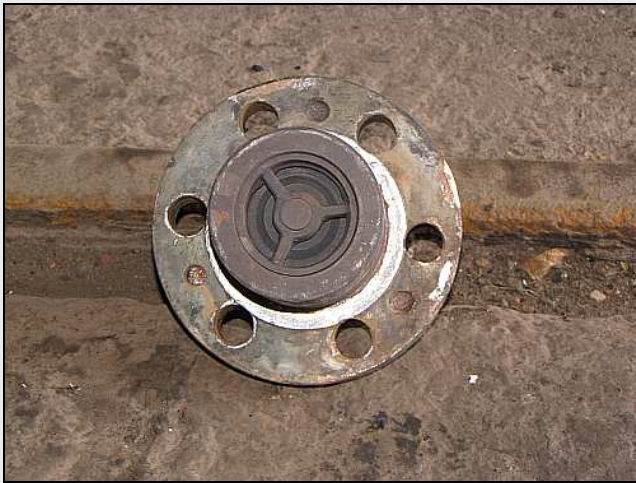
**W09 – Upshot.**

Not a typical view of a safety valve – this is the lower end that is normally recessed into the boiler's steam space. The tri-braced guide yoke for the valve can be clearly seen.

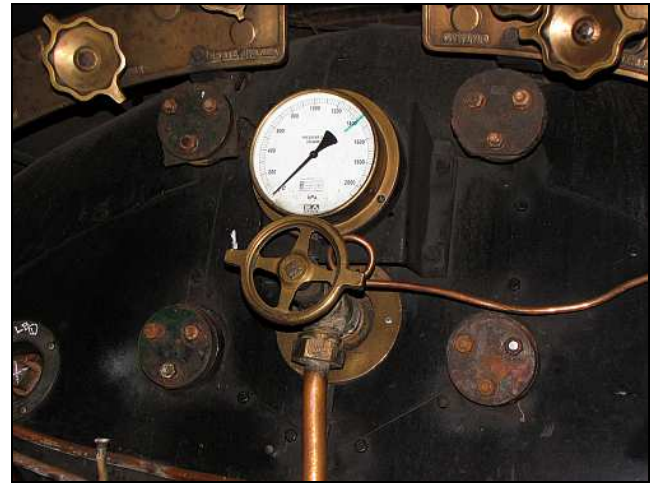
**W10 – A bit bare on the backhead.**

The water glass columns and their cocks has already been removed and their flanges all blanked off with standard sealing plates.

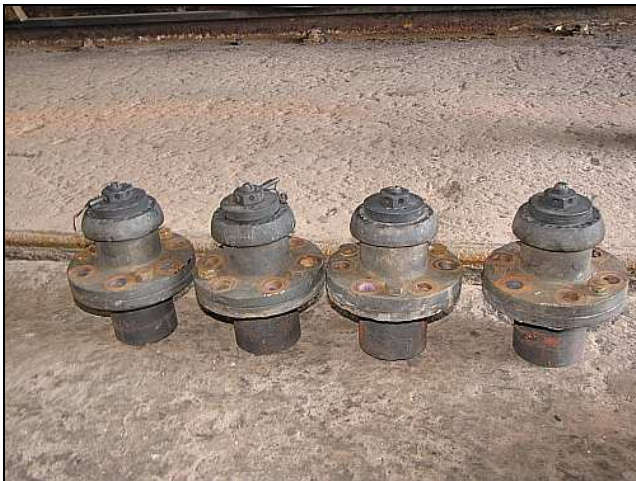
**W11 – Four for Storage:**

Before the day was out, all four safeties valves were carefully locked away for safety. We trust no one with theft, especially with chunky non-ferrous components lying around.

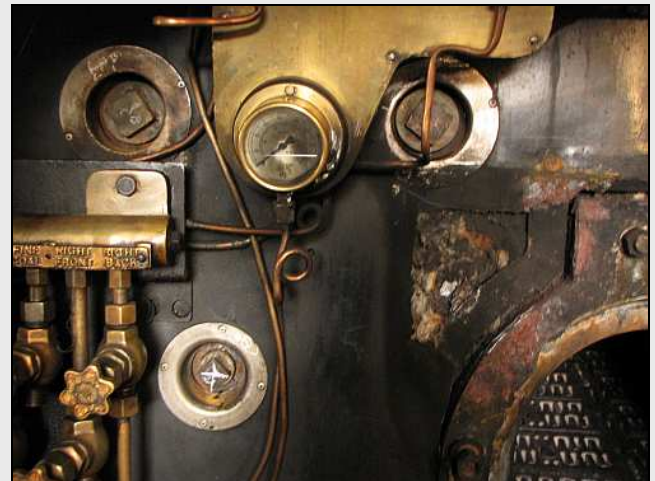
**W12 – Missed a few.**

The washout plugs were tightened and marked with a white stripe as per our standards, But the arch tube plugs hadn't been done yet. The deeply winged firebox door of the 15F was removed to facilitate the visual inspection within.

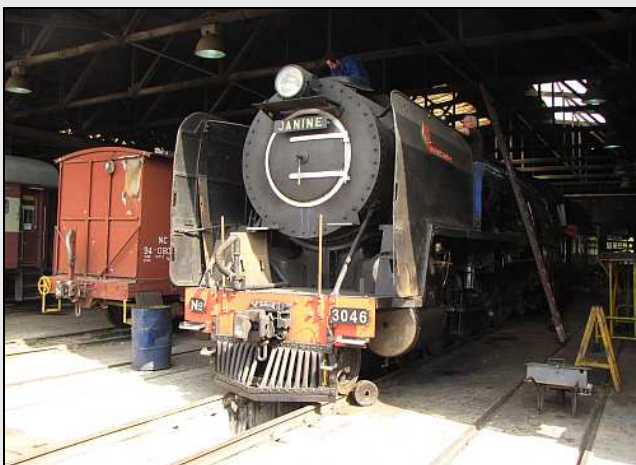
**W13 – Some attention.**

Here's the old girl happily submitting to being worked on. That is Andreas up on top removing the Regulator Cover while Attie supervises from behind the smoke deflector.

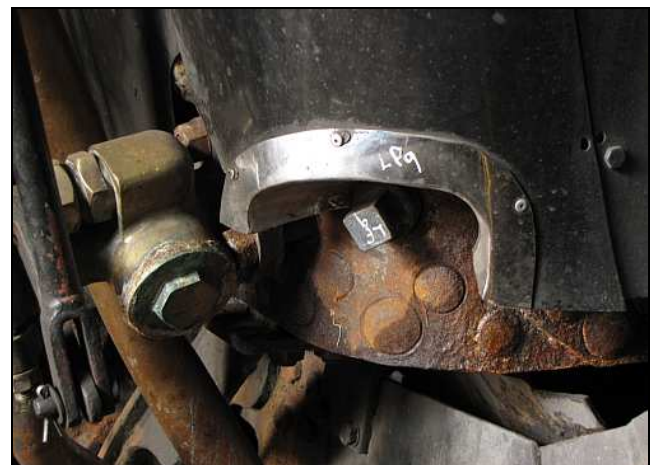
**W14 – The Mark. (Or not.)**

All the external washout plugs have been installed, but this one still needs to be confirmed as tightened and then marked. The blow down valve outlets still need to be blanked off.

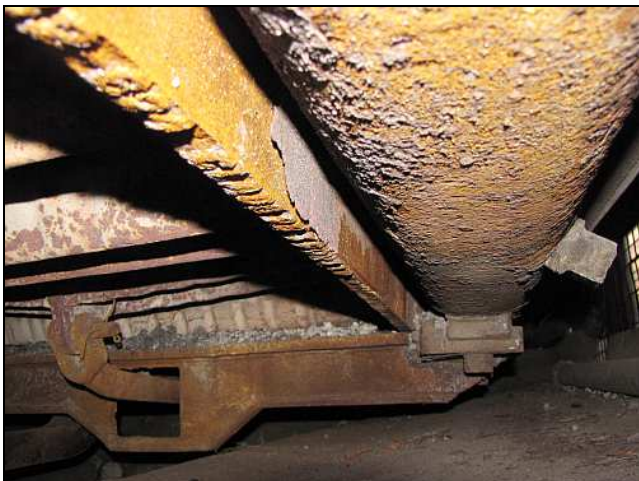
### W15 – The base matter.

This is a longitudinal 'basement ceiling' type view along the ashpan of the modern(ish) welded 'trough' type foundation ring of the 1953-built Class 25NC. This method to be implemented for the Class 15F No.2914 project. This section is actually slightly elliptical in shape, whereas 15F 2914 will have a circular section cut from the stock pipes.

Notice the washout plug mounted low down – that half-pipe is hollow and is thus subject to collecting scale and 'mud'. The lowest section of a conventional firebox has the foundation ring which is solid forged steel and thus doesn't need washout plugs quite so low. This is one of the locations in which Hott-Nutts George will have to design new washout points for on 15F 2914 – and it need to be accessible from the ash pan too.

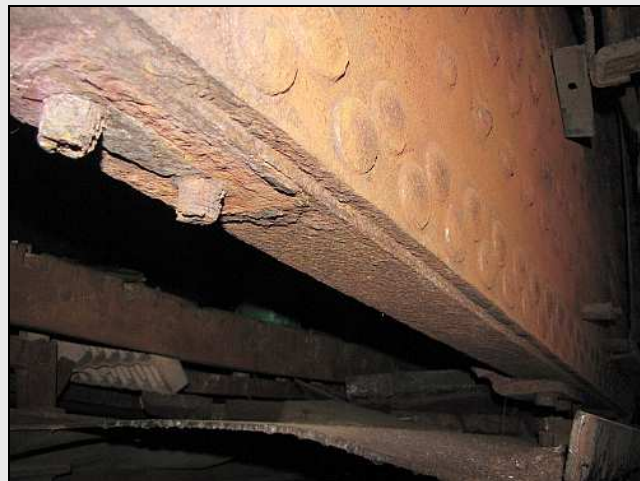
### W16 – In for the chop.

Here is the equivalent iron on Class 15F 2914's firebox. The metal 'bar' protruding from behind the side 'wrapper' sheet is the lower face of the foundation ring. It is held into place with two rows of rivets. It is also taller than it is wide.

A new row of holes will need to be drilled for stays to brace the space between the lowest row of stays (the domed 'rivet heads') and to the cut-line just above those two rows of rivets. As the bottom of the new section is circular, it will not require internal vertical bracing.

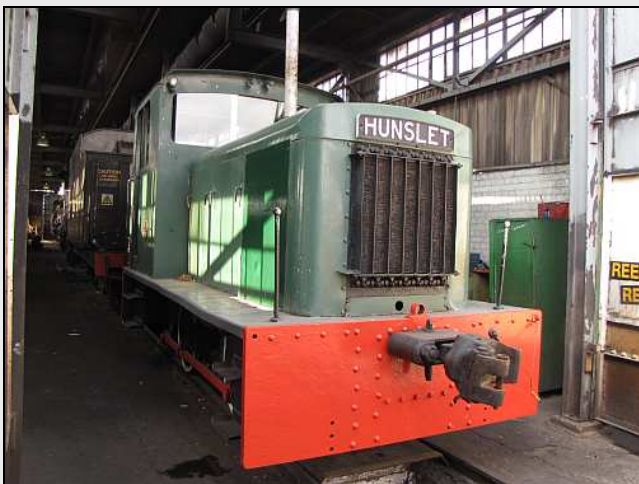
### W17 – Mr. Green:

Our tough little six-banger finally has his new engine covers back on – albeit painted in 'Emerald Green' instead of the original Hunslet colour. They are bolted on as we don't have the handles, and so they have been put on to the end of the engine hood that doesn't need much attention.

We are sure the missing 2 engine covers will turn up some day, but these will keep the feathered pests from roasting, er, roosting in the engine compartment in the meantime.

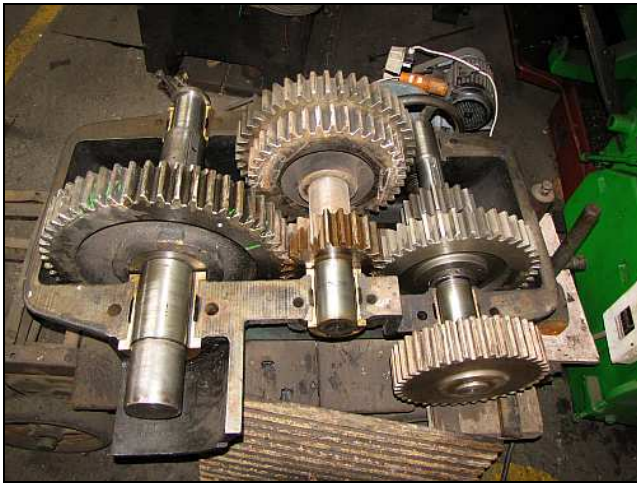
**W19 – Grinder.**

The wheel lathe's tertiary gearbox has been loosely put together to check the gears for meshing and the newly lined bearing shells for fit. The original bronze bearing shells were relined with Vesconite to suit the re-machined shafts.

As you see, no sissy extras such as synchromesh, dog clutches, synchro-cones or baulk rings – this is a proper old cog swapper. Much of the original damage was done by changing gears before the lathe was brought to a full stop.

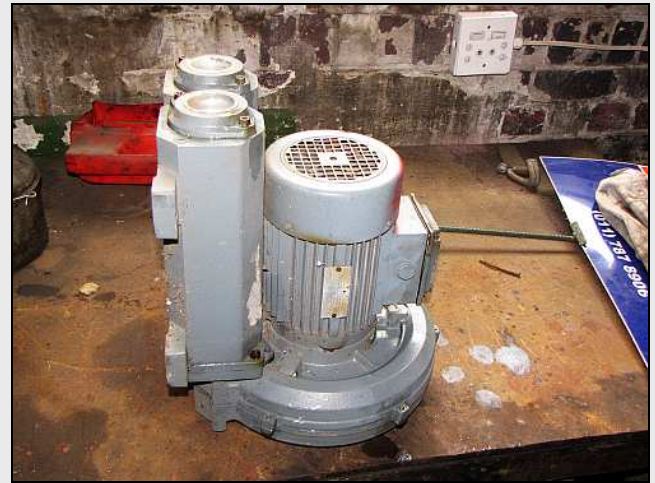
**W20 – Sucked in from Obscurity.**

It is a centrifugal-blown electric vacuum pump.

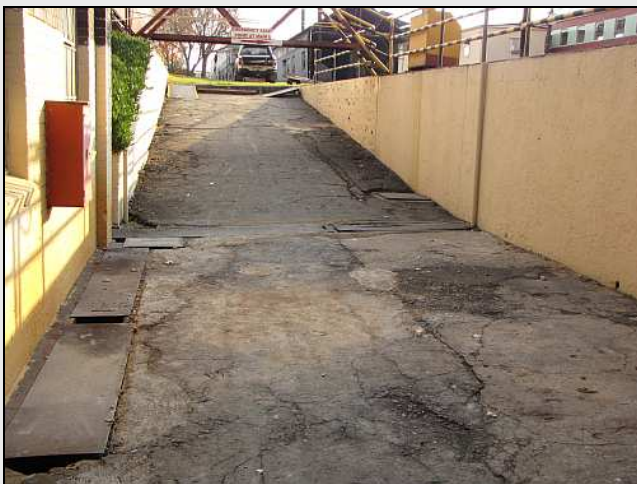
**W21 – Ramping up the standards.**

The main entrance ramp into the 15M shops has had the worst of the holes in the concrete apron filled in with fresh concrete the previous week. You can see some of the patches alongside the rain water trench along the wall.

As a part of our ecological drive, we have left exit ports in the tread plates so the depot rats have a fair place to hide from the owls. (The rodent use the trenches as run ways.)

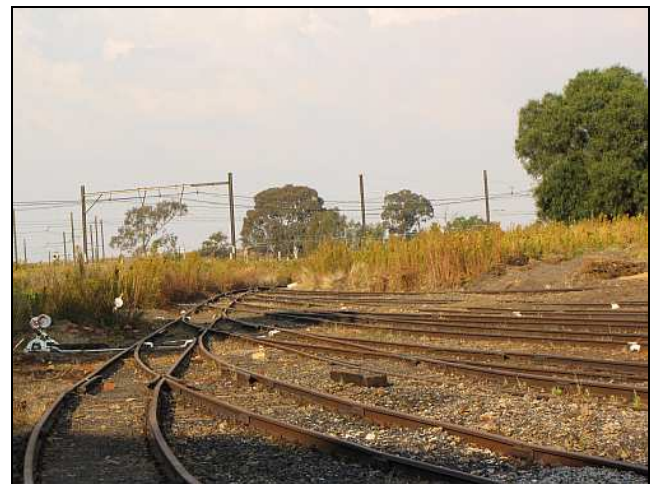
**W22 – Scalped Steel.**

The de-weeding project in the 15M approach yard and the head shunt is just about finished in time for winter, and the labour was paid off with bags of aged coal! That's a good deal all around! (The ladies who did the weeding broke the coal down to smaller sizes and sold it on in the recent cool weather – entrepreneurship!)

The next project in this area is to replace the squatter-stolen points tumpers and rodding. It is worthwhile doing now that the boundary fence is up and running. It will be quite a luxury to be able to use this points ladder without having to use a crow bar to throw the blades over.

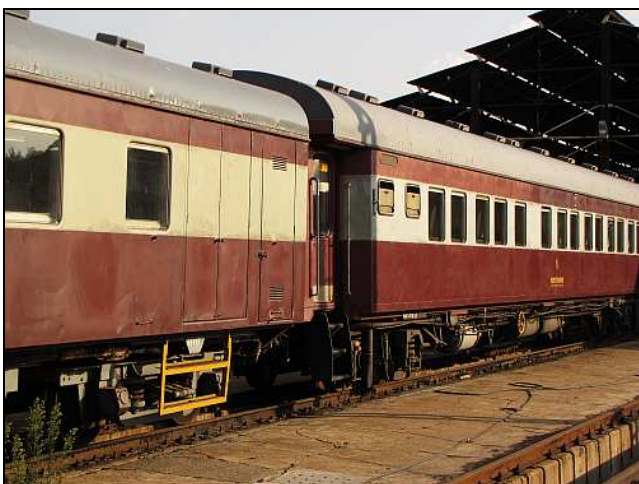
### W23 – The Lavender Special.

The S&B Power Van has developed a grease leak behind one of the axle boxes and has been removed from service for inspection. We are hoping that it's just a faulty seal but it could also be over expanded grease from a hot bearing situation. All the extra work that went into converting the lil' caboose into a small power van is now paying off!

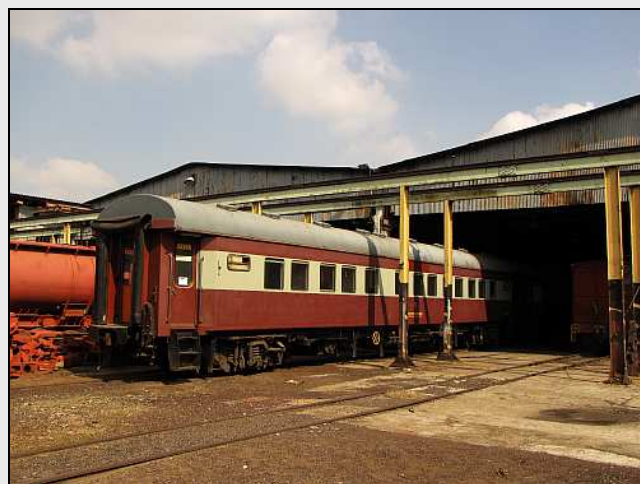
### W24 – Coaching the Gantry.

In between polishing, Oom Attie also shunted the Gold Class and one of the Silver Class coaches down into the 15M shops to facilitate commencing the Coach Upgrade Project. This is the Silver Class coach awaiting her turn.

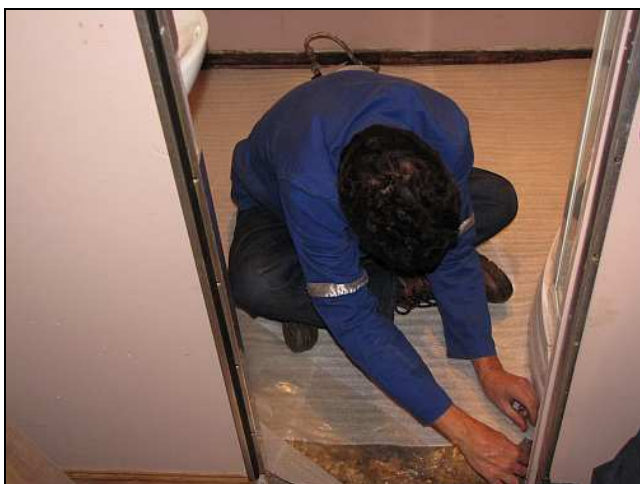
**W27 – Painstaking.**

The bathrooms had been previously done with domestic vinyl sheets. The problem is that they get stiff and then crack at sub-zero winter temps when the coaches stand idle, and their adhesives dry out in the heat of summer. We have since had to repair many of the vinyl floors every single time we try to run a long distance or overnight train.

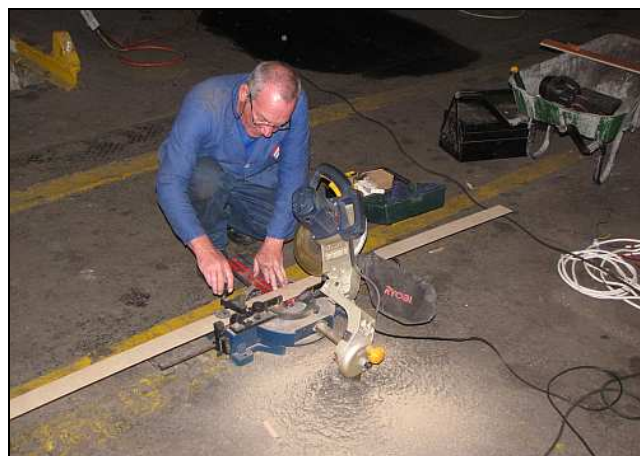
**W30 – Converting wood into dust.**

Alan and Gordon (Pictured) were using Dr. Smudge's useful little portable radial saw to cut the mitres for the skirting boards. As always, it was a trick to measure to the inside or outside ends of the cut (And to remember them) and then to cut the 45 degree angles the right way!

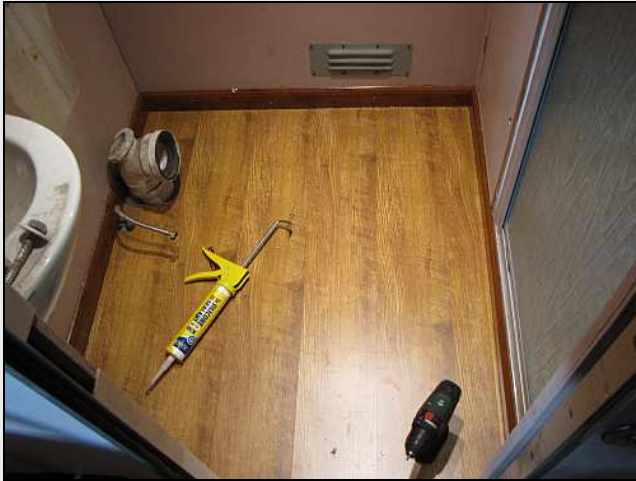
**W31 – Looking good!**

Shining in the light, you can just see the new beads of fresh clear silicone sealer at both the top and the bottom of the skirtings for full water proofing, and it will be repeated around the toilet base and the sink's pedestal. The planks are already varnished, even around their interlocking joints.

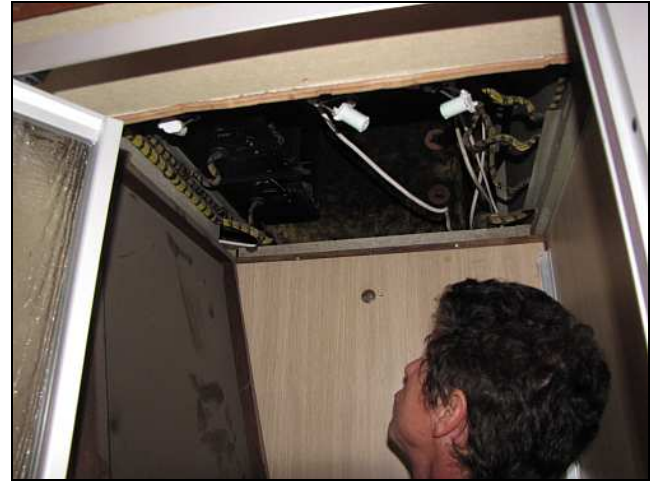
**W32 – Looking up.**

Alan looks up into the ceiling cavity of one of the cramped end-compartment showers. The Gold Class showers were actually built into linen cupboards which used to open into the coach corridors. Above the shower is the old electrical inverter chamber.
