**1). PROJECT – CLEANING THE MAGALIESBURG TURNING TRIANGLE:**

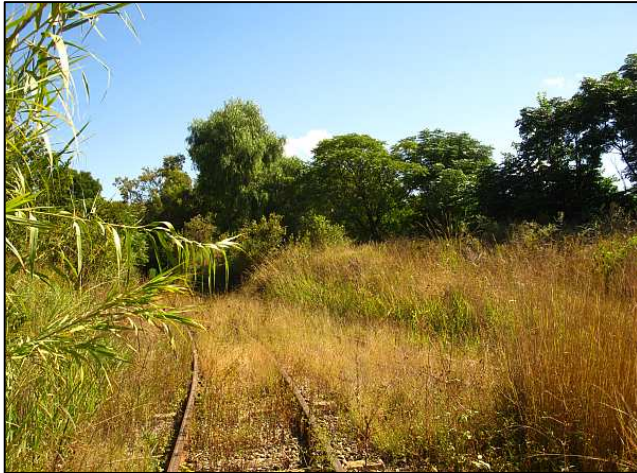
P01 - After a long warm, wet summer, the Magaliesburg turning triangle had become overgrown and the points all gritted and rusty. While Transnet will look after the major repairs such as alignments and sleepers, Reefsteamers volunteers will now need to keep the foliage under control.

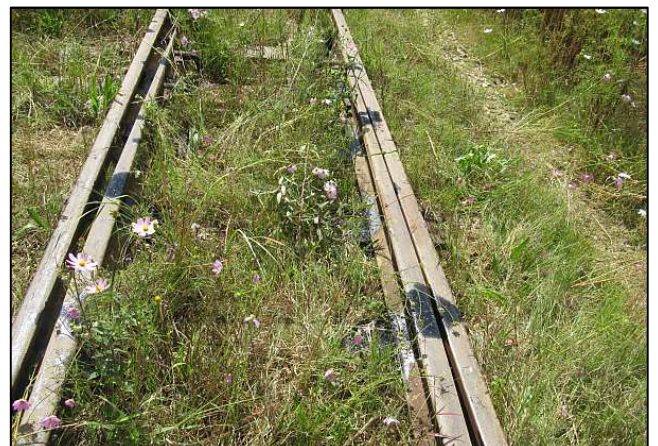
P06 - All of the points had their pads cleaned and liberally lubricated with heavy graphite grease. It was applied with a brush, so grease on the railhead was inevitable. The rail heads will need to be cleaned before the next usage.

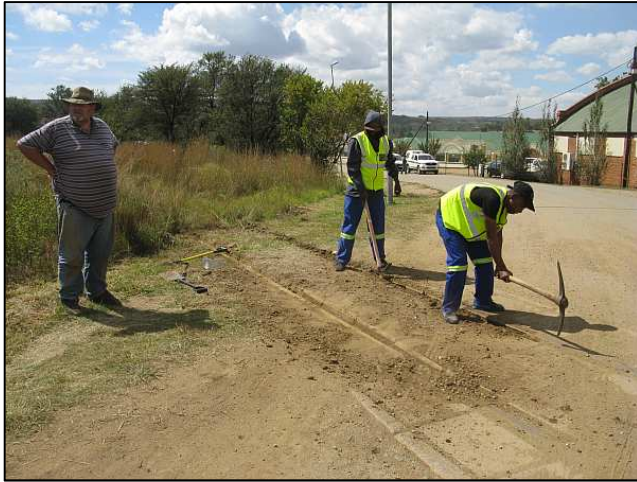
P07 - Work starts on chipping out the grooves in the level crossing. Although the fill was 'only' soil, it had been baked quite hard and repeatedly compacted by the road traffic.

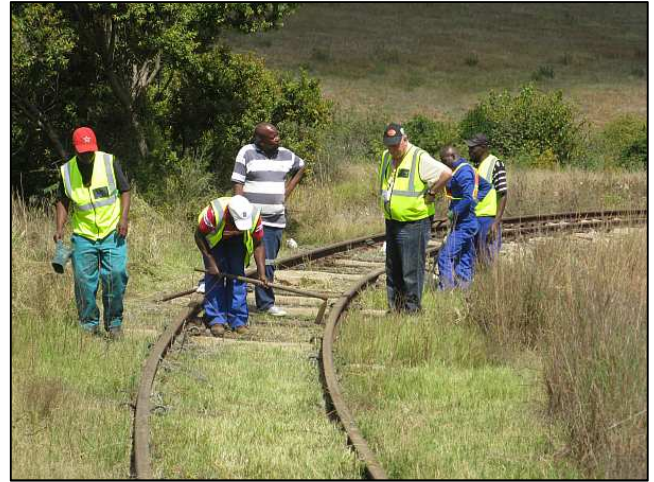
P08 - Joe's team didn't have so much growth to deal with at trackside, but the track itself was overgrown. Grass in the ballast hinders the drainage and dislodges the stones.

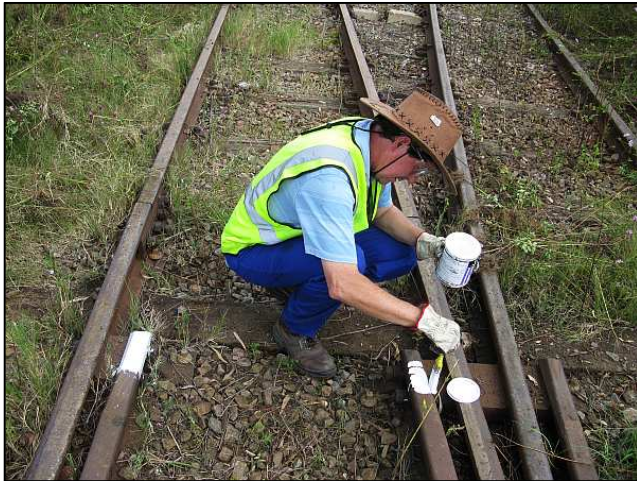
P09 - Alan Lawton paints the tips of the guard rails on the points, as per the standards required to be kept within the Germiston Depot Yard.

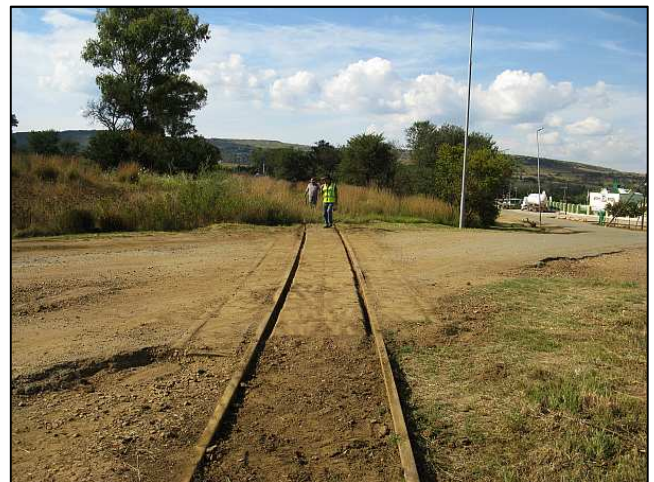
P12 - One of the two road crossings with newly cleaned-out flangeways. Now let's see if our drivers can keep the anvils on the rails instead of the roads!

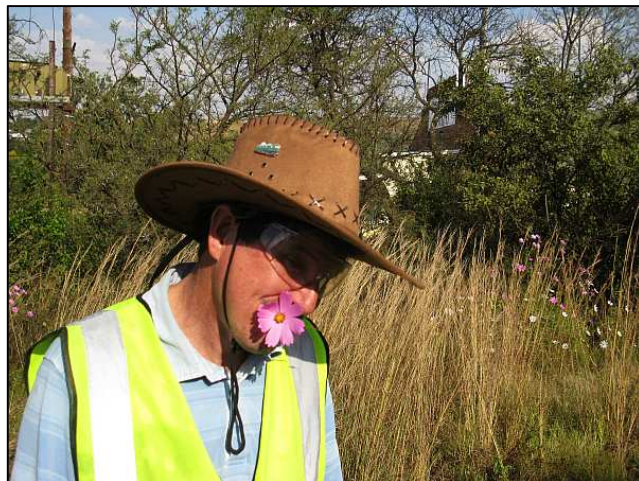
P13 - After we had carefully hand-picked the woody, twiggy bits and especially some surprisingly nasty thin-gauge thorns, we let the weed eater lads out to do the last trim.

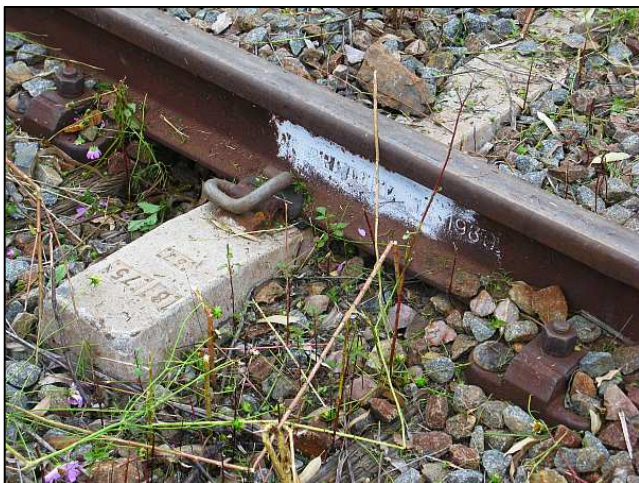
P15 - This rail was rolled in 1939 and likely saw service on the old Pretoria main. By contrast, the concrete sleeper was cast in 1975. Note the hodgepodge of Pandrol clip (left) and rail clamps. (right) Transnet will still replace the wooden sleepers for us in the event of their failure or theft.

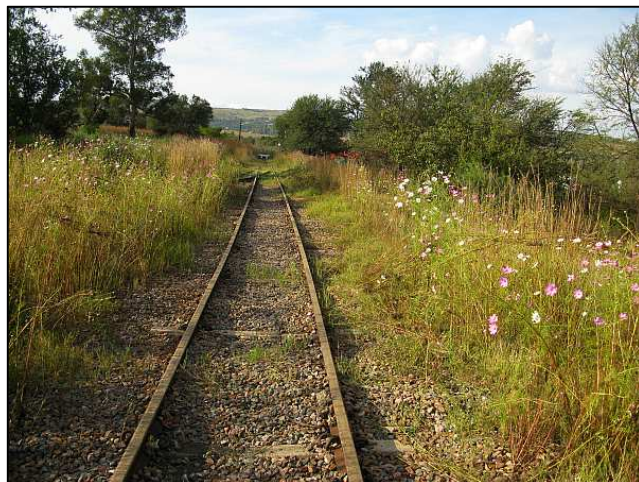
P18 - The 'final product.' A nicely cleaned length of track plucked by Jannie Gouws and little me, and then skinned with Bongani and the Weedeater. Reefsteamers needs to take over the triangle from now on, so we need to plan for a spring weed spraying and an mid-autumn burn-off.
