1). 12AR 1535 – REMOVING AN AXLE FROM THE FRONT BOGIE:

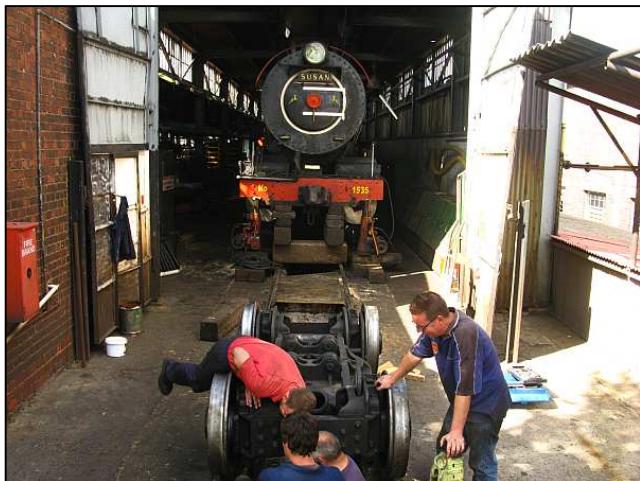
P01 - With the front bogie rolled out and the wheels safely chocked ('Scotched') it was now time to start jacking the bogie up to get the axle horns clear of the front axle bearings. We could have used a wheel pit to just 'drop' the axle, but wanted to expose the whole bogie for servicing.

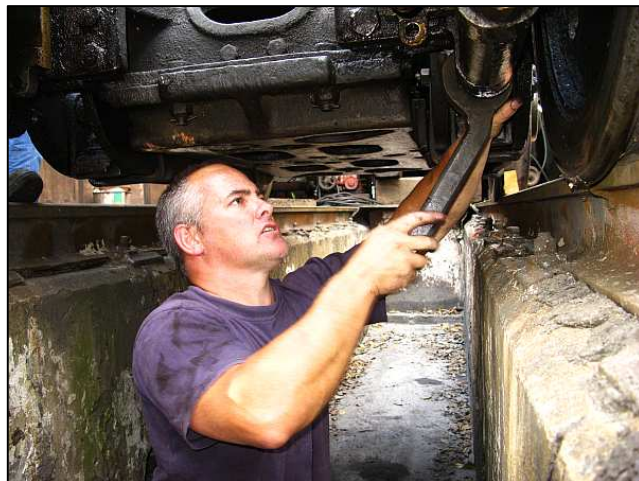
P02 - Grimacing in concentration (Trying to remember which way the nut turns?) Michael applies the slogging spanner. These spanners are intended for whacking to spring tightened threads loose, and the slender handle is also intended to be slipped into tubing for extra leverage.

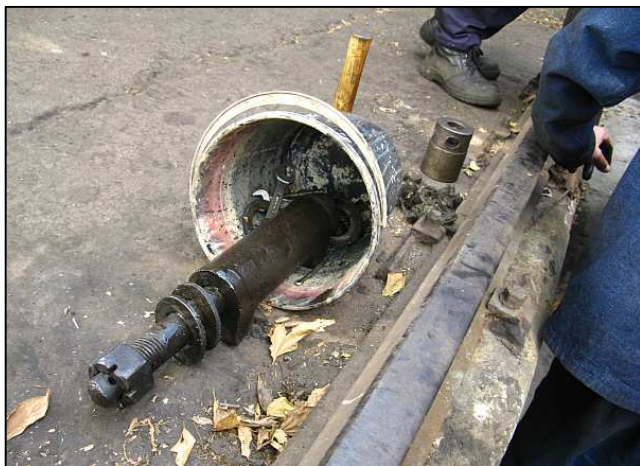
P03 - Before the bogie could be jacked, both of the front axle's tubular axle keeps needed to be removed. These span the bottom of the axle horn space under the axle bearing. In SAR steam practice, the term 'Axle Keep' is often also used to refer to the lubrication hardware such as the removable oil sock boxes and grease pad holders.

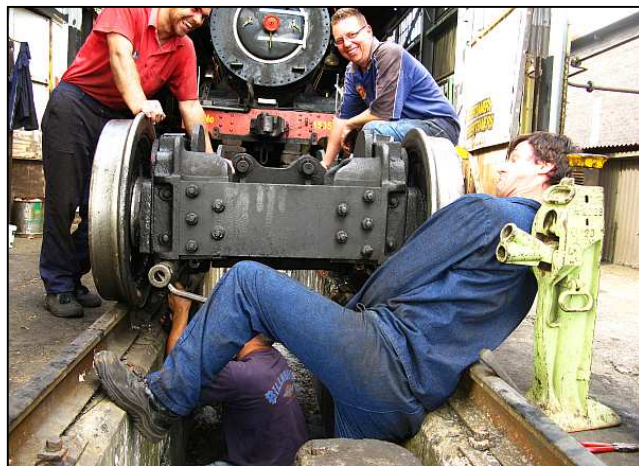
P04 - The left side (Right in the pic) came out easily enough. The nut actually span right off by hand on the decent threads after the initial 'set' had been slogged out. But the other side was binding – and 'Swak Hart' Dawie hams it up here for the camera.

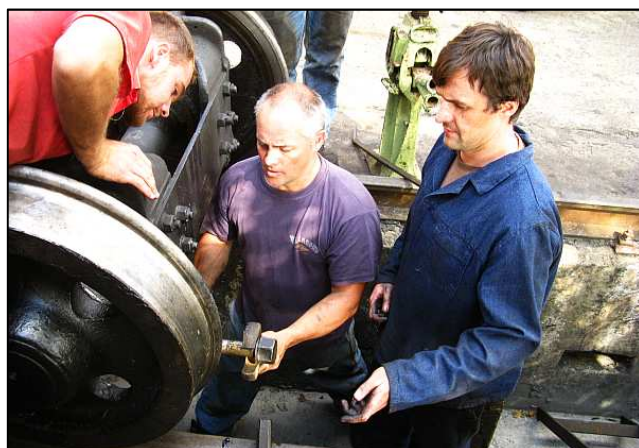
P06 - Due to misalignment, the long keep bolt was binding – even with a spanner used to drift it out under the head.

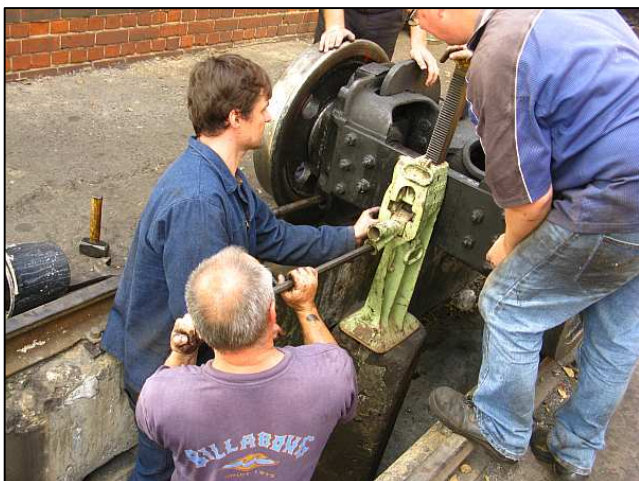
P07 - The bolt came out reluctantly but then jammed when its threads met the frame. The keep and its 'core' bolt was tilting upwards slightly. A click-clack jack was brought out to lift the frame relative to that keep and to use the weight of the axle (still on the rail) to press the keep down slightly. It worked and the bolt was then withdrawn by hand.

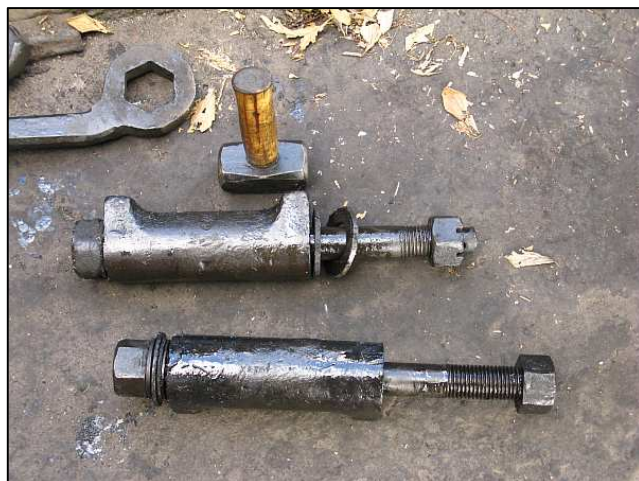
P08 - The tubular keeps exposed. The keeps are cast with generous ends to allow them to either be mildly skimmed down or to shimmed-up to suit different axle horn spans. They are not intended to be the primary adjustment for longitudinal axle box clearances though, as they would pinch or spread the axle horns out of parallel.

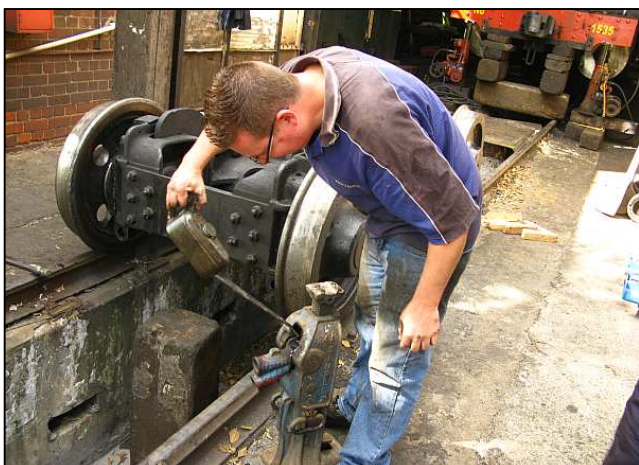
P09 - The green 'click clack' jack was changed for a 'Simplex' jack with a safer (less worn) ratchet and a lower lifting arm. It hasn't been used for a while, so Simon applies the slippery stuff before it is put into service.

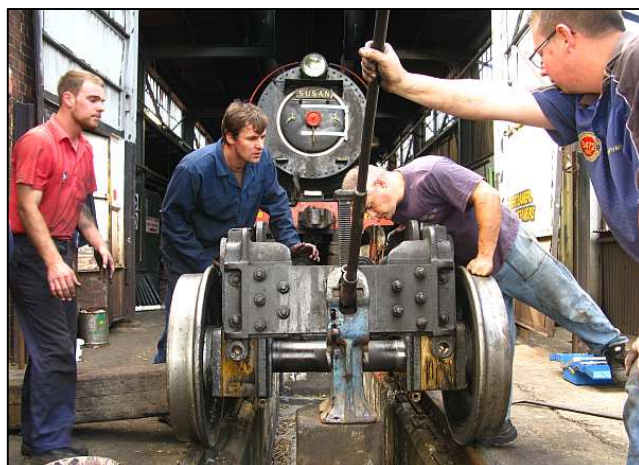
P10 - This is the first stage of a two-stage jack, block and then jack-some more operation. You can clearly see the brass axle boxes being gradually exposed as the frame lifts relative to the axle.

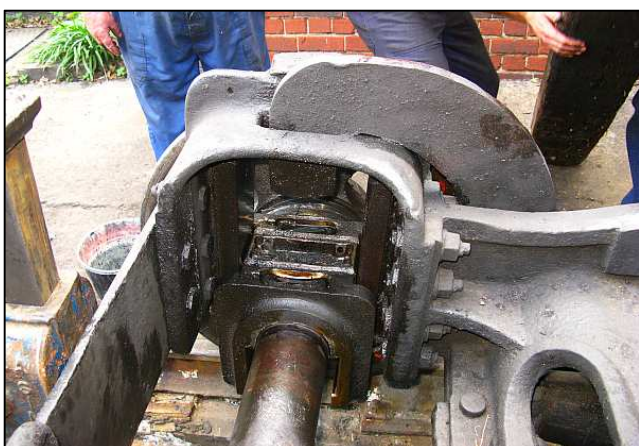
P11 - As soon as the tips of the equalizer beam clear its recess, the brass oil lids were removed from the oil basins set within the crown of the bearing.

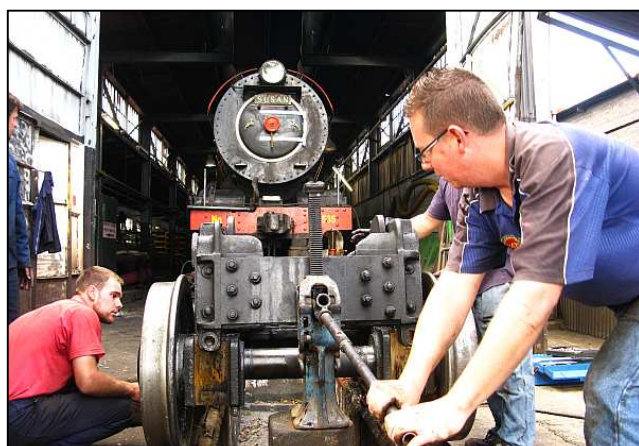
P12 - Almost at the limit of the jack and trying to get enough space for a sleeper to cross the track under the frames. Jeandre is watching the bearings as when the brasses are released, they can just pivot freely around the axle and fall off, like a horse shoe being rotated on a broom stick.

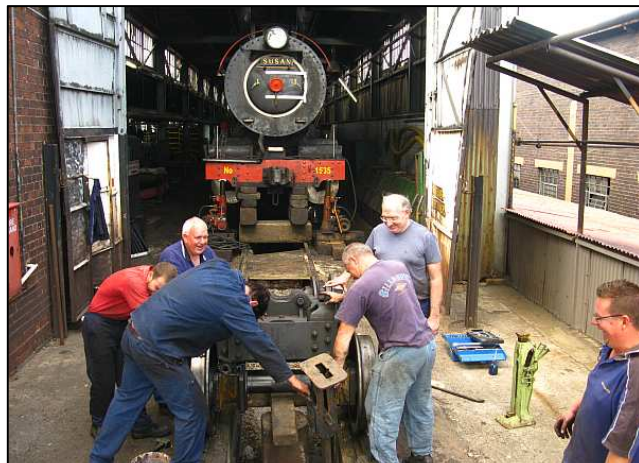
P14 - Dawie and Michael lift the jack away from the blocked-up bogie before the axle could be rolled out.

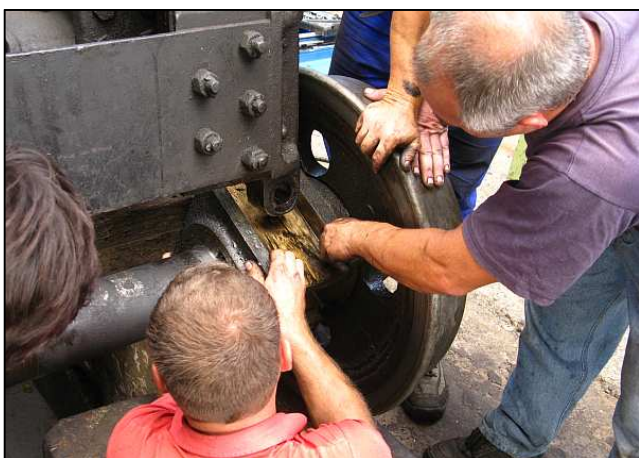
P15 - The heavy brasses are rotated on the axle to clear the keep bolt eyes – and both of them have to be turned around at the same time, preferably without denting the horn faces. This is a deceptive operation as the axle takes the weight, but not the inertia, and it is easy to rotate the bearing too far and suddenly lose your oily grip.

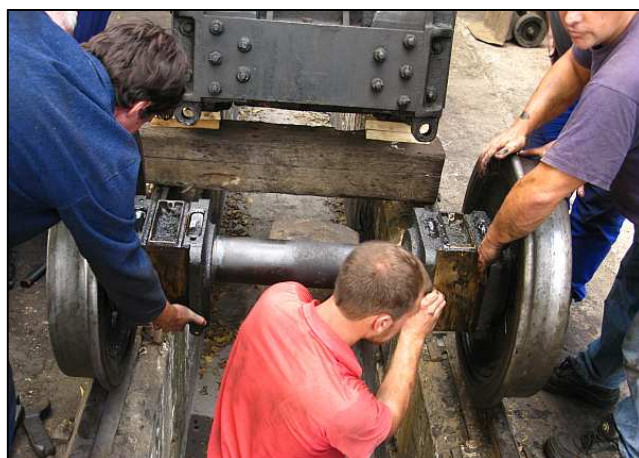
P16 - The front axle is now completely out and being rolled carefully towards the viewer. Notice how Dawie (L) and Jeandre (C) are supporting the bearings against the counter-drag of the rotation. Dawie needed a more secure grip as he had the damaged bearing with the grooved axle journal applying more force.

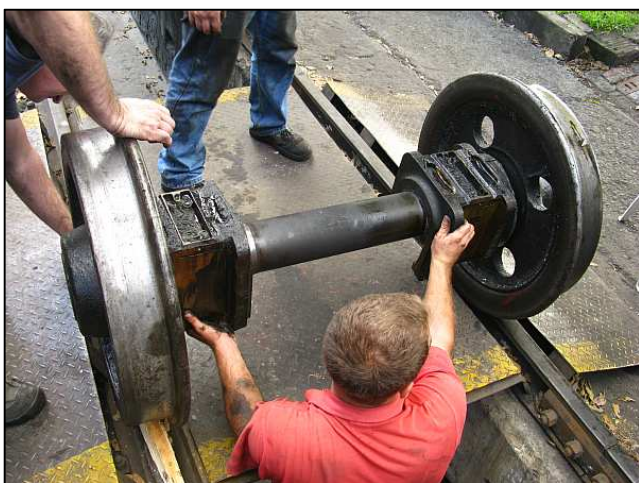
P17 - The axle was rolled over the walkway and was scotched-down by Aidan while Jeandre continued to stabilise the two bearings from accidental rotation. (Even though they didn't have far to fall – the purpose of this location.) Thus, you get a view of a complete loco bogie axle and its two 'plain' bearings in situ on the axle journals.

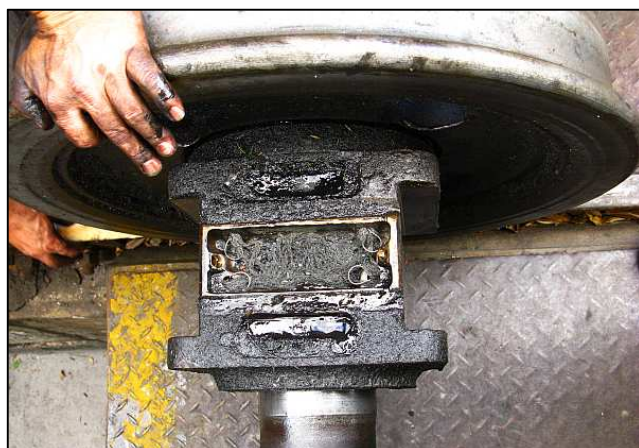
P18 - Another view of the crown reservoir. It looks empty ... which is normal as the wicks continue to deliver oil even when the locomotive is out of use. (All wick-type oil cellars auto-feed until empty.) The fault turned out to be elderly axle oil socks that collapsed under the bearing journal – and it is those socks that provide the main lubrication when the engine is in motion. This axle was relatively new and did tend to a bit run warmer than the trailing axle anyway.
