1). 7 JUNE 2014 - TRACK INSPECTION AND FIRING:

2). 31ST MAY 2014 – CLEANING OUT THE TOP SHED:

3). 24 MAY 2014 – MOVING THE SANRASM TUBER SWAGER:

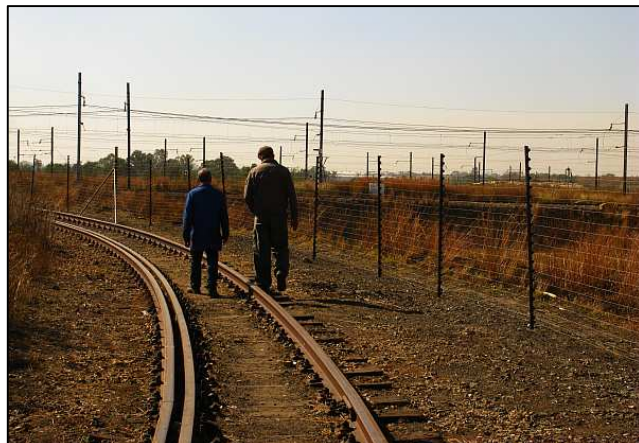
P02 - Gordon and Shaun are discussing the coming repairs to the turning balloon. The sleepers are rotten in several places, the track has a few kinks and many of the fittings and bolts for the check rail (inner rail) have been stolen.

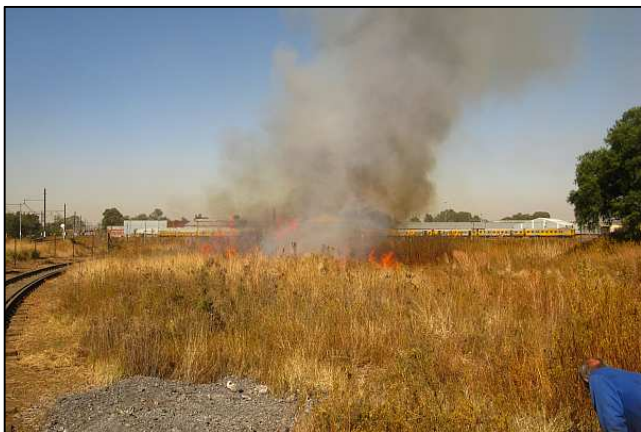
P03 - We fire the depot grounds once a year to keep the overgrowth down. The staff had been deliberately cutting strategic fire breaks over the previous few weeks. Grass firing also eliminates the hiding places that metal thieves frequently use to away hide from our security patrols.

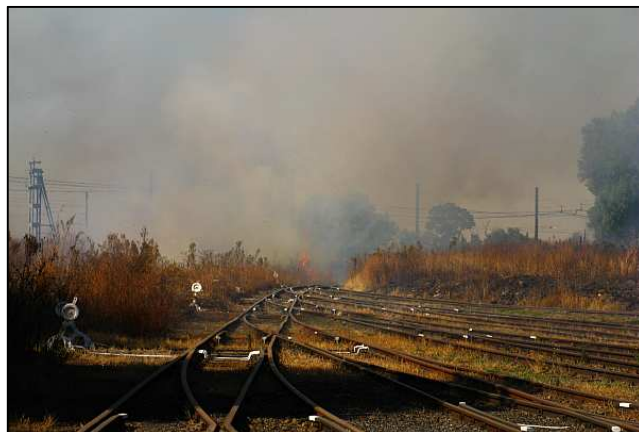
P04 - We also fired the grass around the head shunt. The track is poorly designed, being on curved track. The long grass of late summer can be hazardous for the shunter on the ground as it hides him from the view of the locomotive driver.

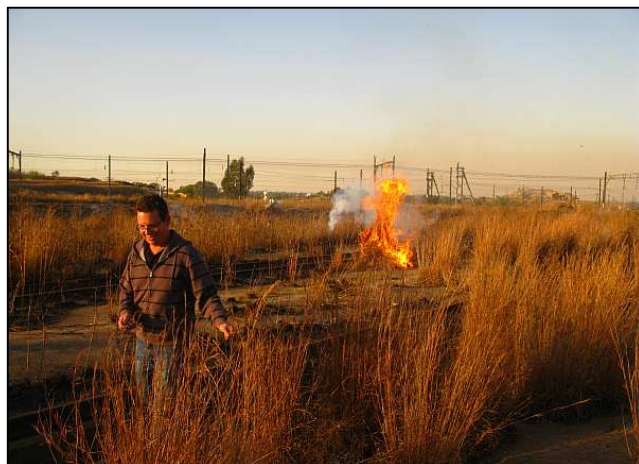
P06 - A Bad Bennett is a happy pyromaniac! This is the earlier washout area with just a few railed pits and a weed-grown concrete slab remaining. One of our dreams is to fill the pits in, screed the concrete level and to use this as a model live steam station and service facility serving a track running inside the turning balloon.

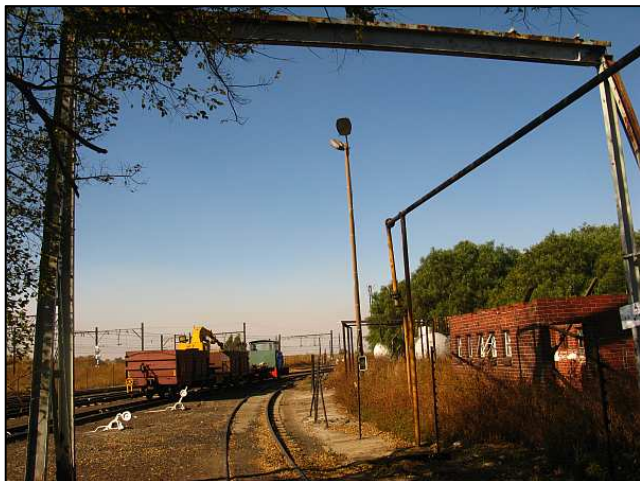
P07 - On May 31, the opportunity was taken to get the coal handling wagon into the unoccupied east end of the 'Top Shed' while the 15F locomotive was out on a run. (The more usual West-end is blocked with the jacked-up 12AR.) We would be using the grab bucket to hoist away junk.

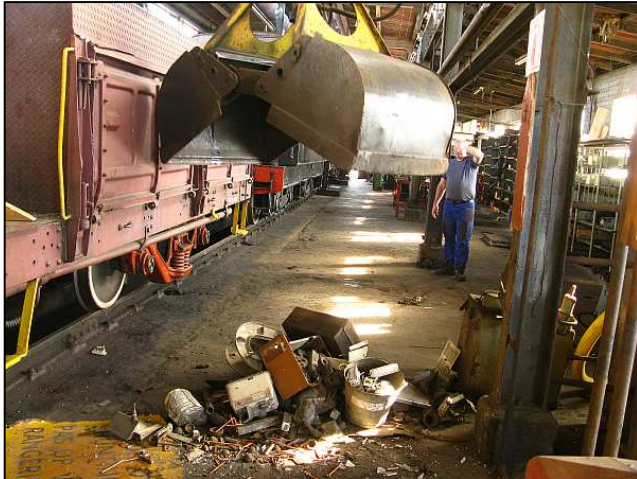
P13 - This is about the fourth load. We could have dropped the sides of the bunker and tossed everything in – but why bother ... as we had some heavier stuff to hoist over the high sides anyway. (The checker plate scuttle boards above the DZ-style drop-doors are not removable.)

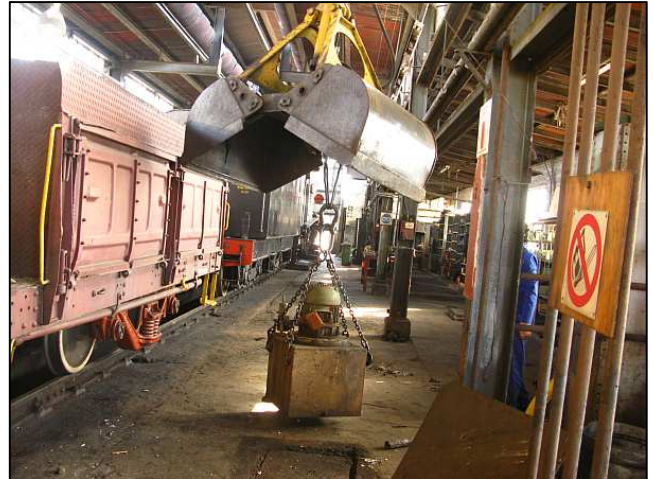
P14 - The hydraulic pump pack is being hoisted out. Rather than scrapping, this unit was being relocated into the 15M shop for repairs. The motor has been damaged by water ingress from the leaky roof. (We use this machine to test the integrity of newly repaired superheater elements.)

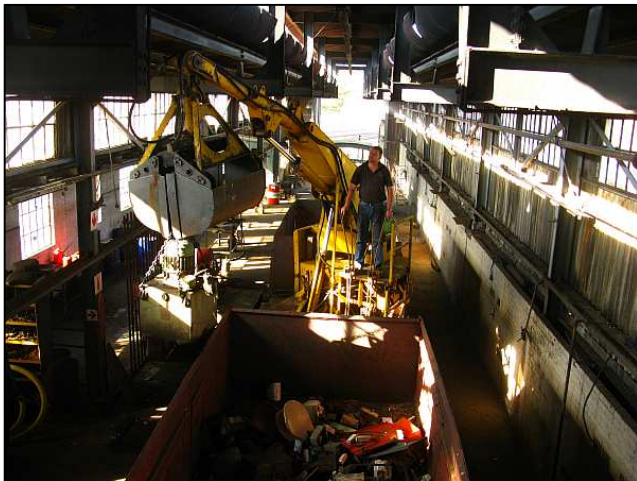
P15 - The high sides made lifting the bigger items more awkward as we couldn't get enough height in the boom under the roof. There were some near misses with the lights too. For this move, the train had to be shifted gently for an extra last few inches clearance below the roof truss.

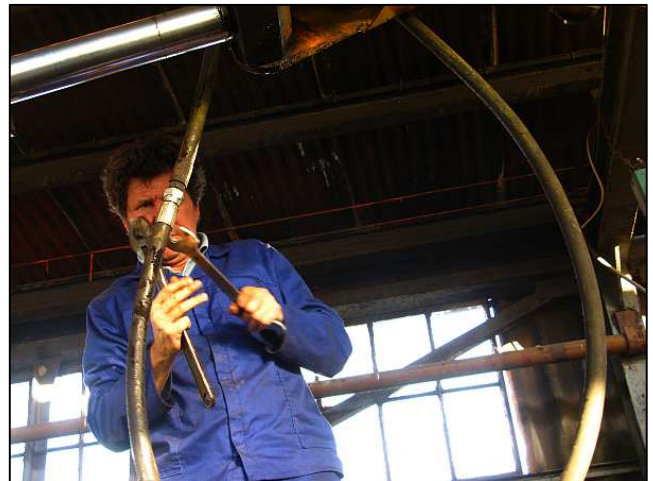
P16 - With the gripping of incompressible objects in the grab, the hydraulics took some strain and one of the hoses burst. It was the hose to close the grab. Alan quickly couples the hoses together to form a bypass loop and the clamshell would remain open for the rest of the day.

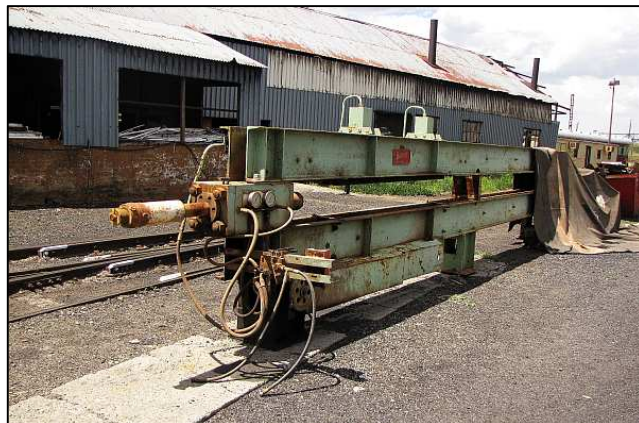
P18 - Here is the rescued Tube Swager in its entirety. It is a simple machine. The hydraulic ram forces a mandrel into the ends of an annealed tube to flare it out. The two rams on top push a Vee-clamp down to hold the tube in place. The brace in the middle is movable and acts as a backstop.

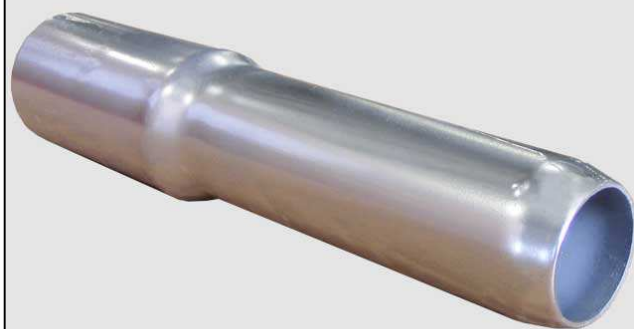
1-1/2" Sch. 40 Pipe

P19 - Here is a swaged pipe. The tube swager is generally used to open up a tube as shown to the left. Reefsteamers avoids swaging boiler tubes if we can – but it is a common industrial practice on static boilers and not many people do it in bulk. We can, once we get the machine running. '\$\$\$!'

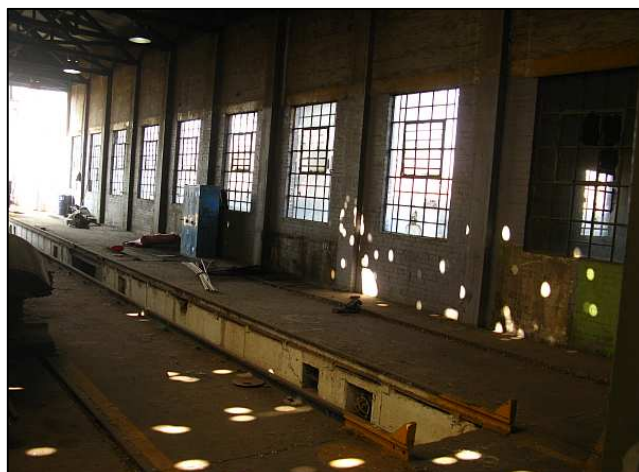
P20 - This is the sun-spotted No.8 bay. Because of the long, thin shape of the Tube Swager – we need a long thin area with both side and end access. The Tube Swager is one of three commercially-orientated projects we have in mind to earn revenue via the use of the workshop facilities.

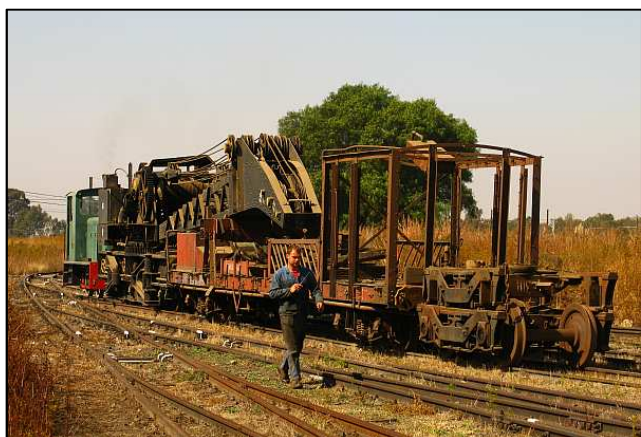
P21 - The pushing move was taken VERY carefully due to the double-stacked bogies being shoved by the crane. These are salvaged tender bogies fitted with roller bearings. They are destined for the upgrading Class 15CA No.2056's tender, which still has plain bearing bogies.

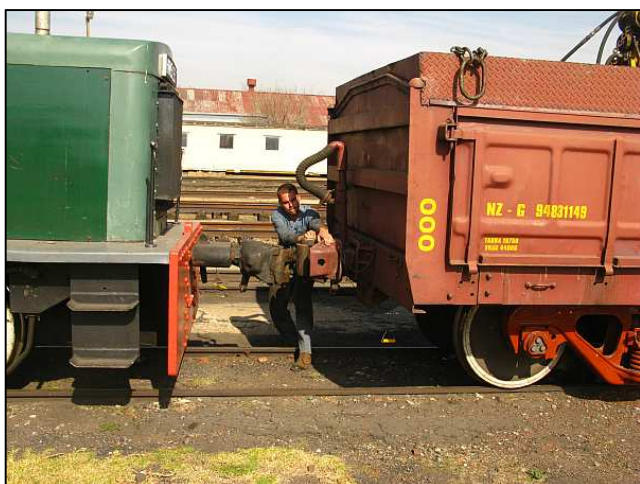
P25 - The wagon's coupler had ended up pushed slightly out of alignment, the effects of which are worsened by the sagging 'alliance coupler' on the diesel. Carefully standing on the driver's side, Jeandre yanks the coupler over.

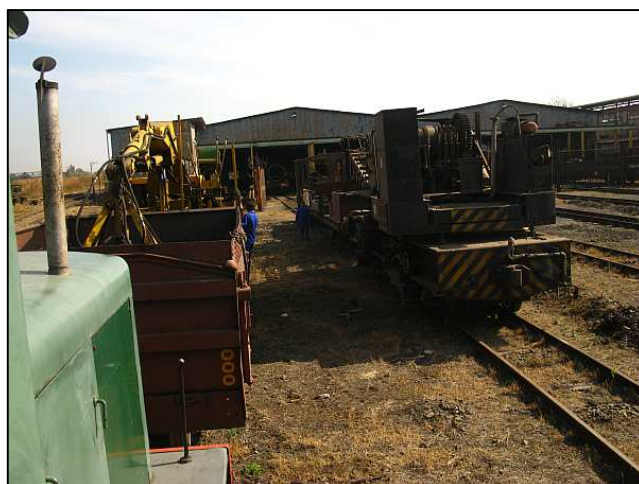
P26 - Alan Lawton (in blue) was already waiting at the head shunt's points tumbler after we had made our long journey back. With the number eight bay cleared, we could park the grab next to the swager and start the hoisting.

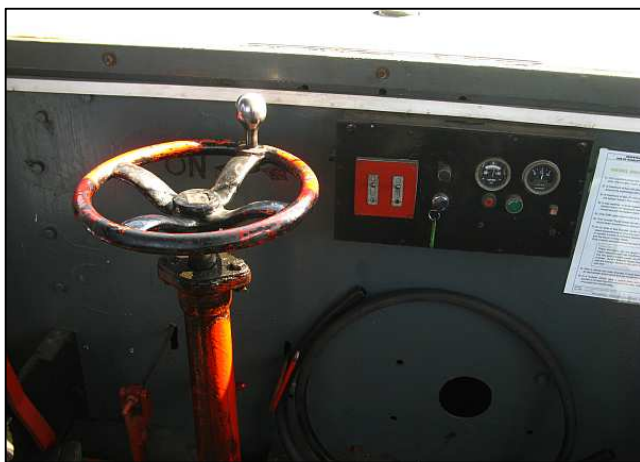
P27 - 'Andrew's' brake wheel stand with the tricky left-hand thread. (Note the left arrow.) The voltmeter shows why the battery keeps going flat. Just under 13 volts is insufficient to charge a calcium LA battery – the Lucas ACR alternator on a slow running diesel motor just isn't up to the task.

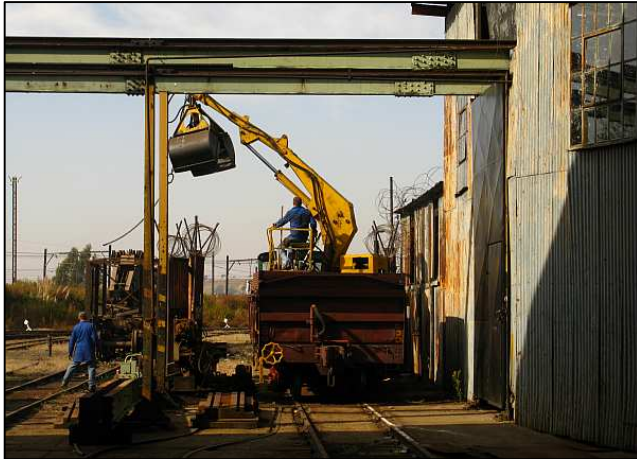
P29 - A great start to the job – you can see the octopus chain swinging from the grab – it had jammed in the grab's pivots. This photo shows the obstacles and walls restricting both the arc and the height of the boom operation, making this technically simple job into a proper 3D challenge.

P31 - When the grab was previously used to hoist the Class 12AR bogie axle, someone had unthinkingly looped the octopus chains over the pivots to make a shorter sling. (They should have been looped around the impulse bar.)

P32 - Suggested by you-know-who ☺, an unusual view of the clam shell's bucket. It was lowered and tipped against the ground and then the boom rotated to offset the weight in the pivots – it worked and we got the jammed chain out.

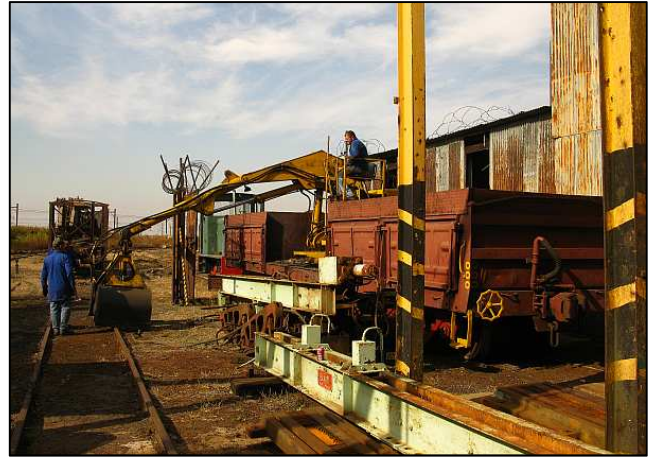
P30 - This picture is educational as it shows the full reach of our useful coal handling wagon. The bucket was placed firmly on the ground in an attempt to relieve the weight in the suspensory pivots and hopefully to release the jammed chain. It didn't. So, out came the wedges and gwalas...

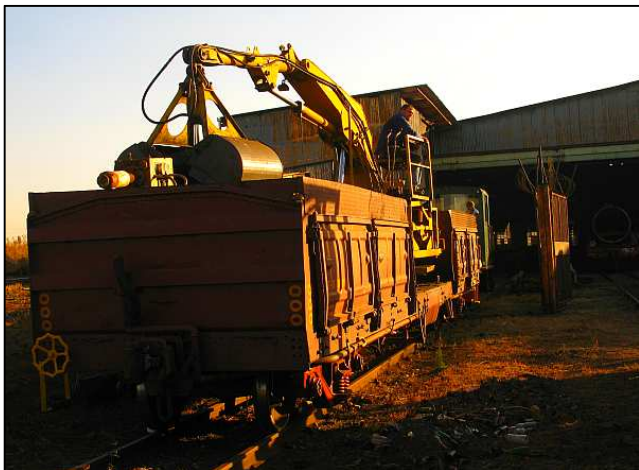
P37 - Getting the asymmetric load through the heavy gates was going to be a problem and you can see by the golden light that it was getting late. Note the use of the open grab to force the ram end down to prevent tipping.

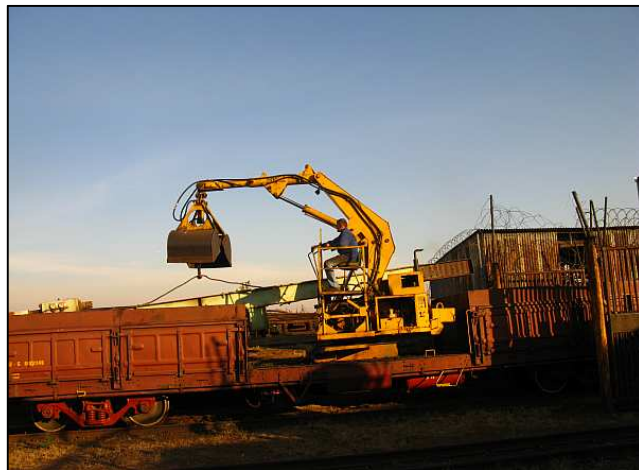
P38 - The load went through the gates, but it would foul on the coiled barbed wire and its supports. Some rather prickly adjustment took place and the load was shifted as well. It had to go in side saddle as there wouldn't be enough clearance room to lift the load later.

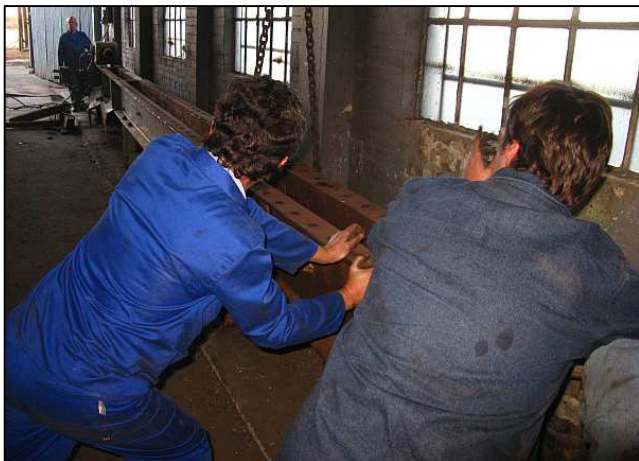
P41 - A synchronized shove to get some momentum going. The final move was a long-levered swing using the ram base as a pivot. I have frequently cursed the uneven, pitted flooring of the workshops. Now I know where those chips come from – we added a few ourselves today!

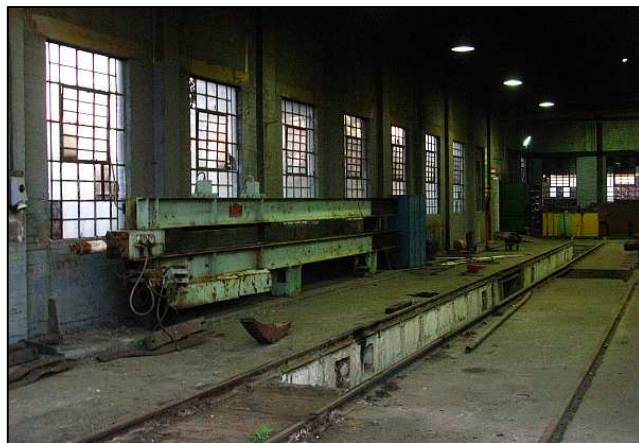
P44 - Dear ol' Swager, finally laid to rest – but to work again in the future. The machine is operated from the side but there is plenty of room for two workers to turn corners with boiler tubes which can be over 6ft long. Where the blue cabinet is will later become a tube storage rack area.

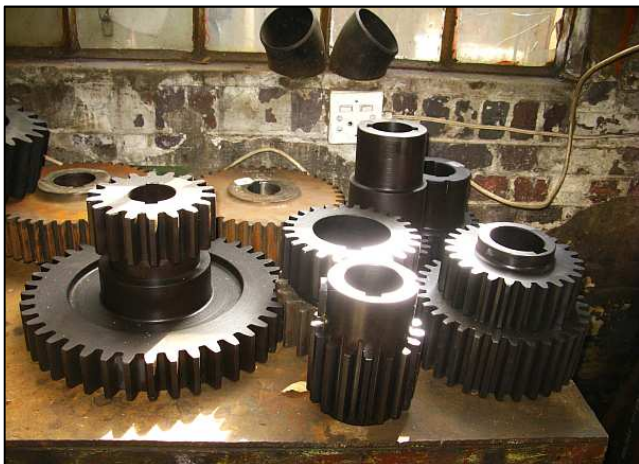
P45 - The wheel lathe gears have been returned from their hardening process and reassembly of the two gearboxes should be starting this week. We plan to contract the electrical work out and if it is done in time, we COULD have the wheel lathe running for the Depot Open Day on 26 July.
