P01 - After standing for several years, 'Dusty' the Semuma Coach is back in the 15M workshop for a total interior refit. This coach is to be refitted as the third of our rebuilt day sitters. She will be the extra coach used to allow other day-sitter coaches to be cycled out for repairs and upgrades.

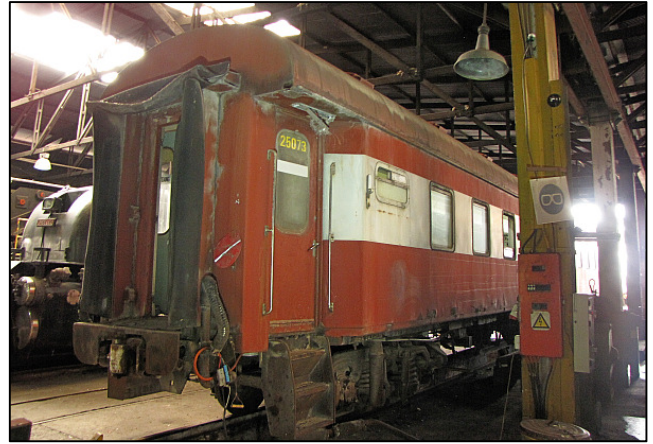
P02 - Some of the hardest work to be done is the repair of the exterior sheeting which is perforated due to the corrosion of coastal air, and the years of using steam heat. Stripping has already commenced on the obsolete steam heating and electrical equipment 'under the decks.'

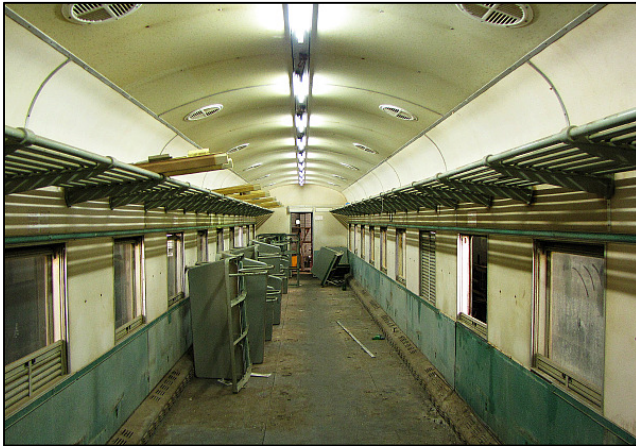
P03 - Although weathered from exposure, and still a bit caked with limestone from her days at a cement plant, the interior isn't in bad shape. It has been stripped to allow better access for a THIRD cleaning, a repaint in our two-town brown scheme and to have new floor coverings laid.

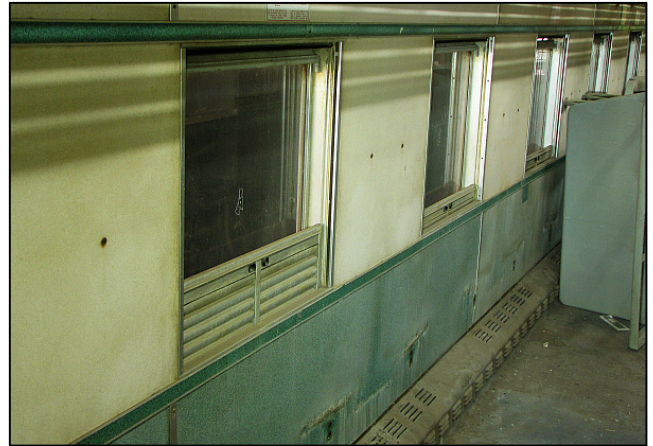
P04 - The louvered shutters are going to be removed and relocated to our sleeper coaches, where they are of more use. The louvered corner skirting and the steam heating pipes within will be removed and scrapped to allow for a clean edge to the flooring.

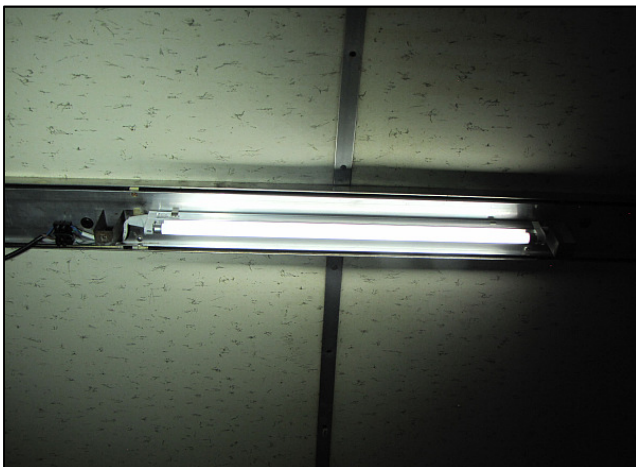
P05 - The lights in the main cabin have already been upgraded to 220V high-efficiency tubes with integrated electronics. The water pumps will need to be replaced.

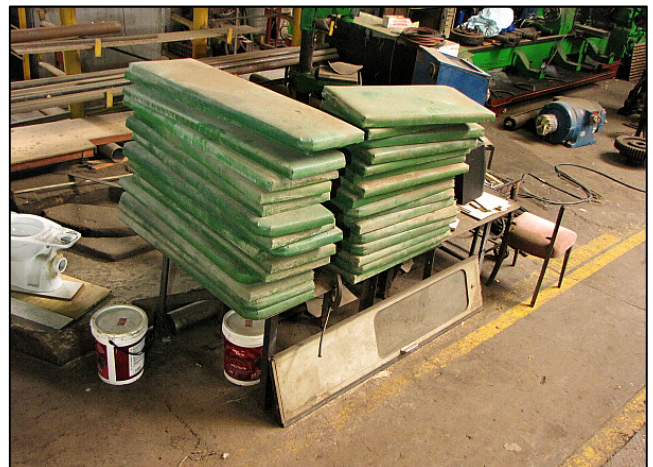
P06 - The seats and their cushions were in fairly good condition as the coach interior was never vandalized. The pile of cushions here simply need a good cleaning. They will be stored away in 'The Millsite' store during the restoration process.

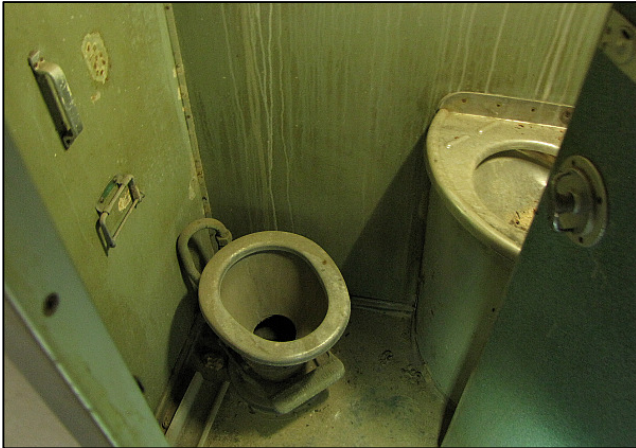
P07 - Dusty's toilets are intact but derelict. This coach will be the first of our day sitters to be fitted with porcelain toilet bowls. We are also considering using this coach as a test bed for our planned on-board cess-tank systems to gain experience before converting the sleeper coaches.

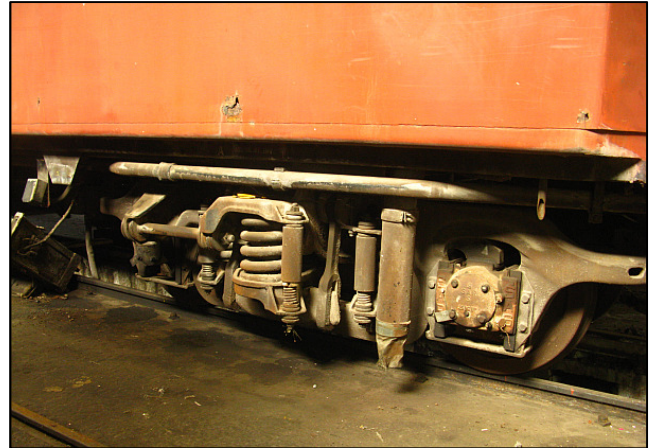
P08 - Although the Semuma Coach was roadworthy before being hauled from Port Shepstone, she will need a full undercarriage service and lifting session before entering service. Of interest in front of this commonwealth bogie is the flexible end to the toilet scat pipe as originally fitted.

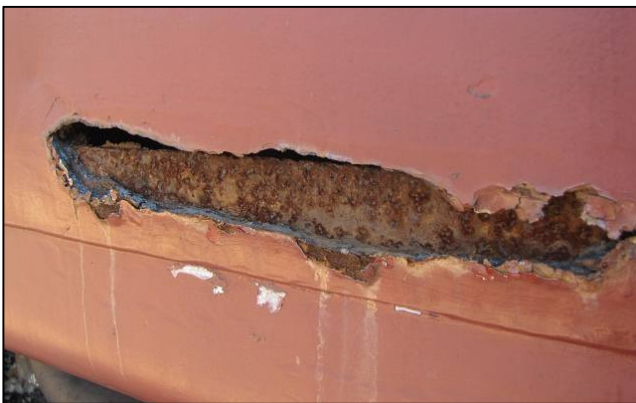
P09 - Naturally, being stored in the coastal region means a lot of rust. Thankfully, 'Dusty' wasn't stored directly at the Shepstone Coast, so the tin worm isn't as bad as it could have been. The coach boys will need to use the techniques they learned by patching up the Sandstone Sleeper Coach to fix this lot up.

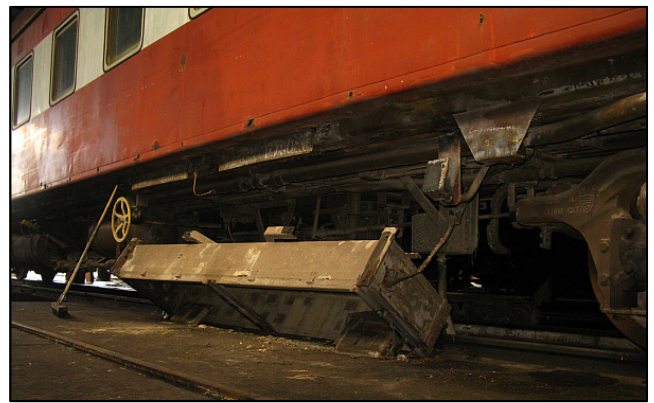
P10 - Underbody clearing is getting under way between other jobs. This is an old fibre-glass battery box that has just been cut away. Obsolete equipment is cut away to reduce weight and clutter, and to free up space for the fitting of new equipment – including the planned sewerage cess tanks. (And extended water tanks for the sleepers.)

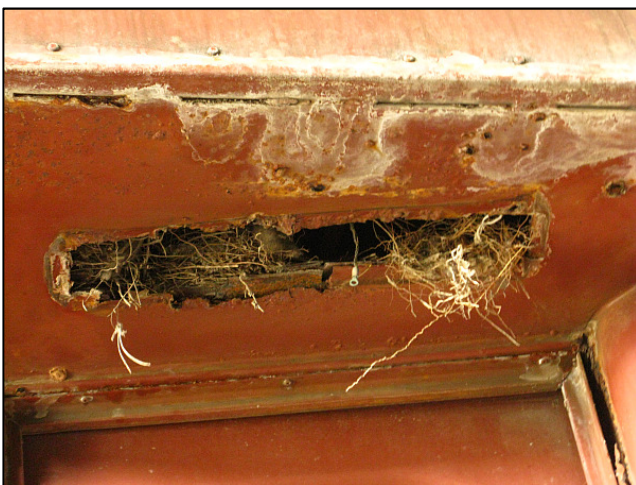
P11 - Union Carriage and Wagon duplex accommodation. Bird's nests in one of the vestibule light apertures. The entire roof of the coach is coated with baked-on lime dust from the Cimpor Cement Factory which stored this coach. This coach will likely need abrasive or chemical treatment to clean the roof for a proper well-bonded re-paint.

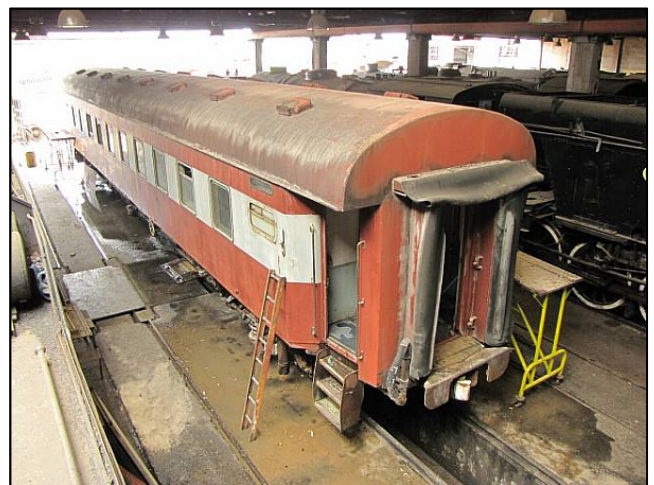
P12 - This is what 'Dusty' the Semuma Coach looked like after her first high pressure WAP washout in May 2012. You can see how caked the roof and crevices were, and where the evil rust has taken a hold.
