1). PROJECT : 12AR BOILER HYDRAULIC PRE-TEST (26 JAN):

2). PROJECT – WHEEL LATHE REBUILD:

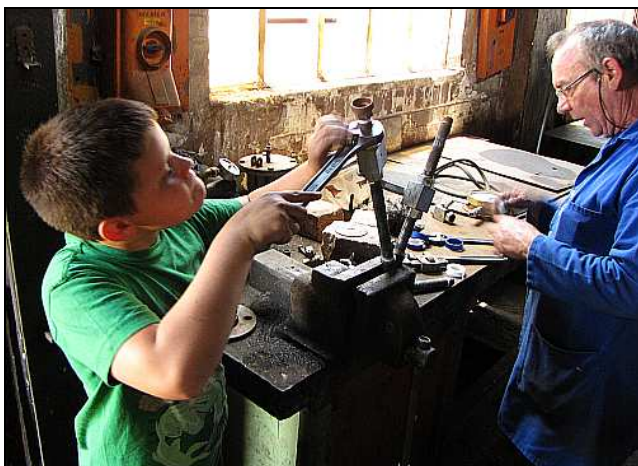
P03 – Gabriel Blore puts on his concentratin' face as he matches up the 'shifting spanner' to the pipe fitting. This would be the drain outlet. He had just been taught which way to use an adjustable spanner (Moving jaw leading into the rotation) and is happily applying his new knowledge.

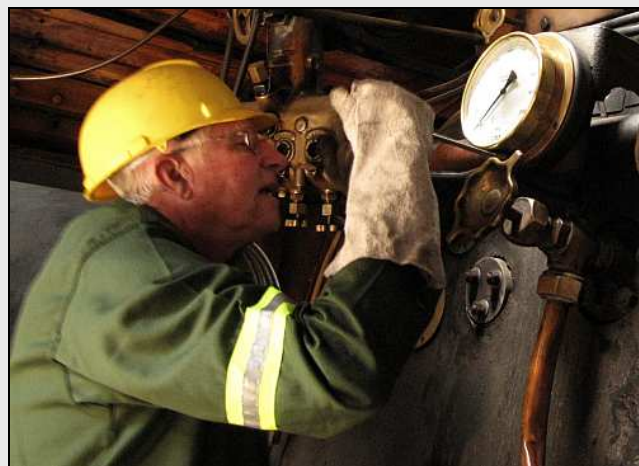
P04 – Club Secretary Stewart Currie has recently retired and will be putting some locomotive time in. Here he is just tightening the small bore steam pipe after snugging down the gauge's base ring. He wasn't sure of the gauge shut-off cock's location and would soon be doing some pipe tracing.

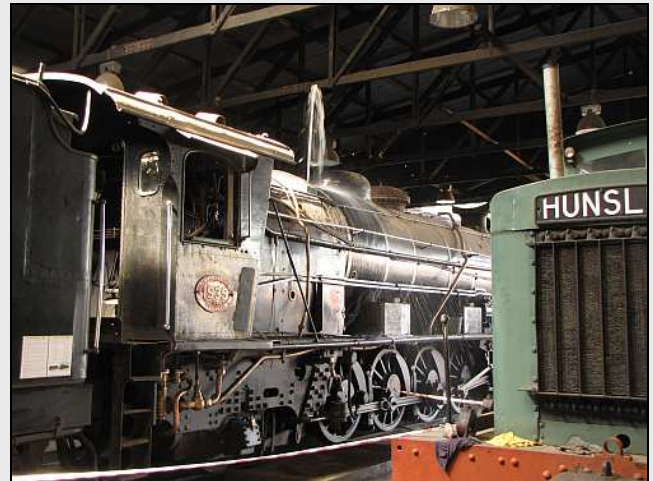
P08 – That she blows! The boiler is full and the water is shooting out of the upward-facing washout hole. This was undesirable as it becomes hard to tell if water seen trickling downwards on the boiler is from a leak or from spill water.

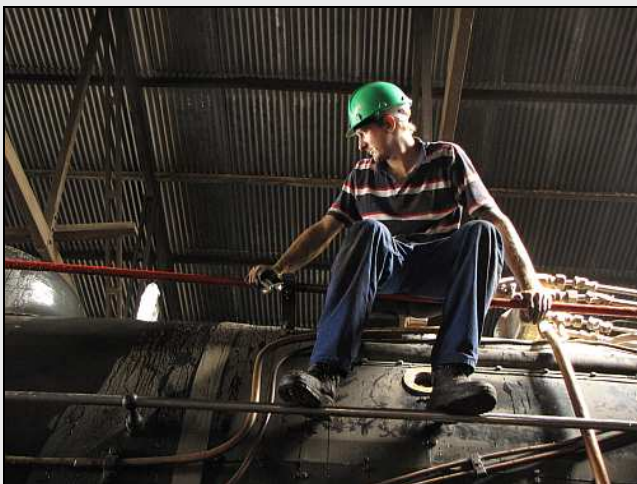
P09 – Our Hott-Nutts shuffles warily cab-wards as not to become Wett-Nutts. It was interesting to see how long the water continued to gush, even after the hose was shut off – showing how the boiler and its plates flex just under the weight of the several tons of water constrained within.

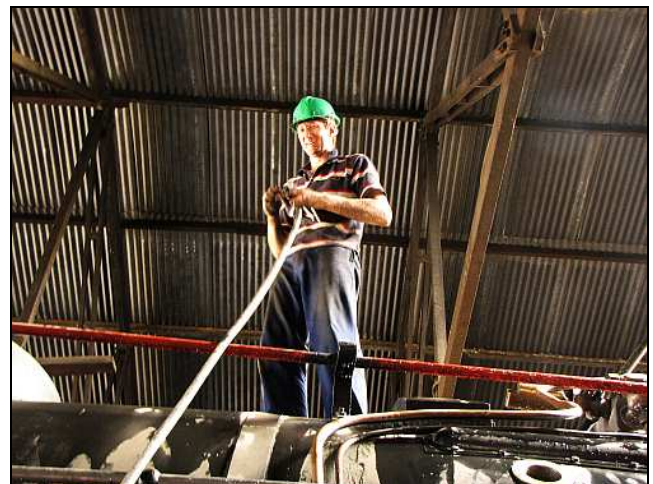
P10 – While he was up there, George was asked to clamp a long hose onto the vent pipe so we could vent air down to ground level and bleed off the initial pressurized water in a gentle fashion. The pressures attained during the official test would cause shock to the boiler if suddenly released.

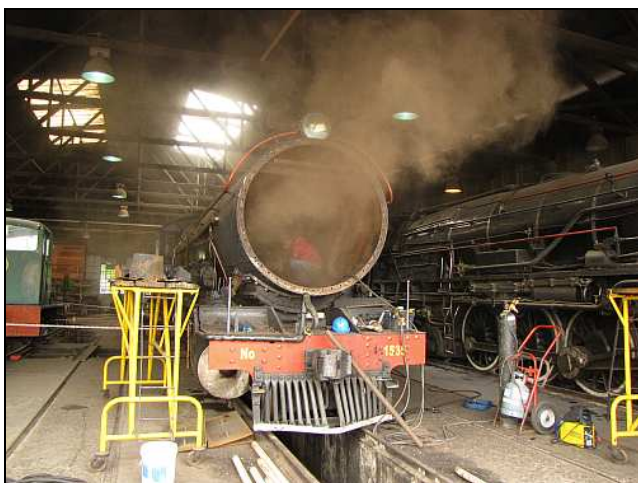
P15 – Here's what Susie's front tubeplate scrub-a-thon looked like a few weeks back with Jeremy Wood really raising the rust after the boiler boys had gotten clear. As per workshop rules, Jeremy had goggles and a facial mask on. The boiler is hydraulically tested with expanded tube ends only (rear end with copper ferrules), the rear end beading and bead-welding done afterwards.

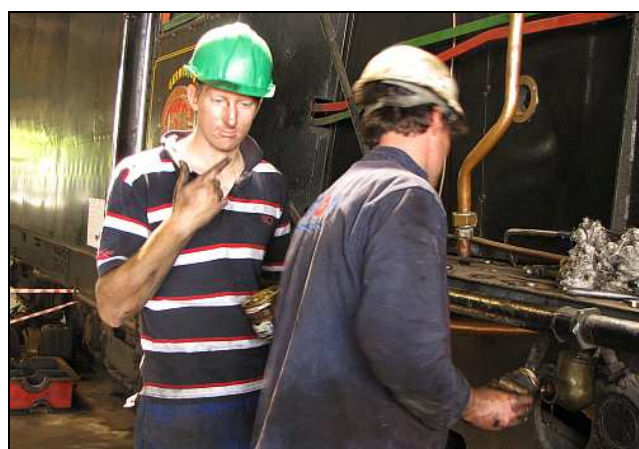
P18 – Copper Slip! Yummie! George tries it out as the slightly saner Dawie re-assembles and seals the RHS blow-down outlets. It may as well have been done even they couldn't pressurize the boiler that day.

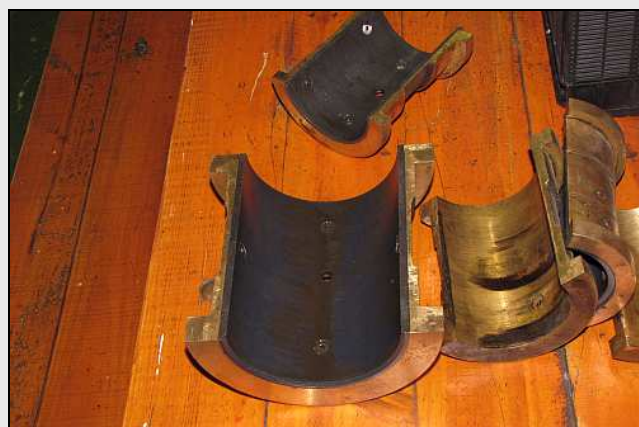
W04 - The loose bearing shells were locked away from theft and souvenir hunters. As these are gear shafts, the reaction loads are sideways rather than downwards – so the single screws are correctly at the joints where they would cause the minimum disruption to the oil's boundary film.

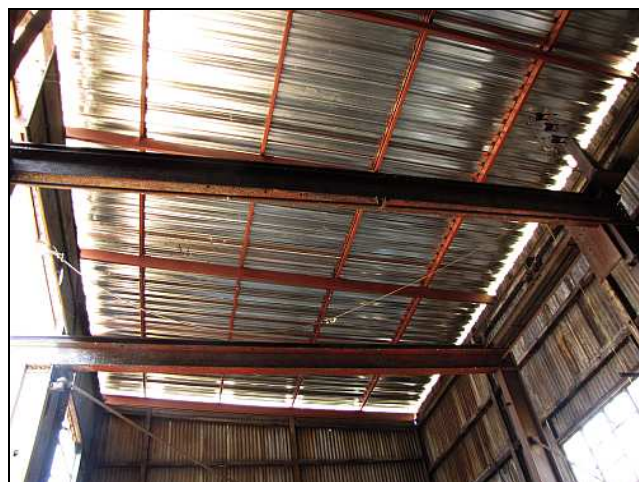
W06 – Another shot of the new roof shows a new detail. That loose-looking rope is the pull rope for the traversing crane's flap door. The rope was simply routed through a rehabilitated old pulley and extended down to ground level.

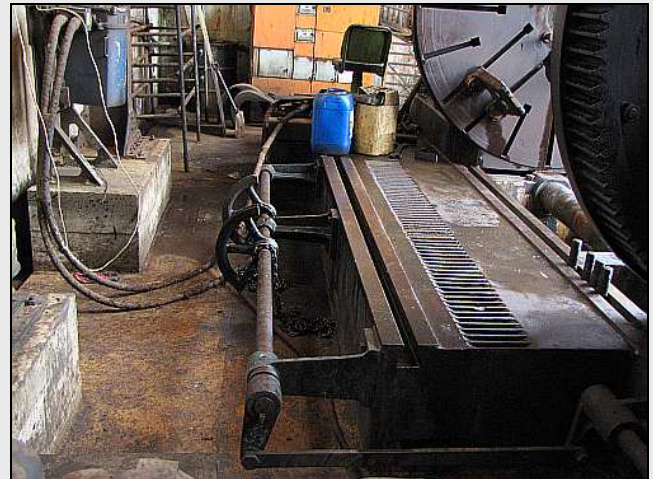
W08 – The same area a week later. The wood and floor boards have been removed. The cranks and linkages for the tool feed quadrants are now exposed. No flooring does expose the mechanical parts, but reduces the fire risk, improves drainage and reduces the risk of losing tools.

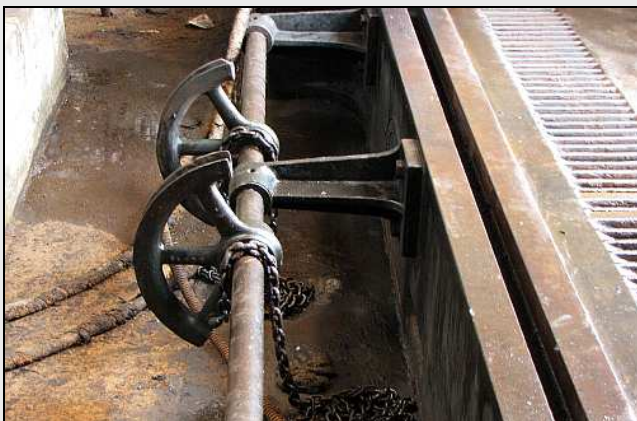
W09 – Here is a close-up of the newly cleaned tool feed quadrants. If you look at the lower end, you will see where the chains are held captive. The chains are looped loosely over the ratchets and engaged into their notched rims. Notice that the bearings have old open style lubrication holes. With the shaft clear, we might put grease nipples in.

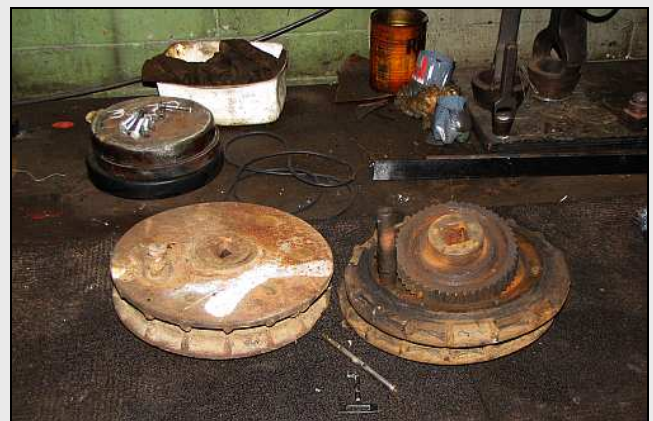
W12 – The missing tool-feed ratchet clutch (LHS) was later found amongst the junk. You can clearly see the indents where the chain links run. The chains are looped around the ratchets and are pulled at a slow rate by the quadrants. (W09) If the chains are lifted from the rims, the outer casing can be manually wound back to release the cutting tool.

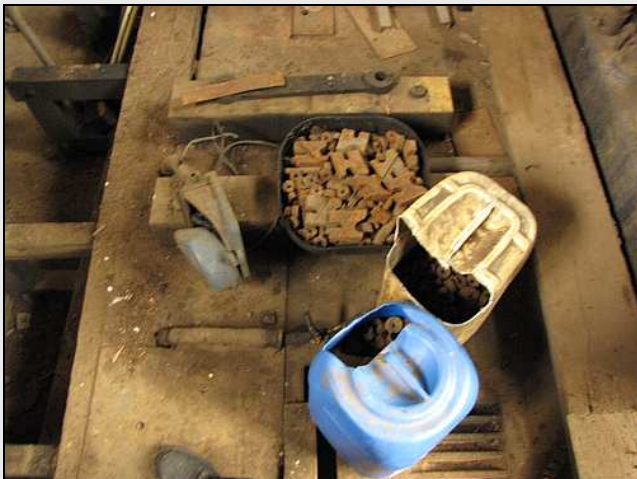
W15 – Three containers of cutting tools and accessories were recovered from under the floor boards and around the base of the machinery. Over how many decades have they been dropped through gaps and replacements have just lazily withdrawn from 'never-ending' stocks?

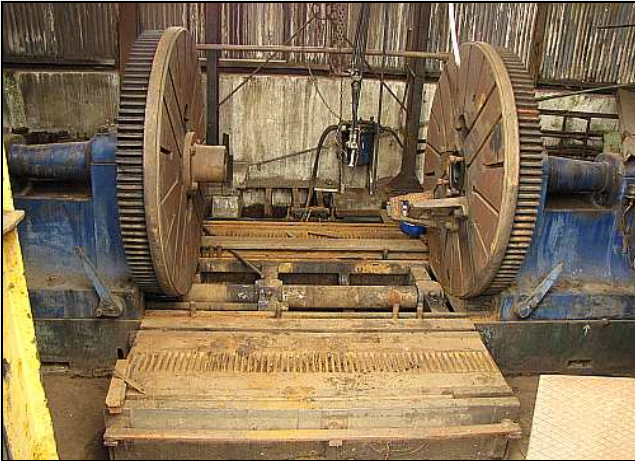
W19 – These are the two mighty wheel lathe chucks themselves, set in between two of the racked bars upon which the tool posts are mounted. We still have all the wheel clamps. Tread plates need to be re-fabricated to cover the transfer shaft pit.

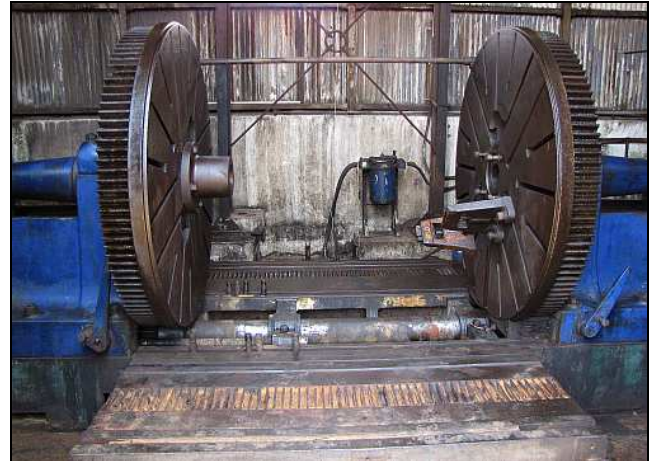
W20 – The lathe bed area has since been cleaned up and the rear tool bed has been de-rusted. The chucks have been cleaned and lightly greased. The rear bed was wire brushed, the sliding bolts loosened up (W18) and then the whole assembly sprayed with paraffin as a water repellent.

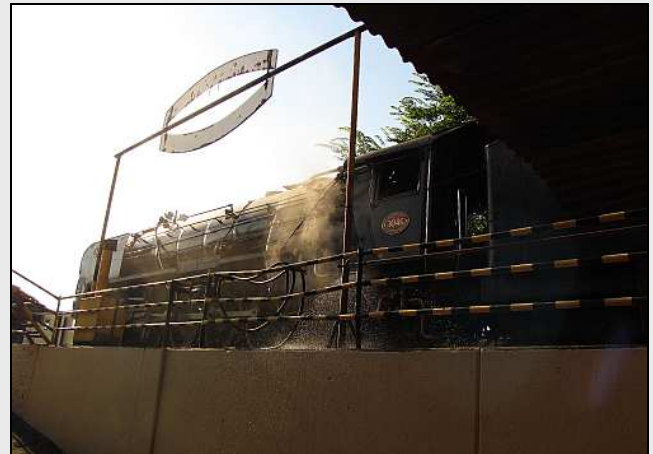
S14 – You don't often get to snap this angle in daylight, up from the entrance ramp to the 15M workshops. That water is cross-spray from the fellow hosing the ash pan down from the other side while the grate shakers are being used.

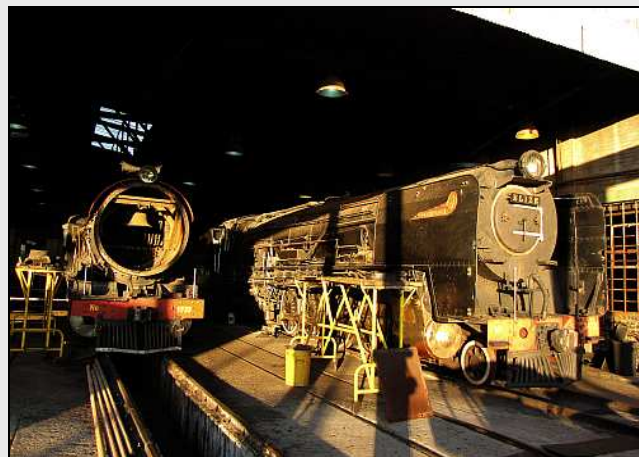
M02 – There is nothing like lying in bed and having the sun creep up and kiss you right on the face. Long-static 25NC No.3472 (RHS) is still fully functional but she awaits wheel profiling. We'll do the GMAM first, as that loco doesn't have issues with turning triangles as the long-framed 25NC does.

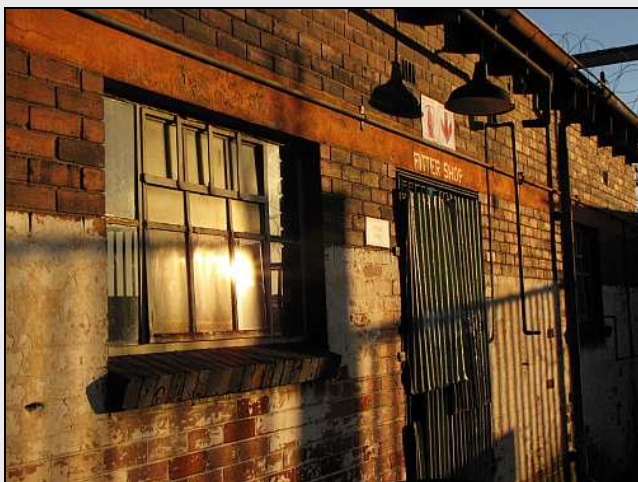
M03 – Sunrise on the Fitter Shop, north of the fenced 15M compound. This shop is being cleared out and refurbished to serve as a General Workshop, although the axle pad presses will remain. The contents of the various tool stores will also be moved here, to be in one centralized location.

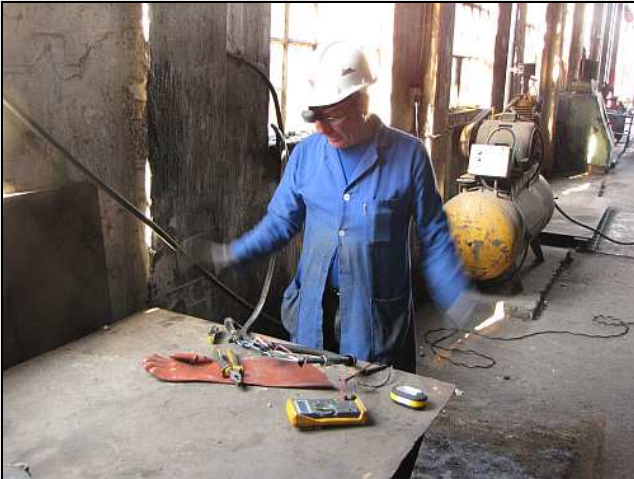
M07 – Gordon had made a temporary wiring joint for the 'small' air compressor. Is he waving the smoke away before I catch it on the cam? The 50 ton hydraulic press has recently been moved from this location to stand amongst the main 15M machine shop, as a part of the current workshop rationalization project. The compressor itself is likely to be moved later.

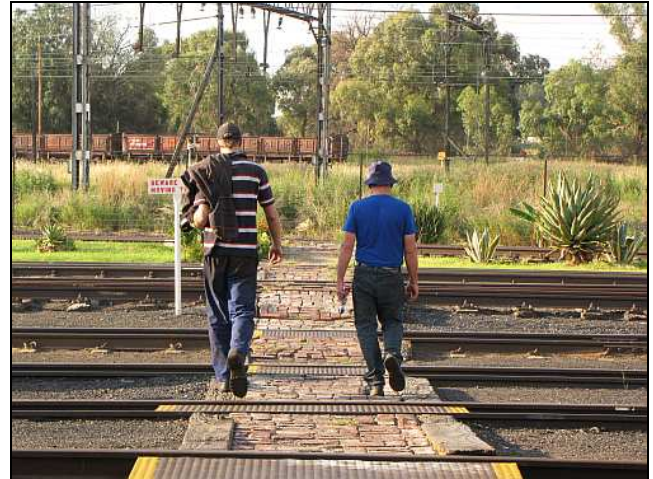
M08 – After a busy day at the Depot, George and Gordon walk off companionably. As we couldn't get the WAP going, the 12AR's boiler couldn't be fully pressurized (26 Jan.). The fellows were tired and soaked, and not up to draining the 12AR's boiler to try and sort out those leaky blow-down spacers. So they called it an early day....
