**1). REMOVING THE RIGHT SIDE SLIDE BARS – 01 MARCH 2014:**

2). MACHINED SLIDE BARS – 2014-M03-15:

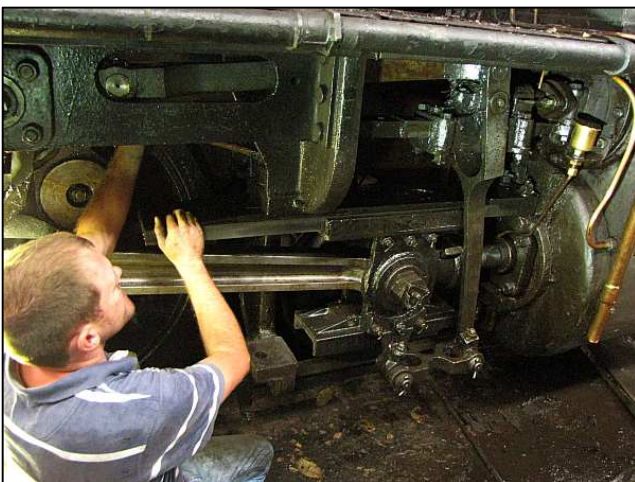
P11 - The upper bolts at the back end are easy-peasy to reach – with the fingers. But there isn't enough room to swing a dead depot rat behind the motion bracket – we lost time trying to find short cheaters to match the wrench.

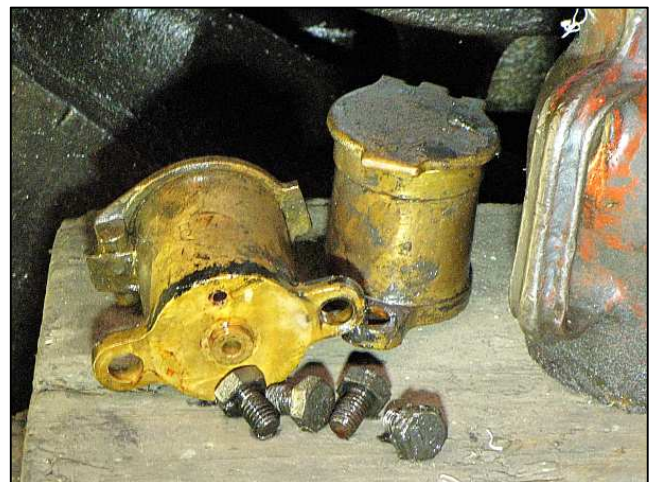
P12 - The two oil cellars were removed once the back bolts were loosened. You don't often see this underside view of a direct discharge oil cellar. (i.e. : Without a drip feed pipe.) These were carefully locked away, as all our brass stuff is.

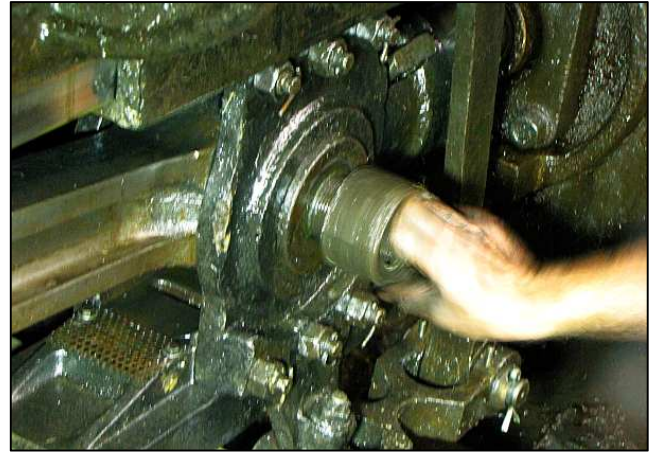
P14 - After removing the safing wires and the castellated lock washer, and then a bit o' sloggin' to spring the threads, the wrist pin nut just spins away on the juicily oiled threads. Evidence that Reefsteamers actually OILS their engines.

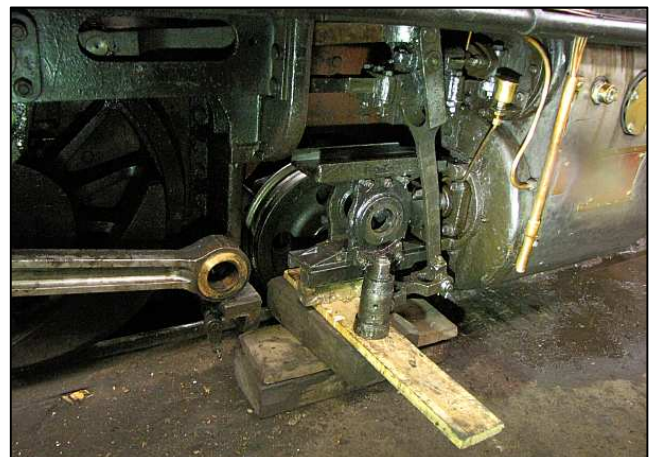
P18 - Here's the end result – the connecting rod's small end was successfully disengaged from the crosshead and resting on the rear motion bracket. The piston was pushed forward with a crowbar once a gap appeared in the crosshead bore – thus we managed to avoid moving the now-unsupported piston rod too much. (The point of this extra exercise.)

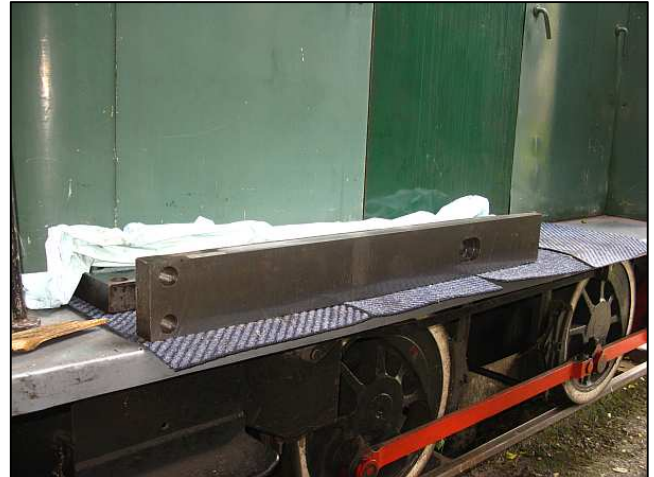
P20 - A closer view of the newly machined and freshly oiled crosshead slide bars – this is the plain-topped lower bar.

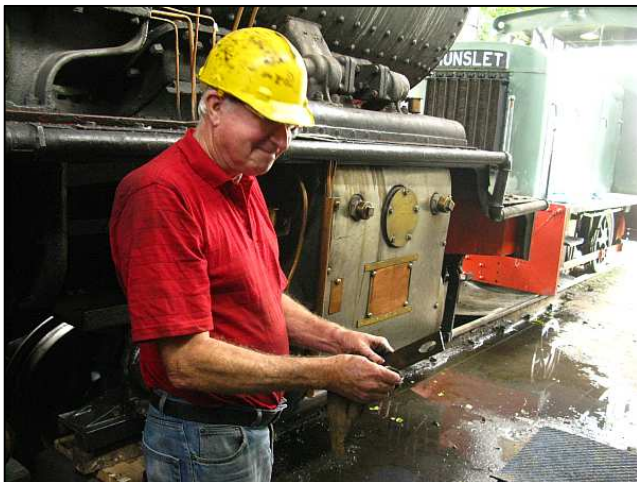
P21 - This was a day of various meetings, so there wasn't much we could do with the key guys being taken up with talking. Finished with taking notes for the day, Club Secretary Stewart Currie keeps himself busy by scraping the crud and oil off from the waiting shims.
